Field Observation Report

Project:	Riviera Club - 7500 Estero Blvd, Fort Meyer Beach, FL	Report Number:	
Client:	Claremont Property Co.	Inspection Date, Time:	Wed, 10-26-2022, 10:49 AM (-5 GMT)
Architect:		Report Date:	10-28-2022

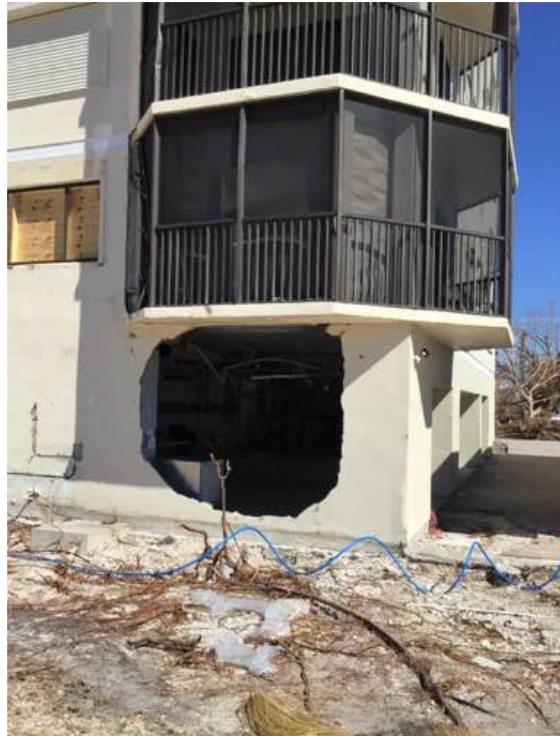
Southwest corner. Blown CMU wall with damage to the first floor slab. See following photo for slab damage.

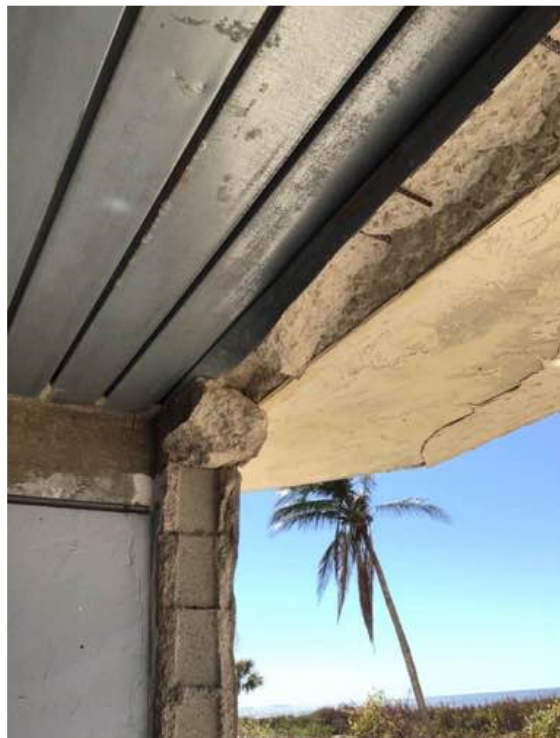
Damage to second floor slab at south west corner.

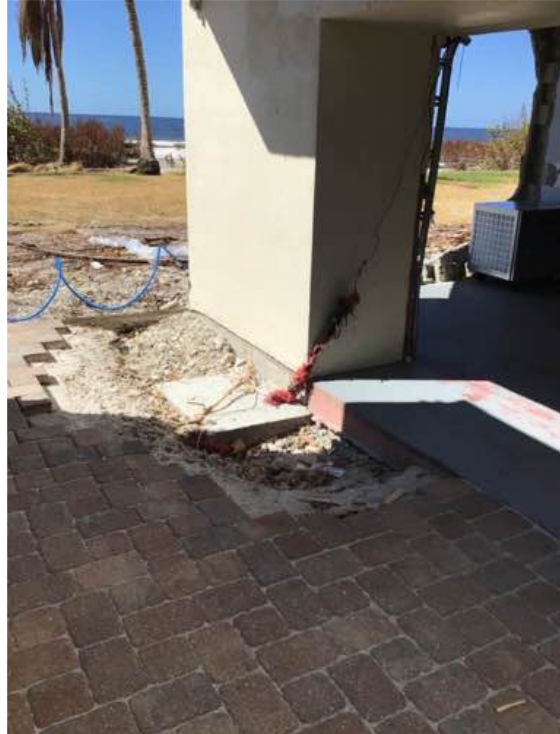
Wash out at south west corner. The foundation appears unaffected.

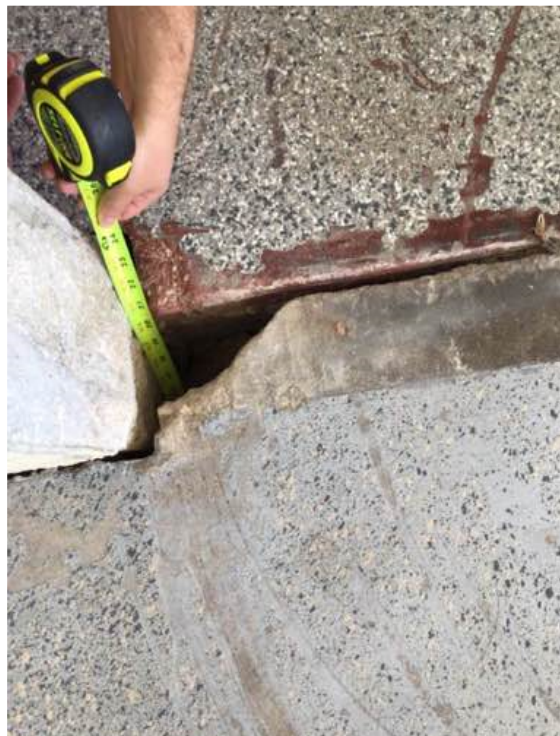
Wash out under the ground floor slab.

1. Slab wash out at the ground level. Multiple areas of voids were noted below the ground level (parking garage). Recommend the slab be replaced on a properly compacted subgrade.
2. Barrier wall and column damage at garage west of garage.
3. All ground floor CMU walls to be repaired and replaced as required.
4. Room 107. Damage to balcony. Will require further investigation and repair.

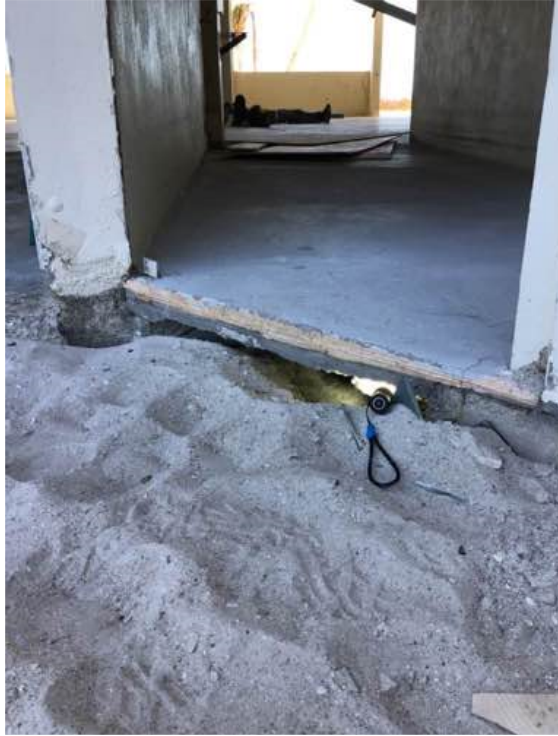
Slab wash out front of ground level.

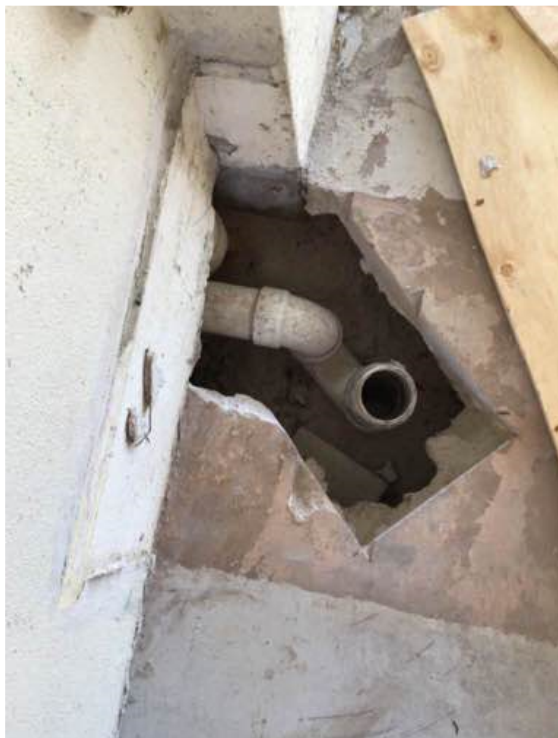
Slab wash out

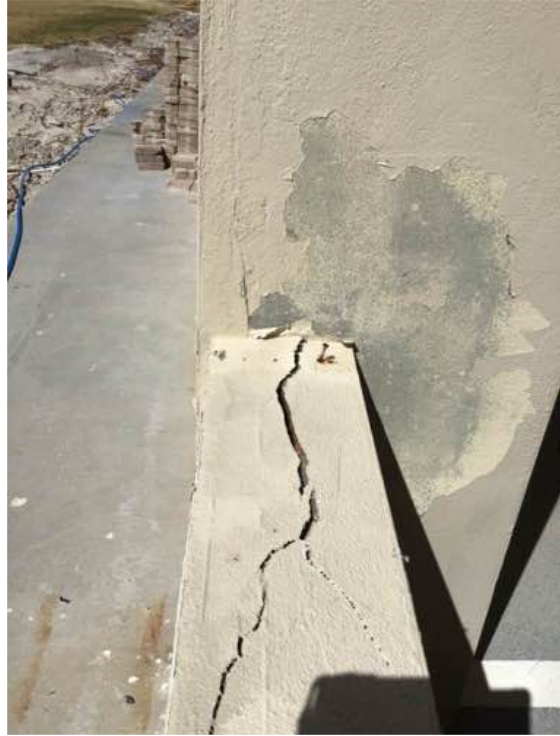
Damage at parking barrier wall with crack extending into column.

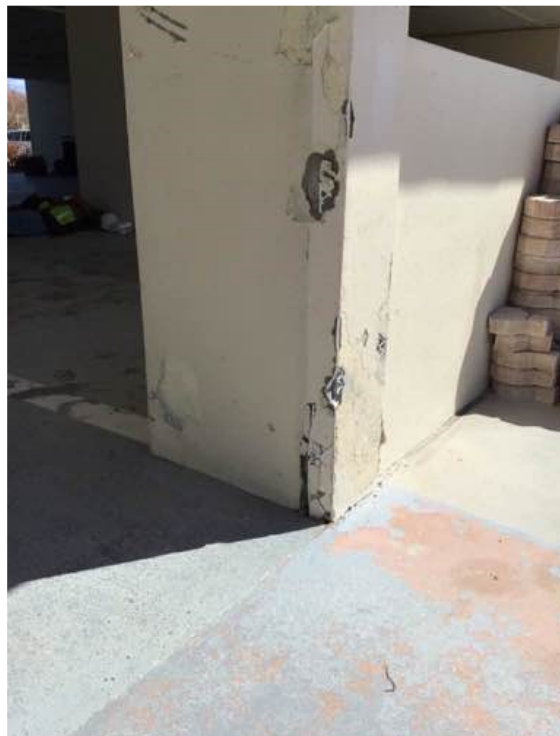
Minor damage to column at beach entry from the garage. After the stucco/wall finish removed the column should be re inspected.

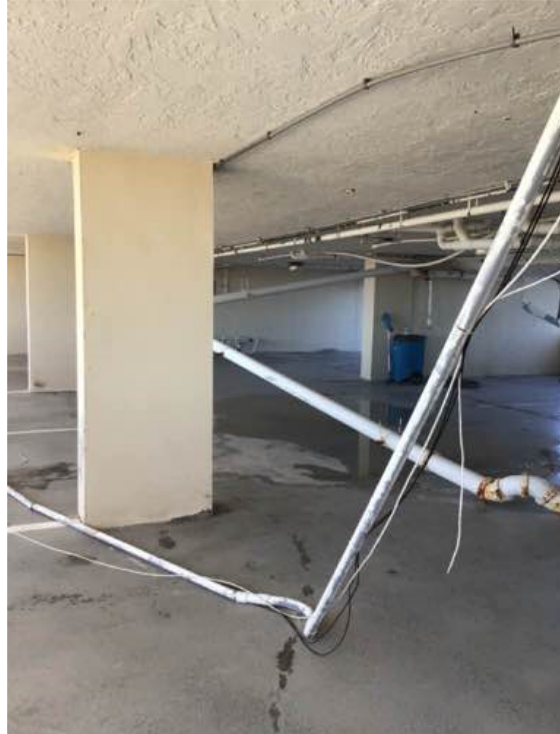
Building columns appear to be undamaged.

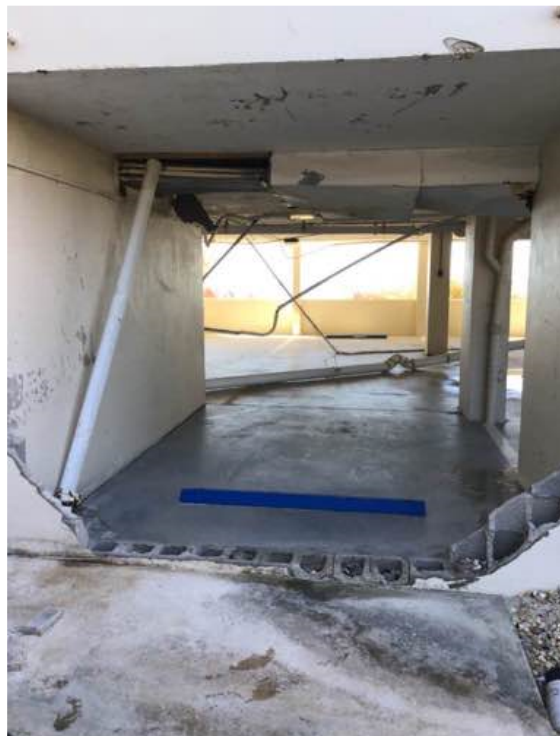
Blown out CMU wall. Replace as required.

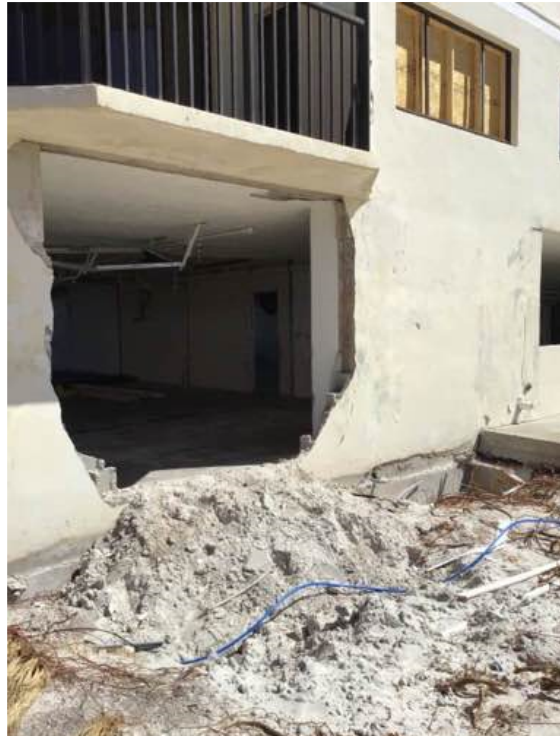
CMU wall blow out and foundation wash out.
Foundation appears to be undamaged. The block wall
blow out did damage the floor above.

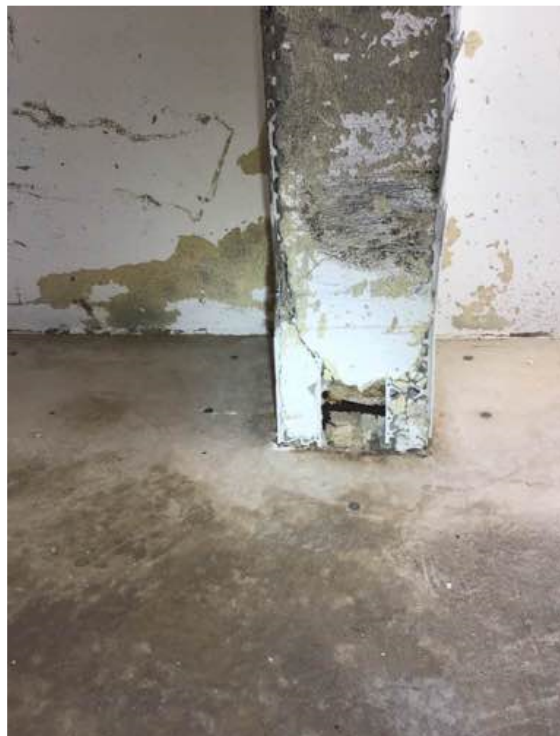
Exposed and rusted rebar in the column(northwest
corner of building).

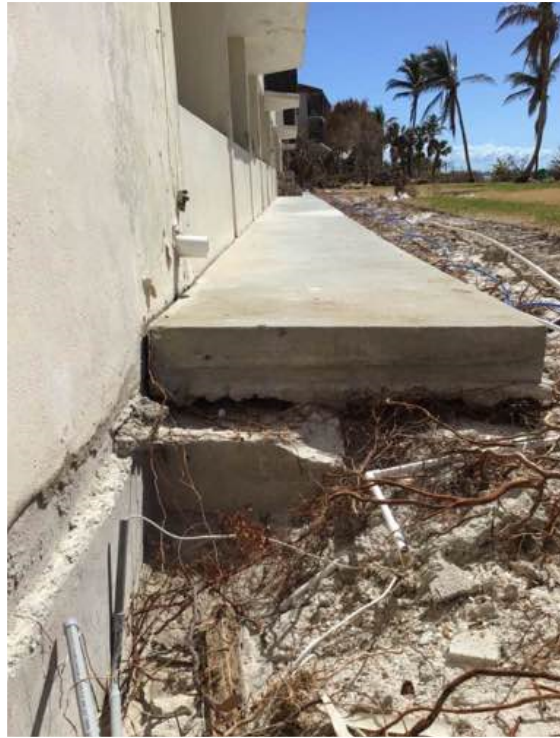
Exterior walkway. Pulled away from building and experiencing wash out.

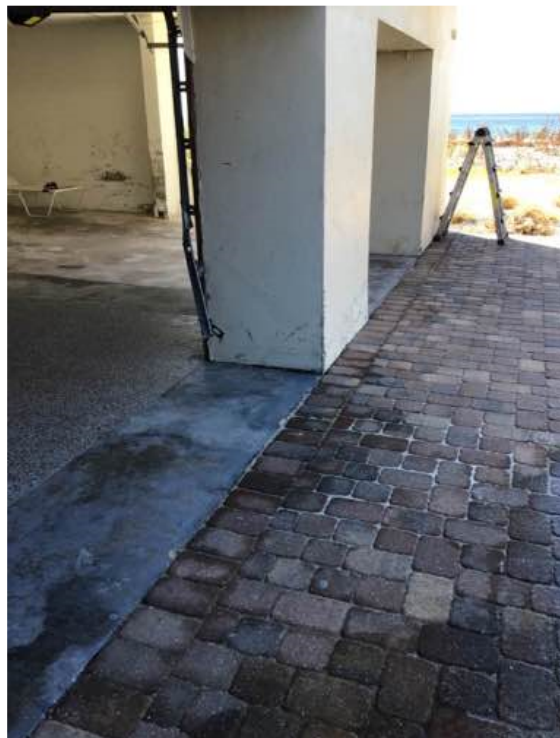
Exterior columns at northwest corner of building. No noted damage.

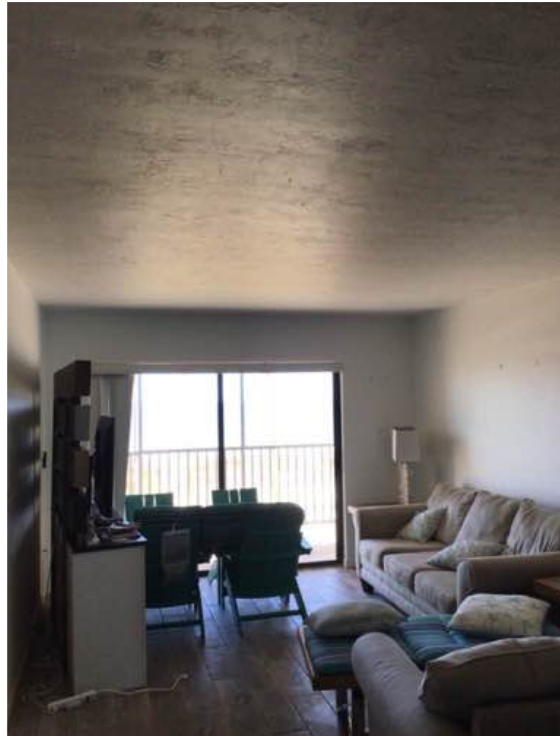
Typical first floor unit. No noted damage. The balcony showed no signs of distress and still had its architectural finishes in place.

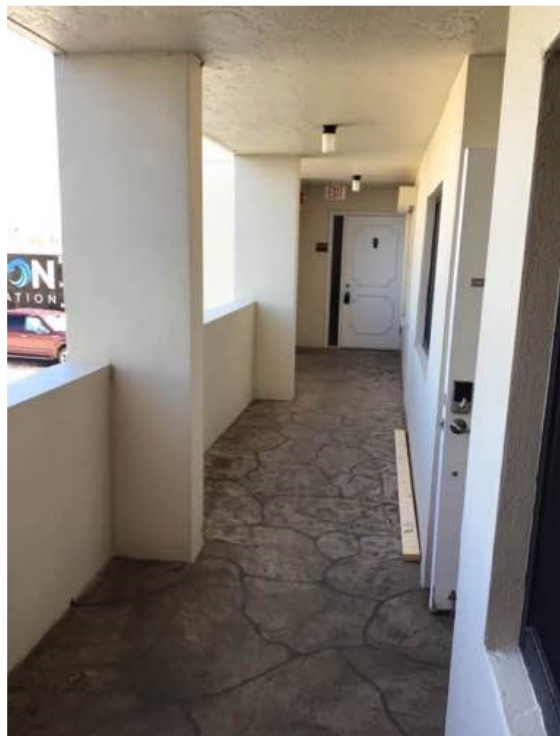
Typical first floor walkway. No structural distress noted.

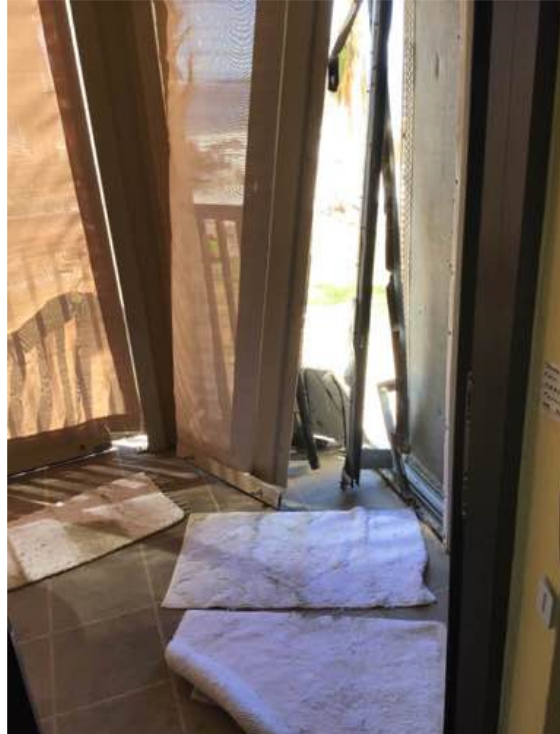
Room 107. Damage to balcony. Will require further inspections and repair.

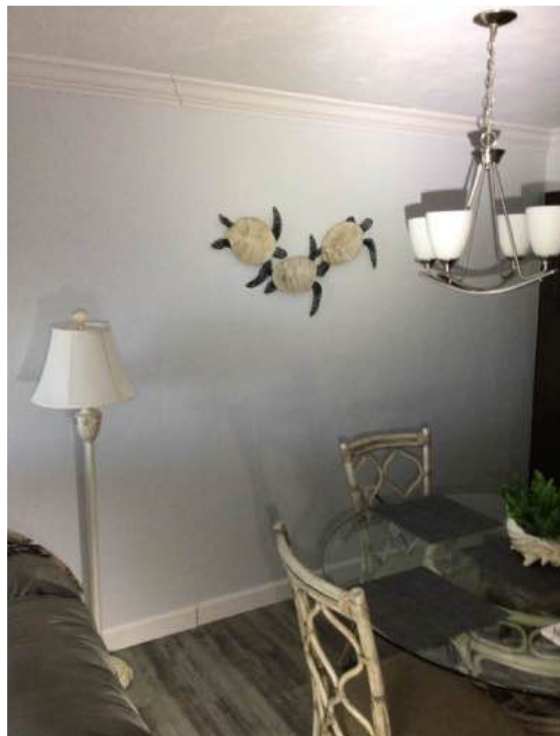
Unit 406. Separations in crown molding and floor board trim.

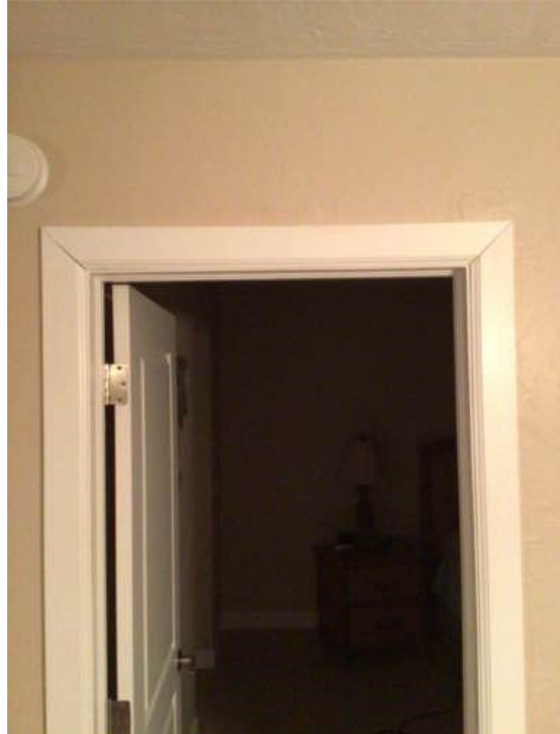
Typical door trim separation. Likely caused from building vibrations.

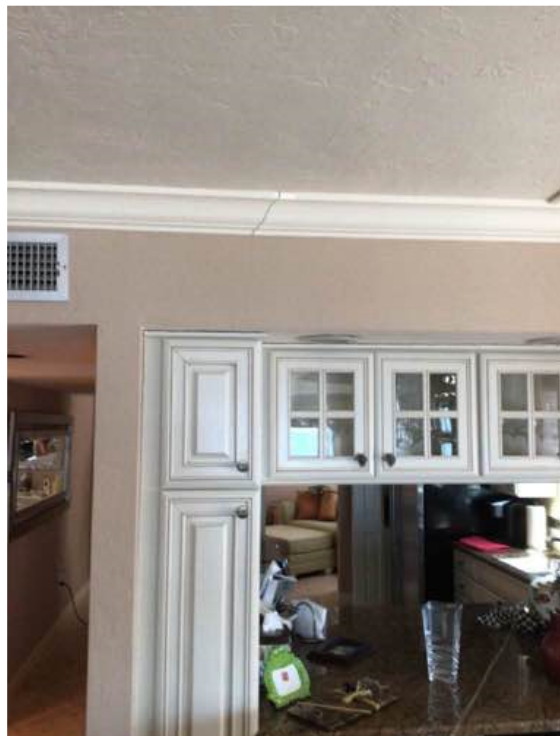
Trim and cabinets separation.

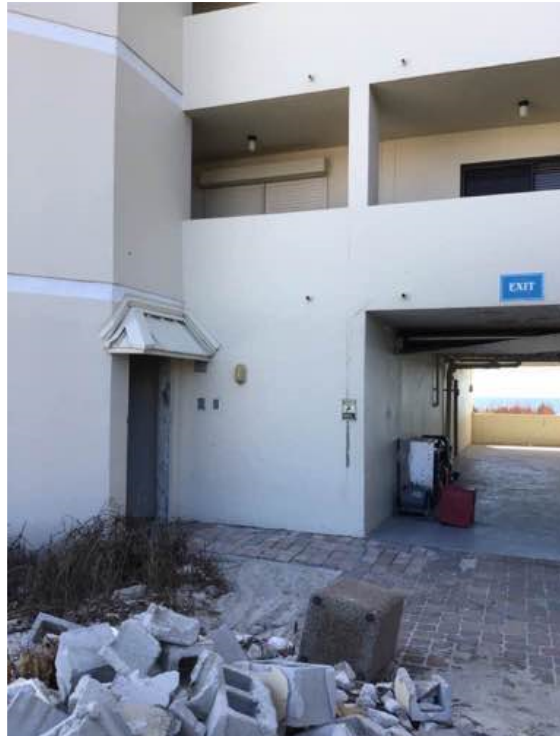
Front elevation at parking garage. Likely CMU damage. Remove stucco/paint for more thorough inspection.
