MATERIAL FINDINGS AND RECOMMENDATIONS:
INSPECTOR SUMMARY OF MILESTONE PHASE 1 INSPECTION

Property Name: Riviera Club Condominium

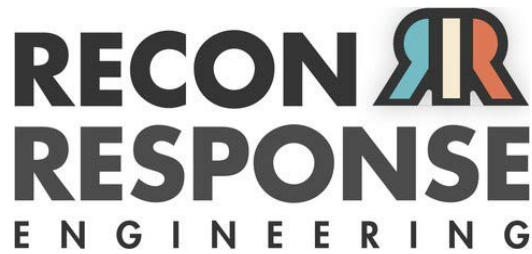
“Substantial structural deterioration” is defined in Florida Statute 553.899 as substantial structural distress that negatively affects a building’s general structural condition and integrity. The term does not include surface imperfections such as cracks, distortion, sagging, deflections, misalignment, signs of leakage, or peeling of finishes unless the inspector determines that such surface imperfections are a sign of substantial structural deterioration

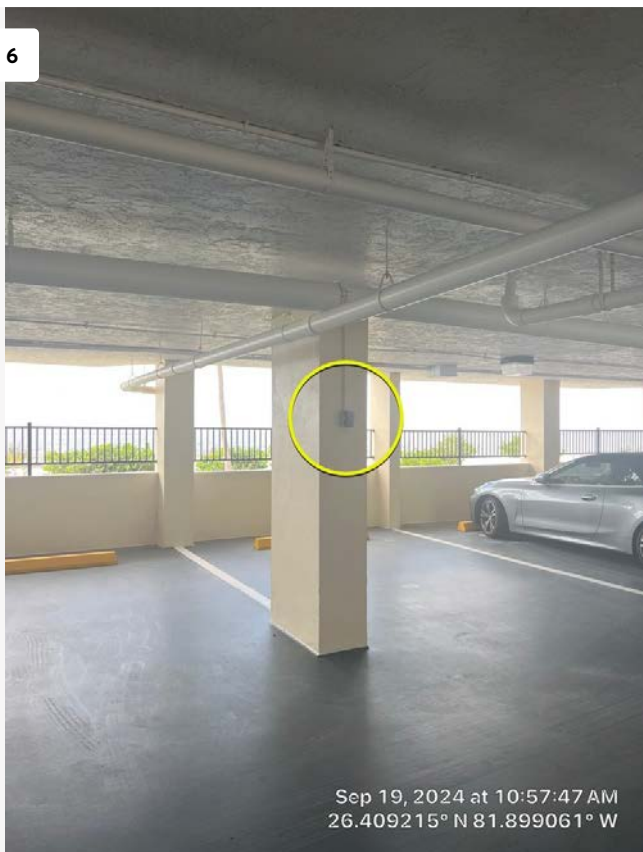
Open electrical junction box in garage just outside of elevator entrance door. This needs to be repaired.

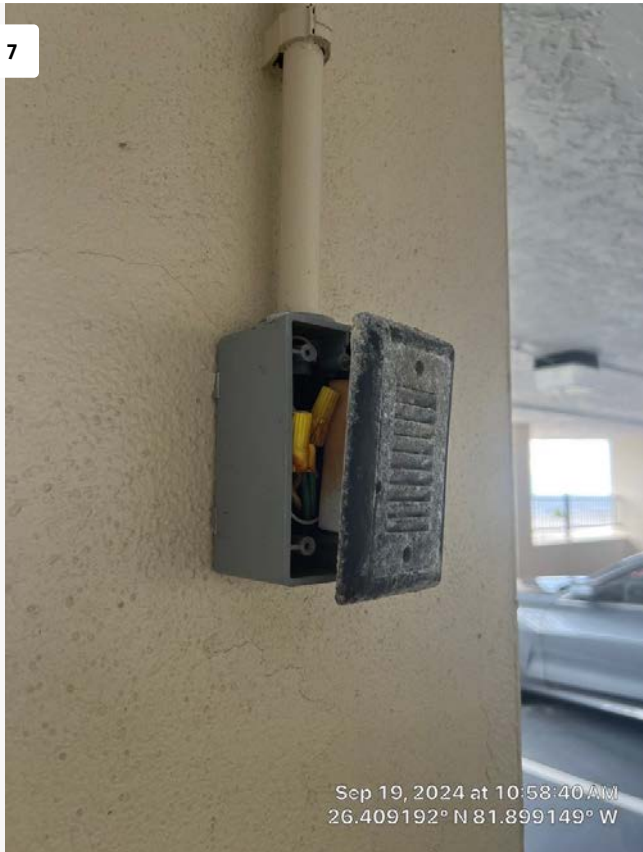
Sep 19, 2024 at 10:58:40 AM
26.409192° N 81.899149° W

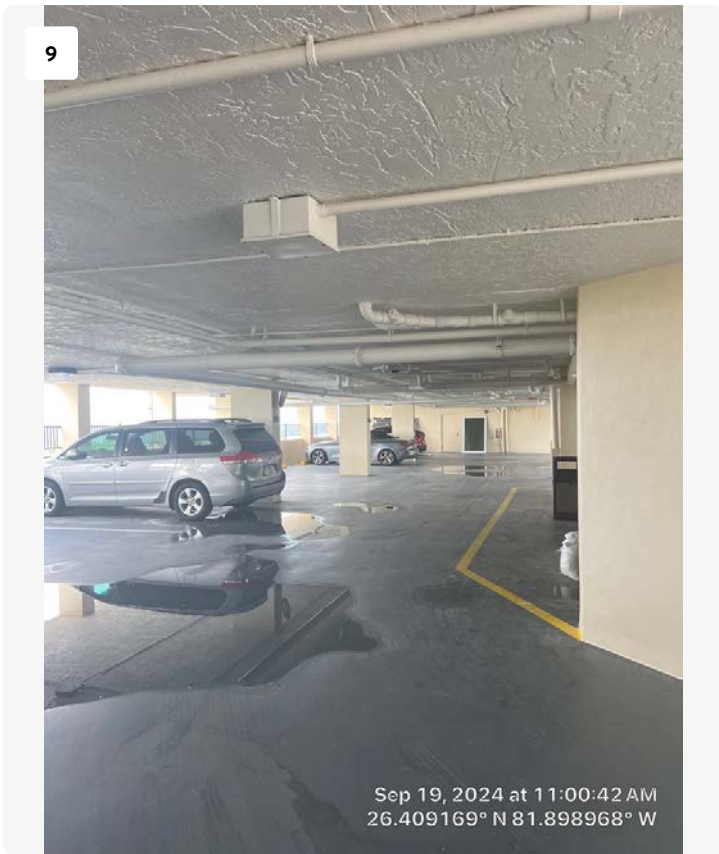
View to the north in garage. Structural condition is good.

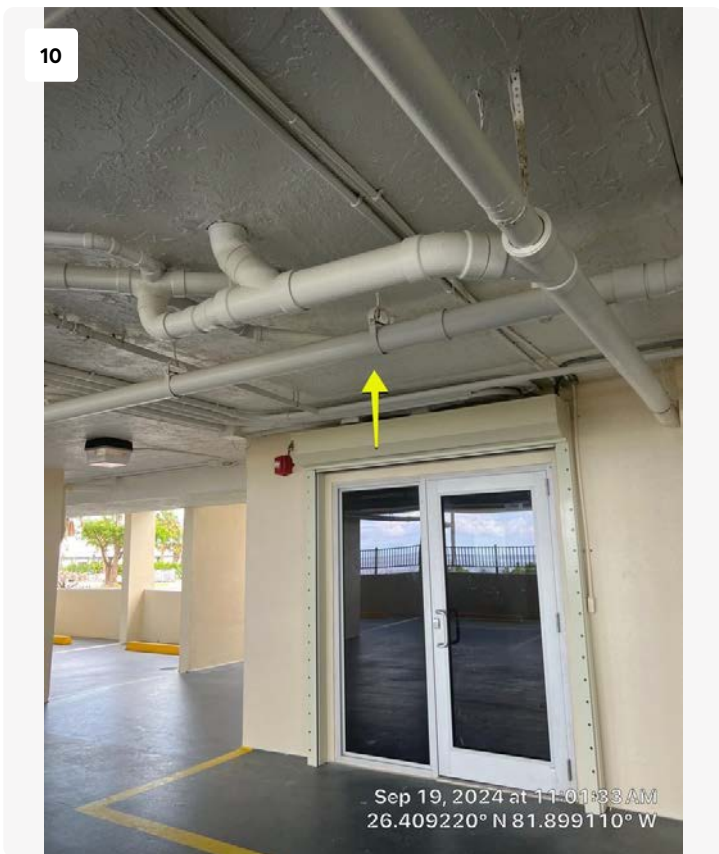
Minor corrosion observed on hangers located just outside garage entrance doors.

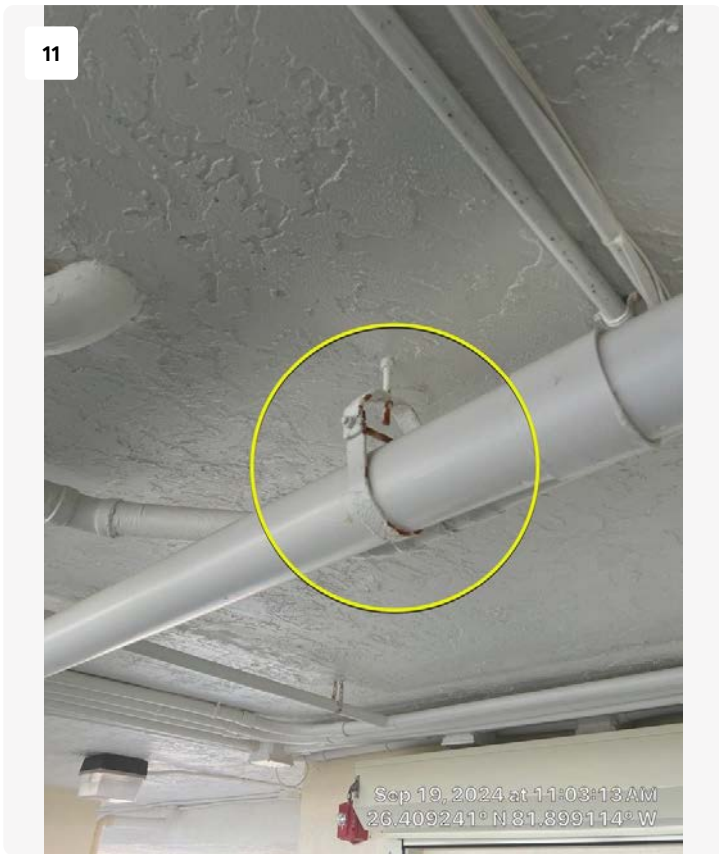
Minor corrosion observed on hangers located just outside garage entrance doors. These areas should be cleaned and repainted, although they will continue to rust and will eventually require replacement.

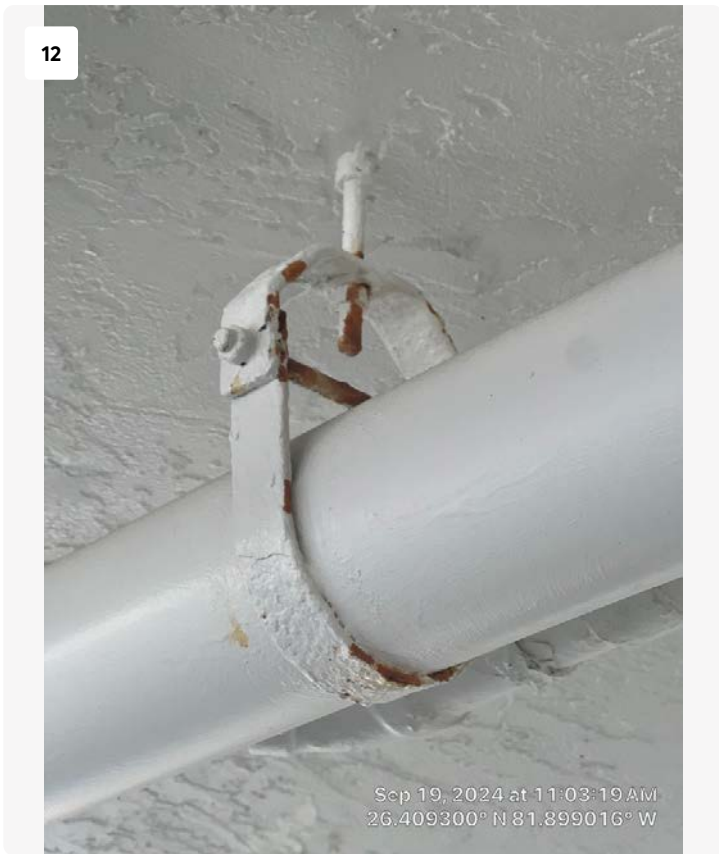
Close up of corrosion noted on garage hanger hardware.

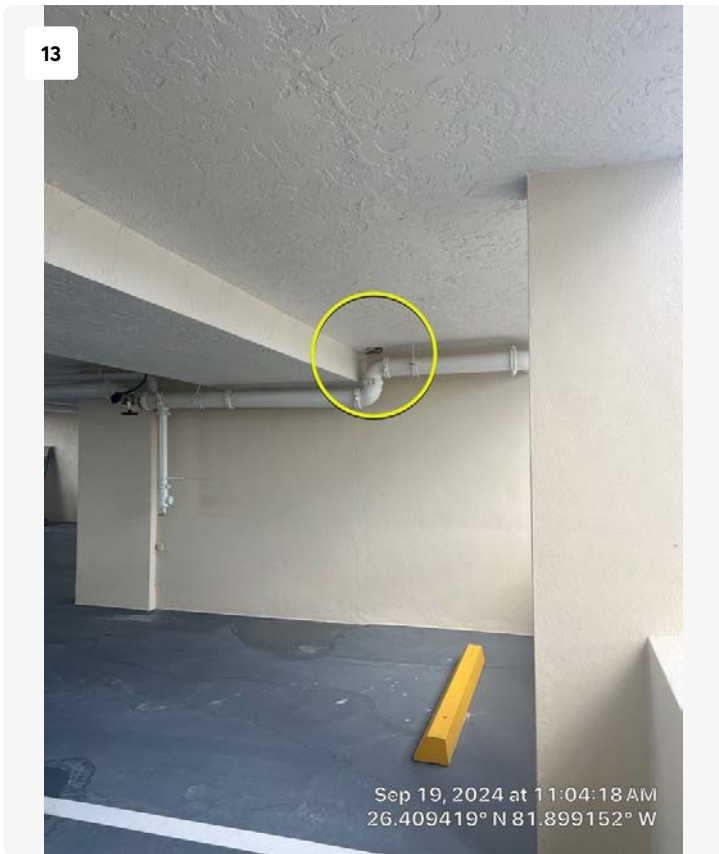
Northwest corner of garage. Corrosion noted on drain pipe.

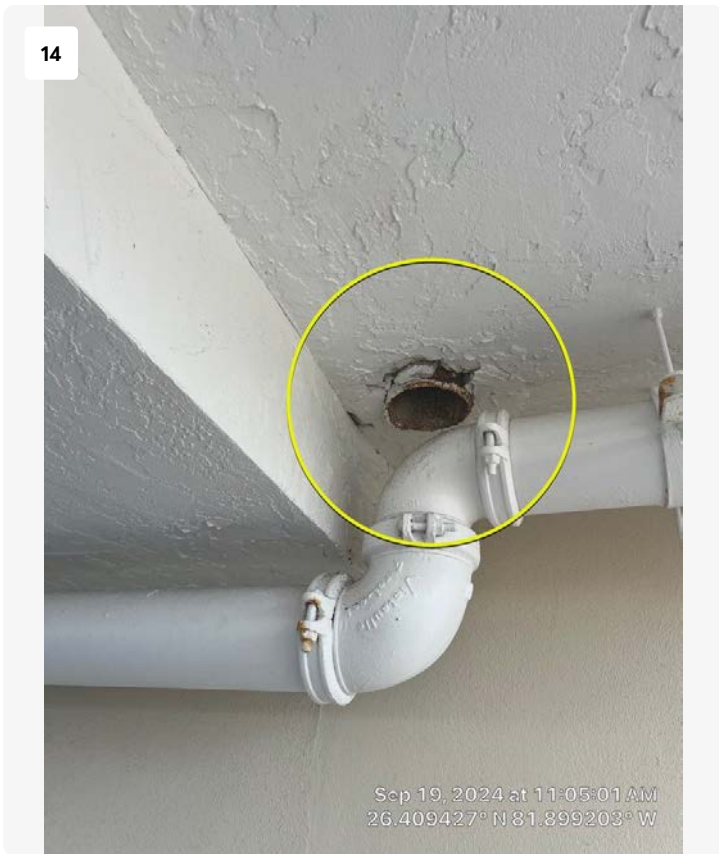
Northwest corner of garage. Corrosion noted on drain pipe. It is unclear if this pipe has been abandoned previously. No immediate action appears to be required, although eventually the pipe will rust and then contribute to concrete spalling in the surrounding slab.

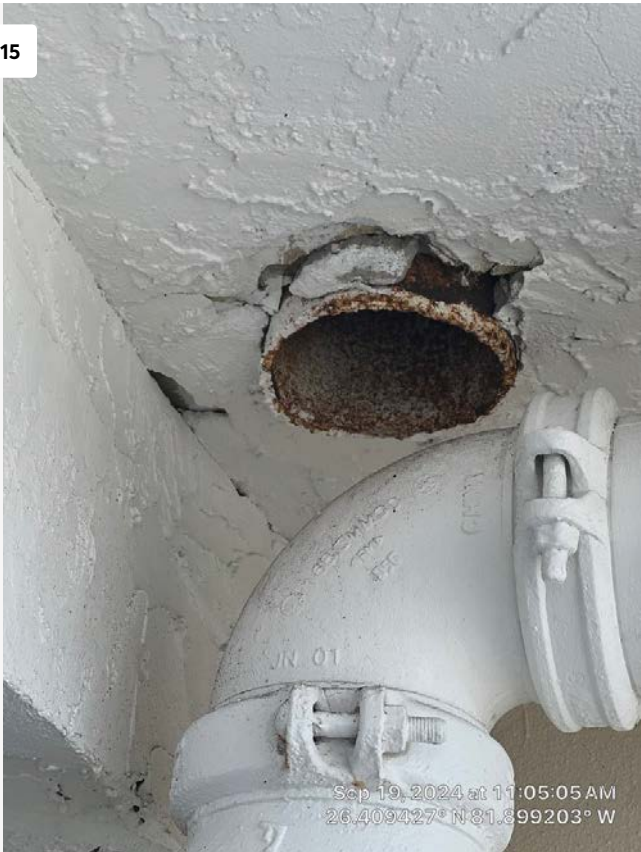
Detail photograph of corroded drain pipe located on northeastern corner of garage.

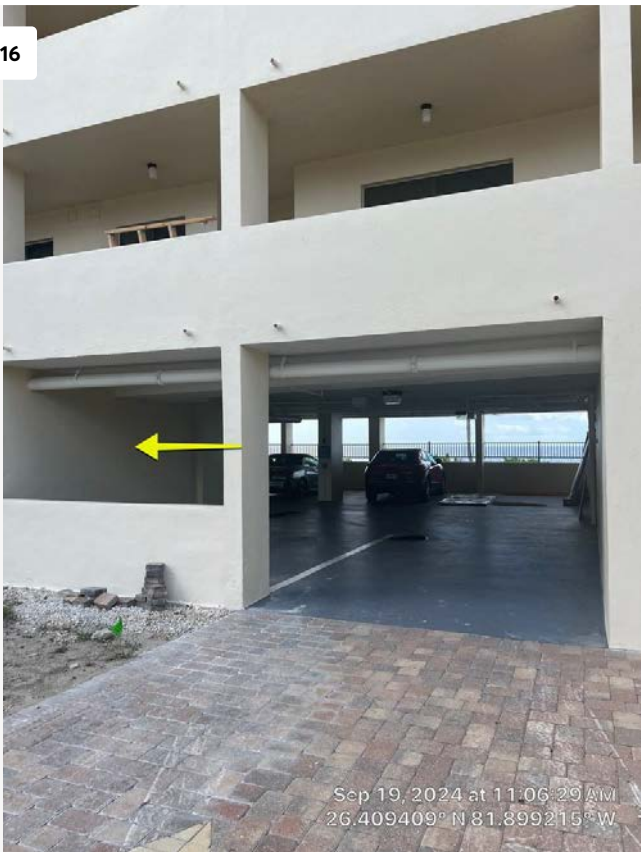
North garage entrance. Coating texture mismatch noted on wall.

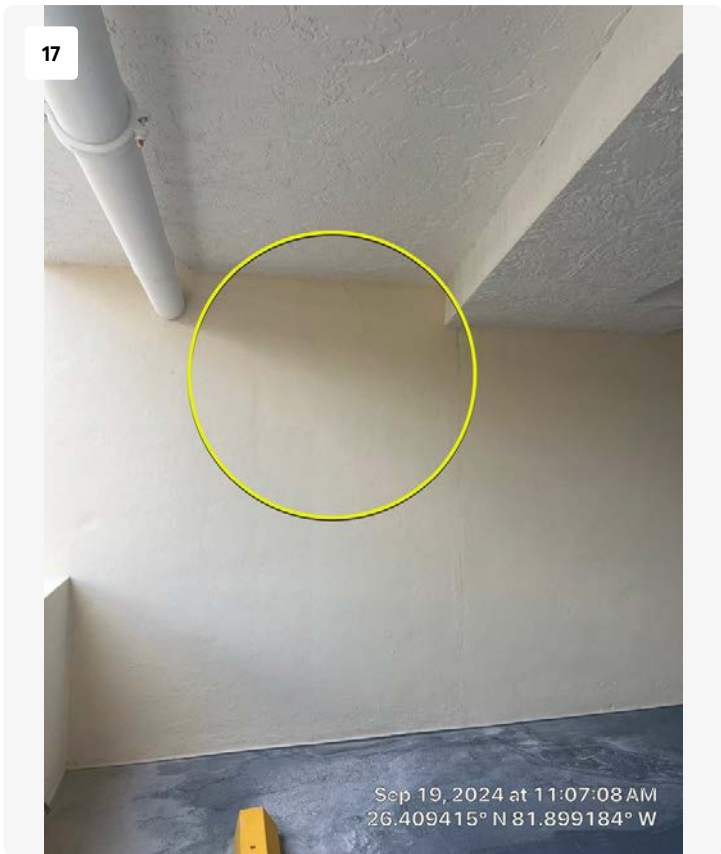
North garage entrance. A crack-like pattern was observed on the wall, although on closer inspection this appears to be a texture mismatch due to a previous repair or removal of paint coatings in the area. No action required.

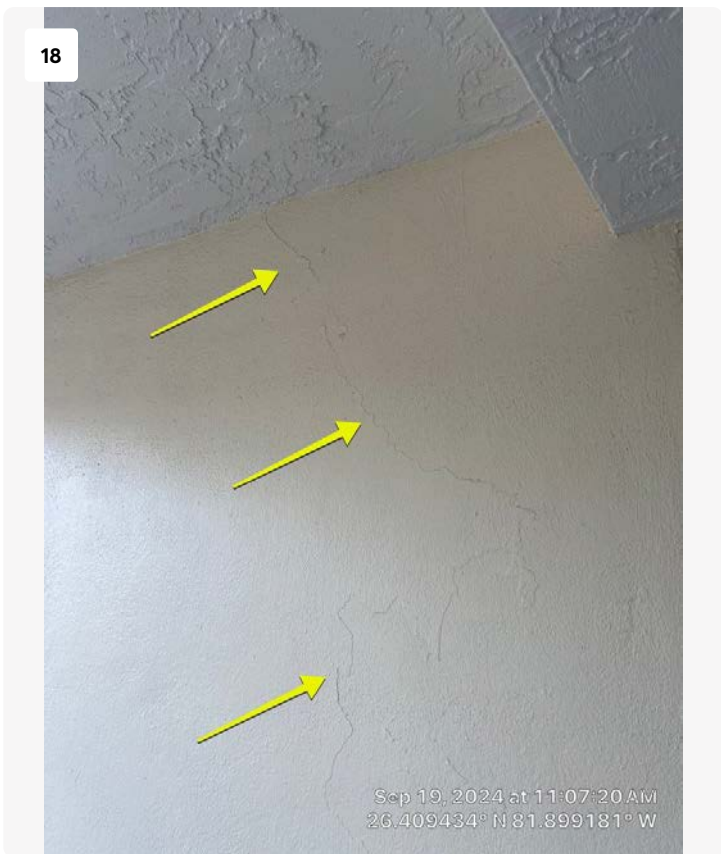
North garage entrance. Texture mismatch, aesthetic issue only. No action required.

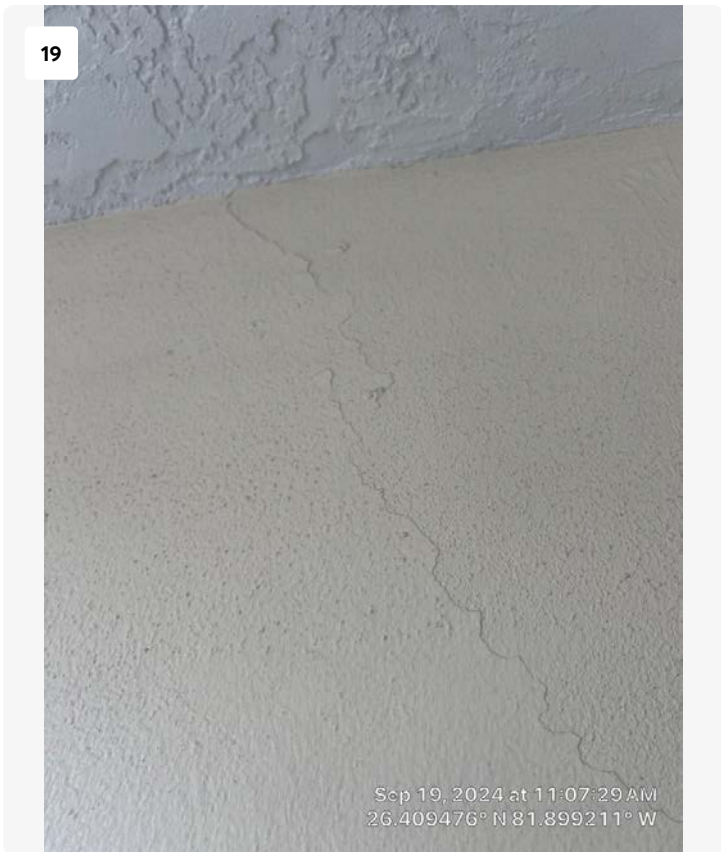
Close-up of texture mismatch observed on garage wall just inside northeastern entrance. Texture mismatch, aesthetic issue only. No action required.

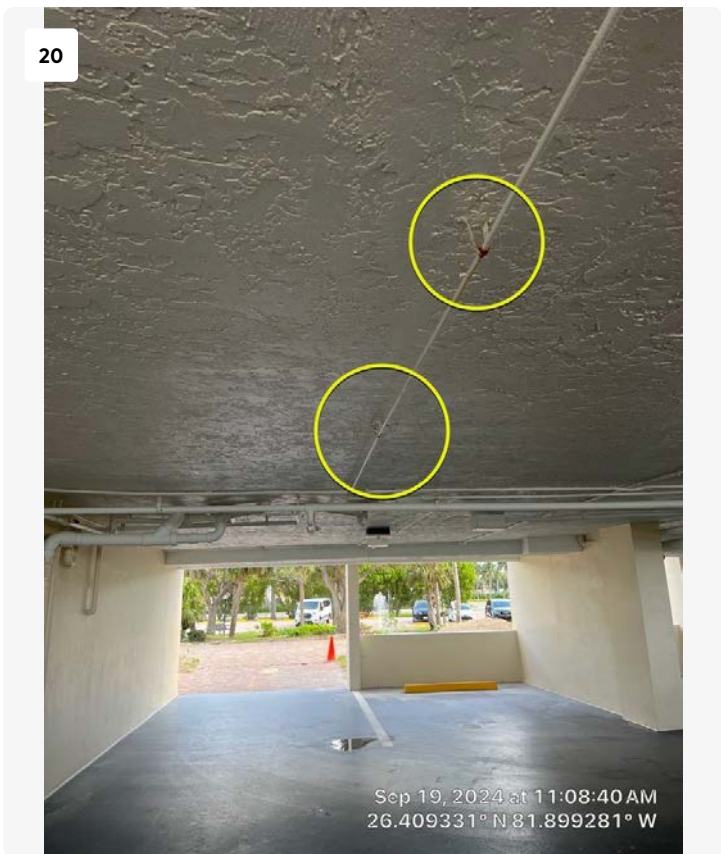
Looking east at north garage entrance. Corrosion noted on hangers. Typical of conditions throughout the garage. They should be cleaned and coated, and may require replacement on an as-needed basis.

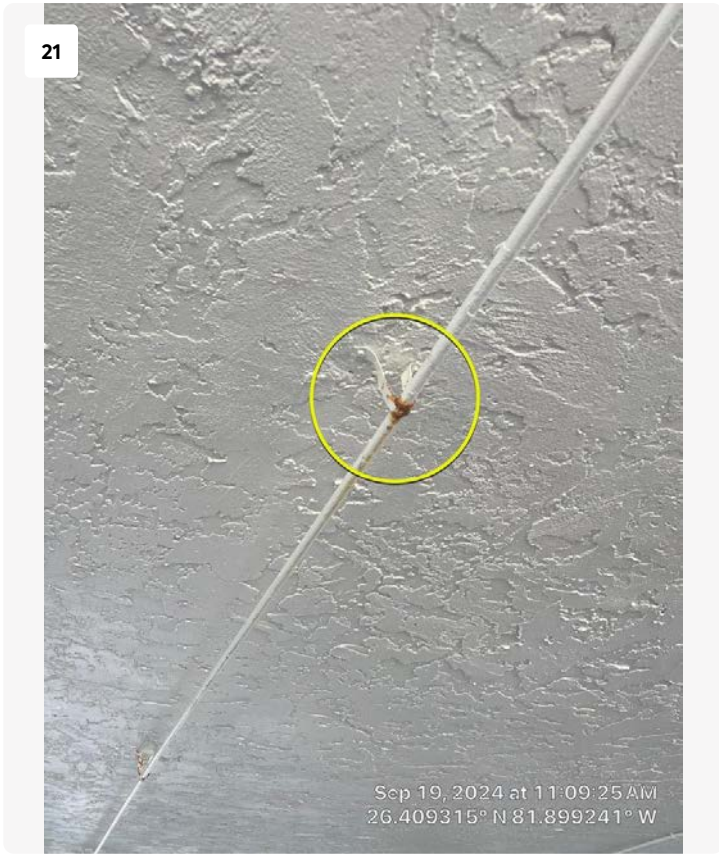
Looking east at north garage entrance. Corrosion noted on hangers. Typical of conditions throughout the garage.

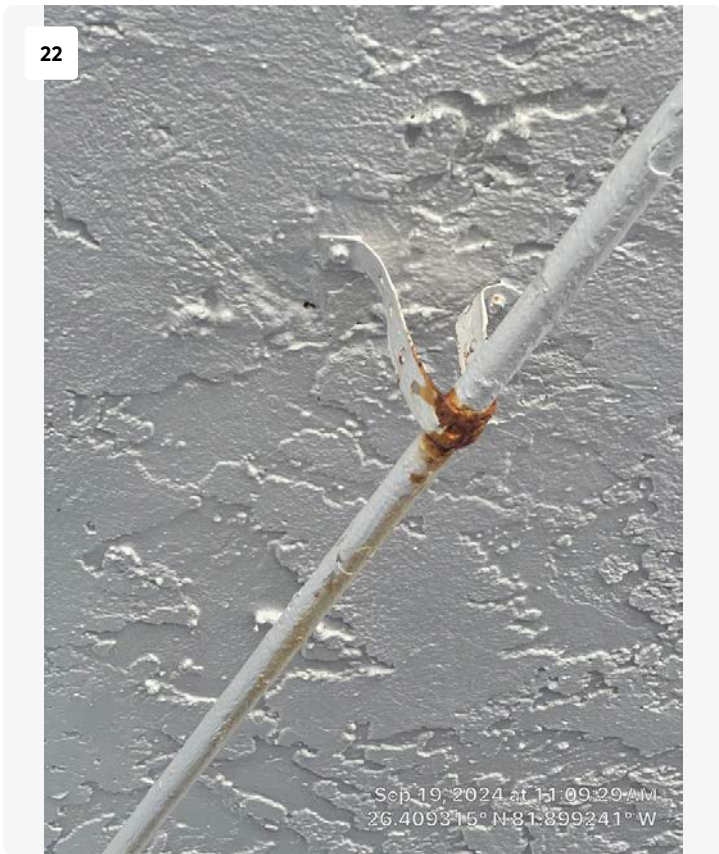
Close-up of corrosion on hanger hardware.

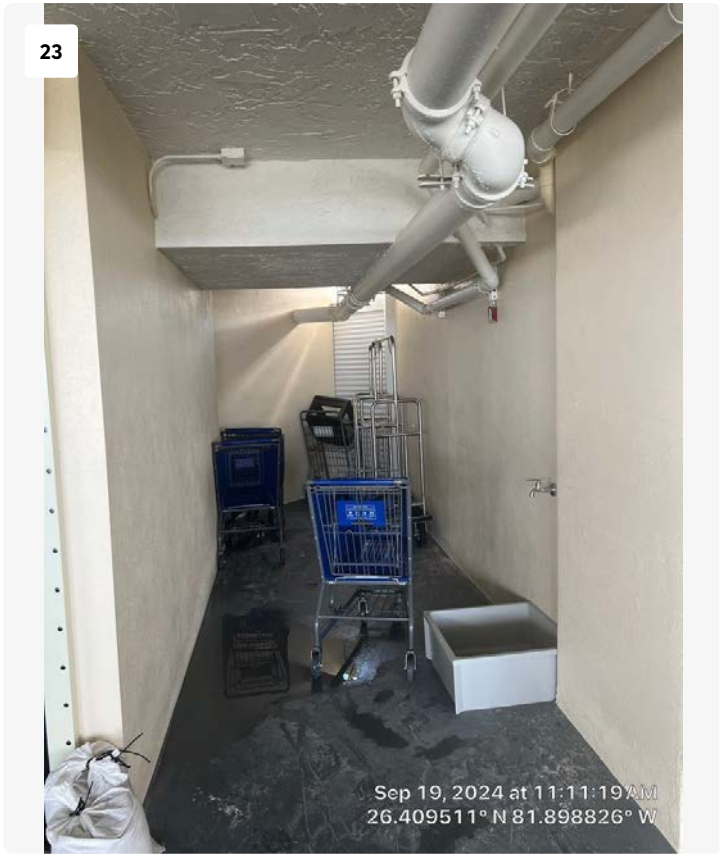
Storage area outside of interior garage elevator doors. No adverse conditions noted.

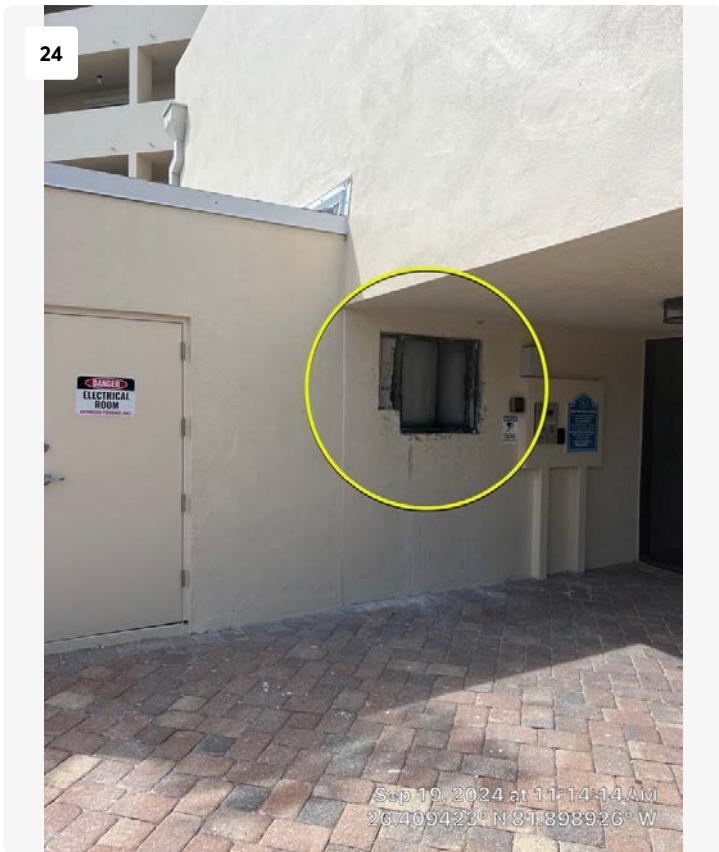
Front entrance. Concrete repair in progress

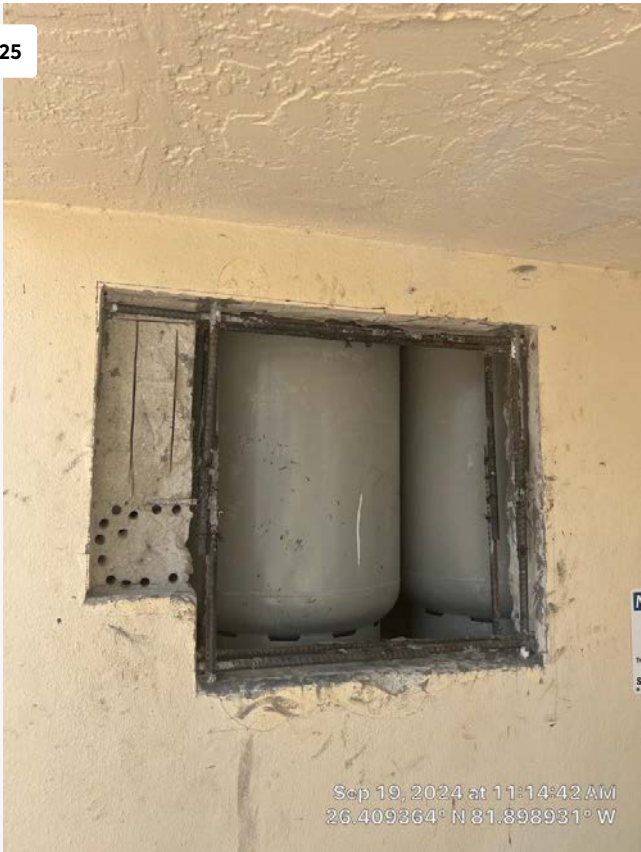
Front entrance. Concrete repair in progress

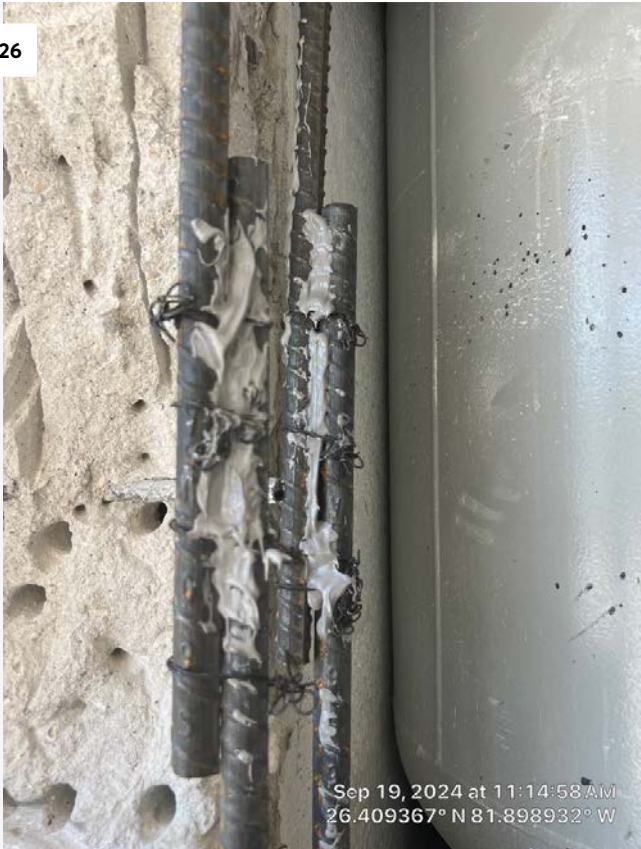
Front entrance. Concrete repair in progress

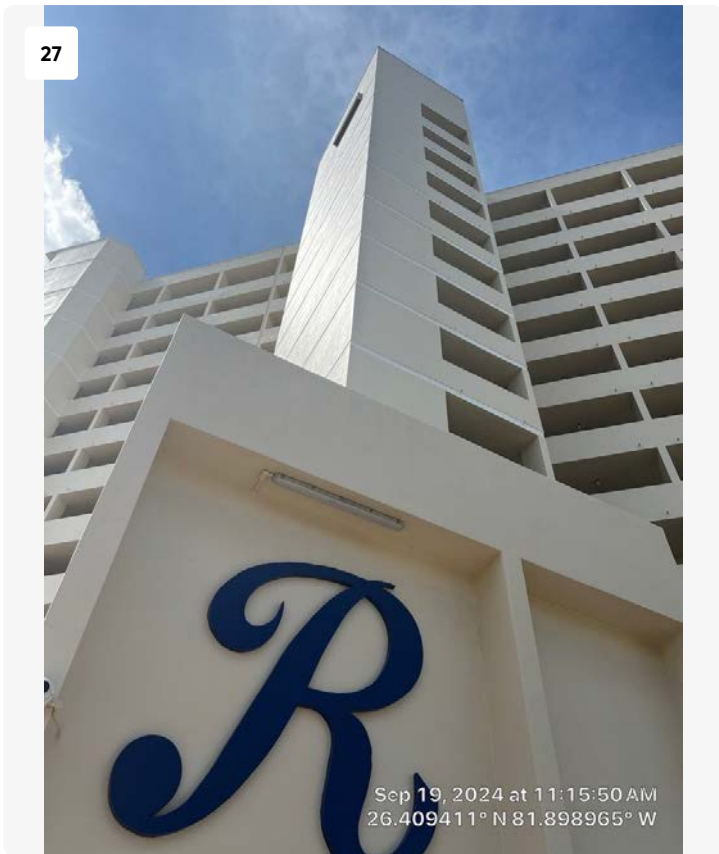
Front elevation. Typical conditions observed.

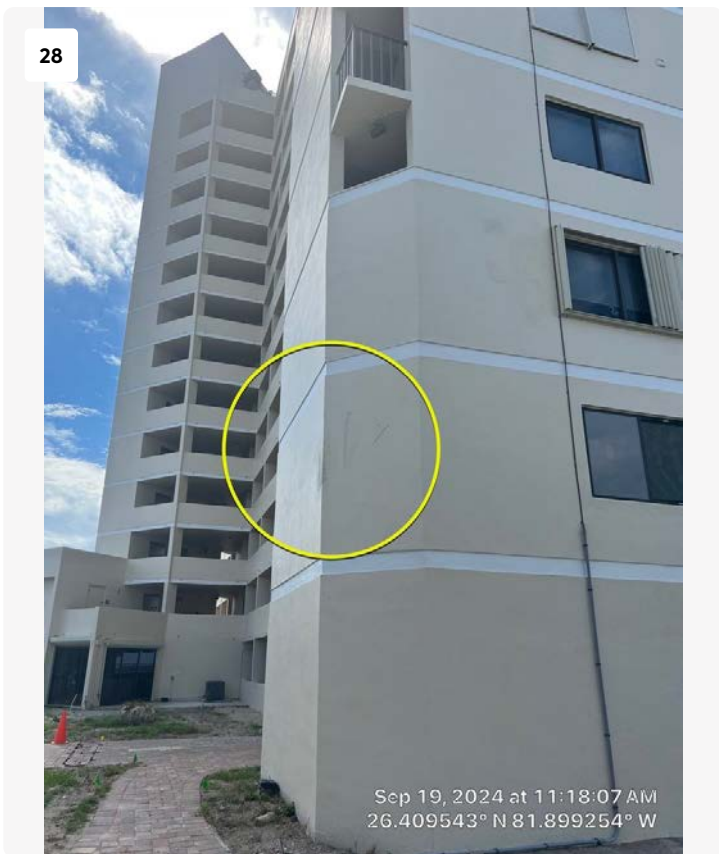
Northeastern corner of building.

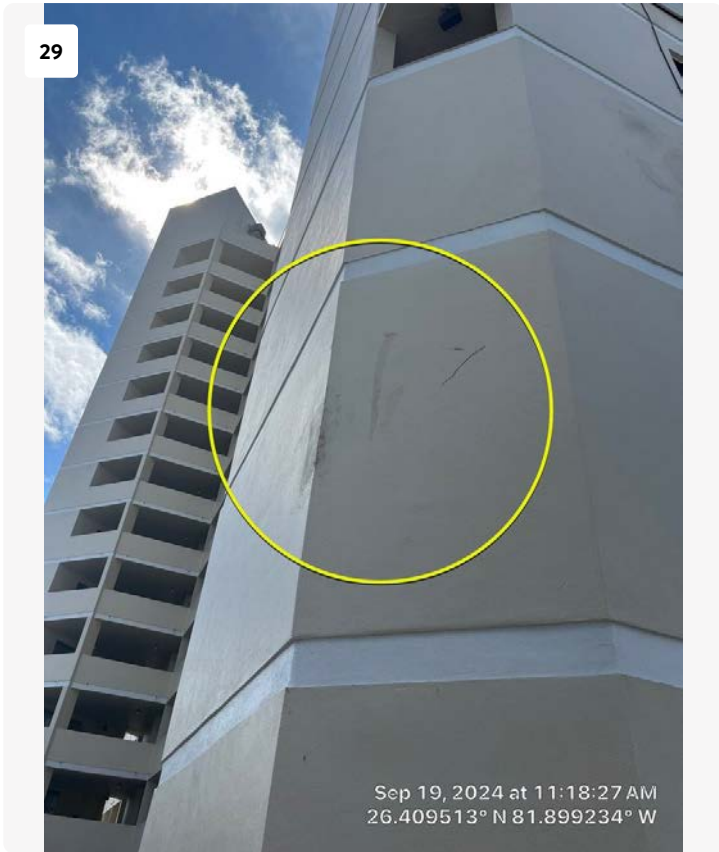
Northeast elevation, corner of building. Texture mismatch and discoloration suggests prior repairs being performed.

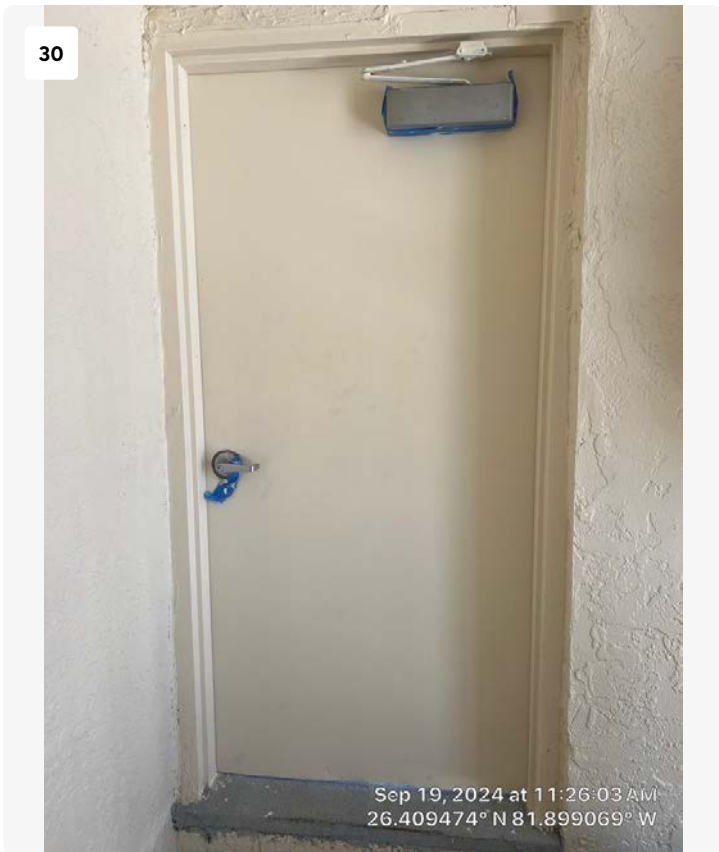
Roof access 12th floor.

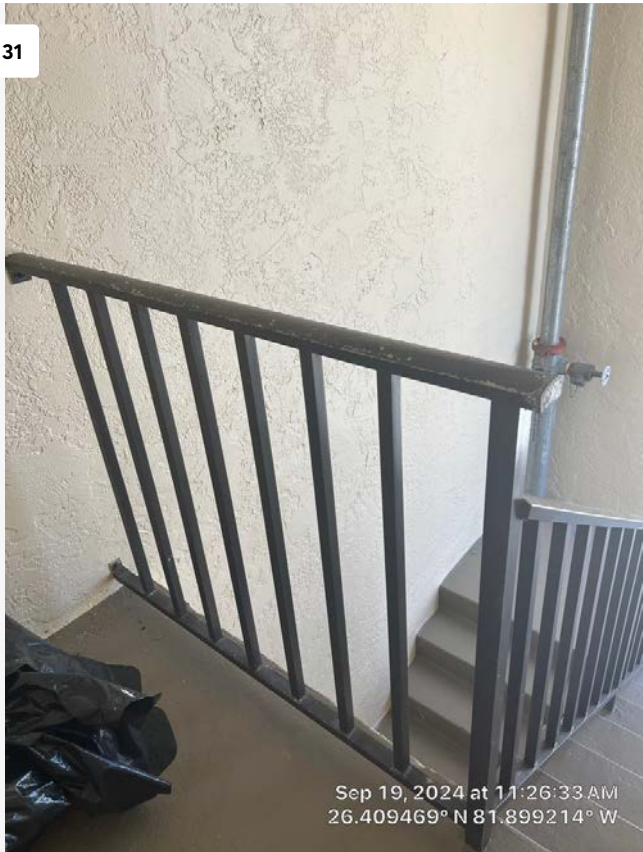
Sep 19, 2024 at 11:26:33 AM
26.409469° N 81.899214° W

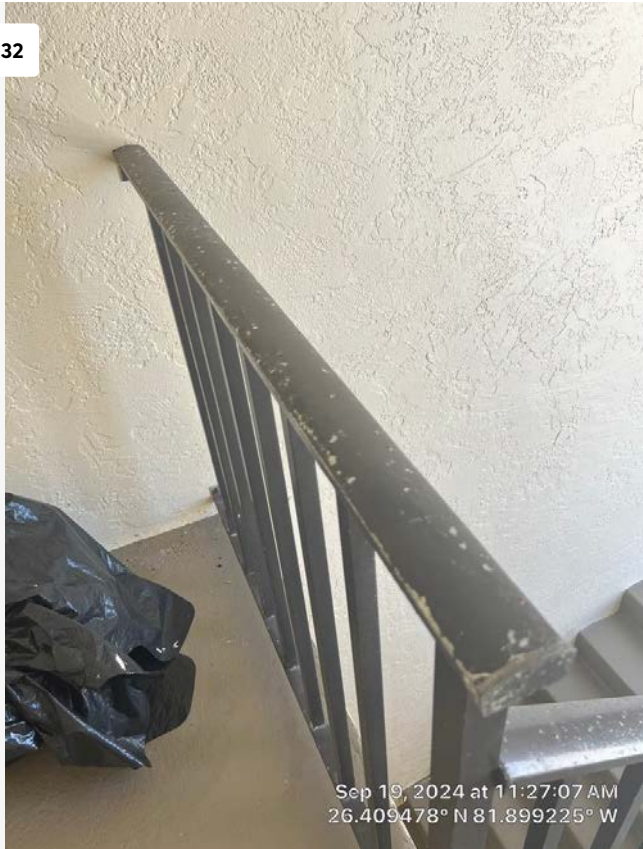
Sep 19, 2024 at 11:27:07 AM
26.409478° N 81.899225° W

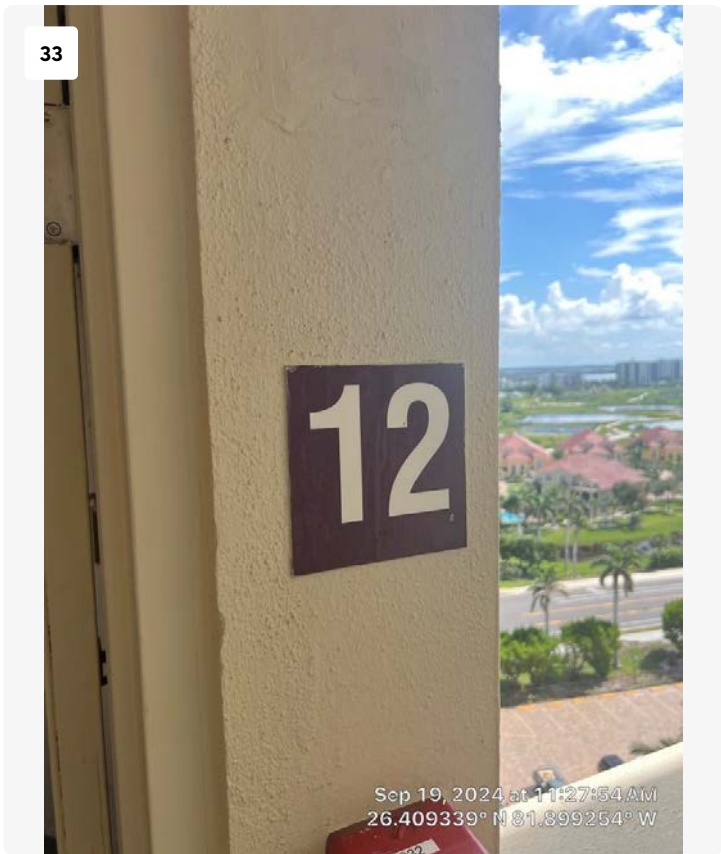
Project: Riviera Club
Date: 9/19/2024, 11:27am
Creator: Field Tech #1

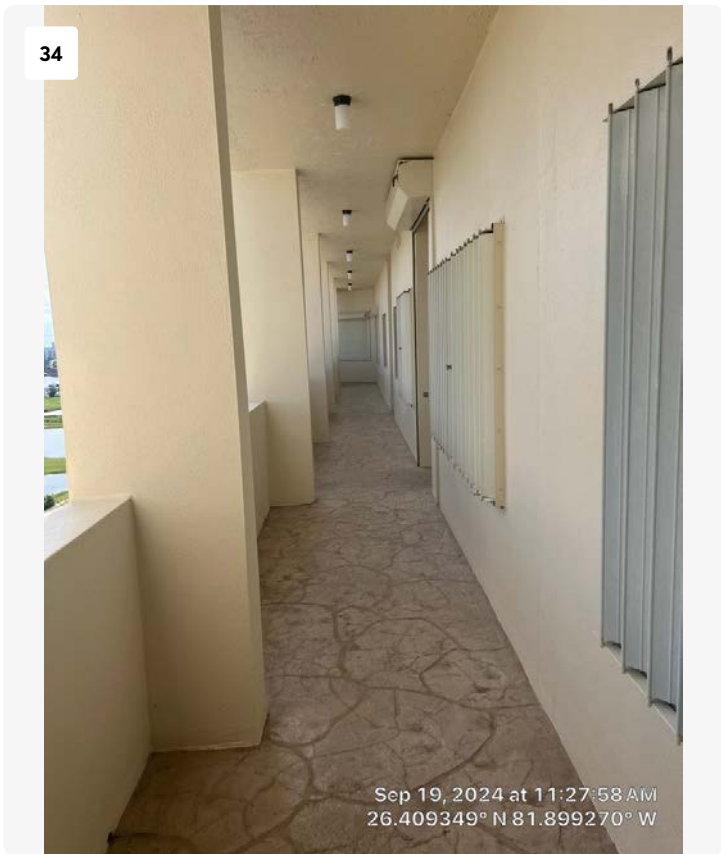
12th floor walkway. Conditions observed were generally very good. The paint and floor surfaces are well maintained.

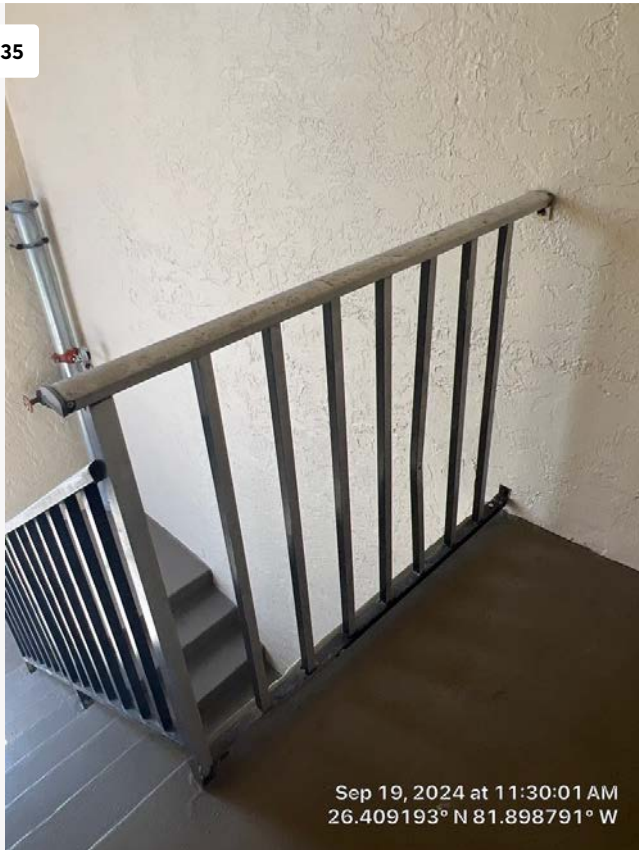
12th floor stairwell outside roof access door. Deteriorating coatings noted on guardrails. This is the top of the south stairwell.

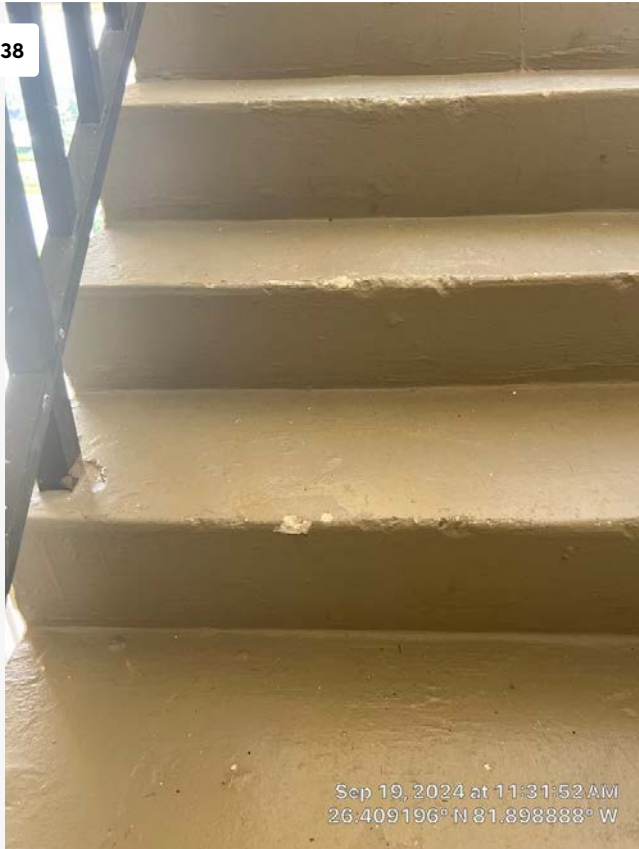
Chipping on stairwell edges, due to long-term wear and tear. Typical of entire stairwell. This is the riser from the 11th floor down to the 10th floor. No action required at this time, although the condition could eventually create a trip hazard and should be monitored periodically.

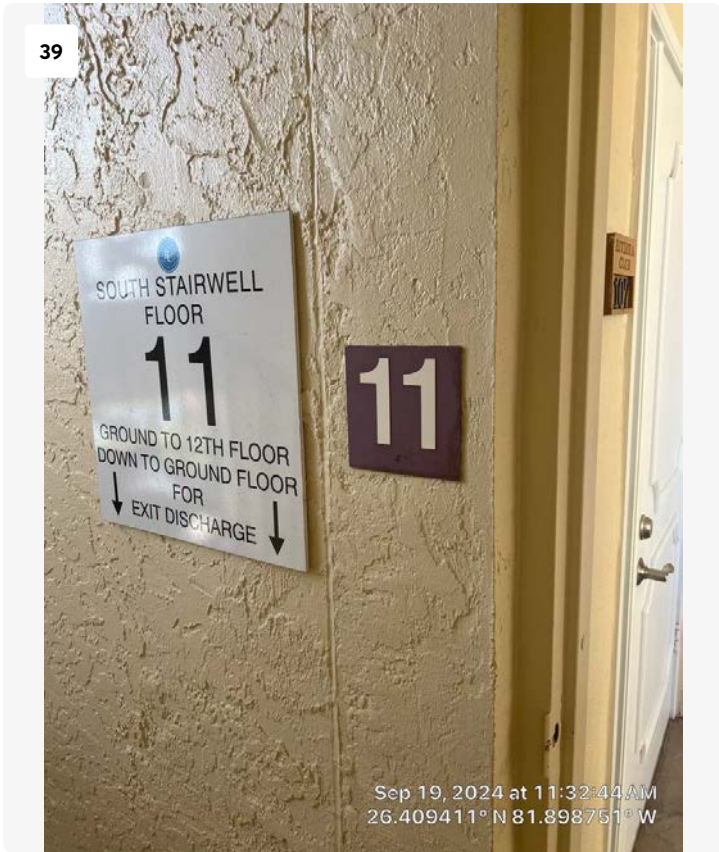
11th floor south stairwell landing.

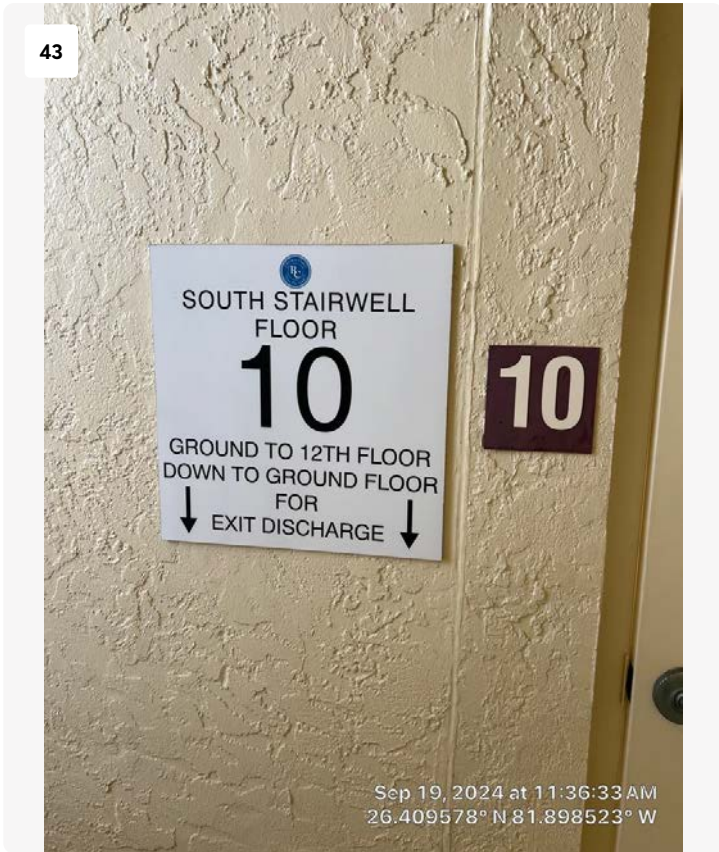
Location of damaged concrete observed on riser headed down to 9th floor.

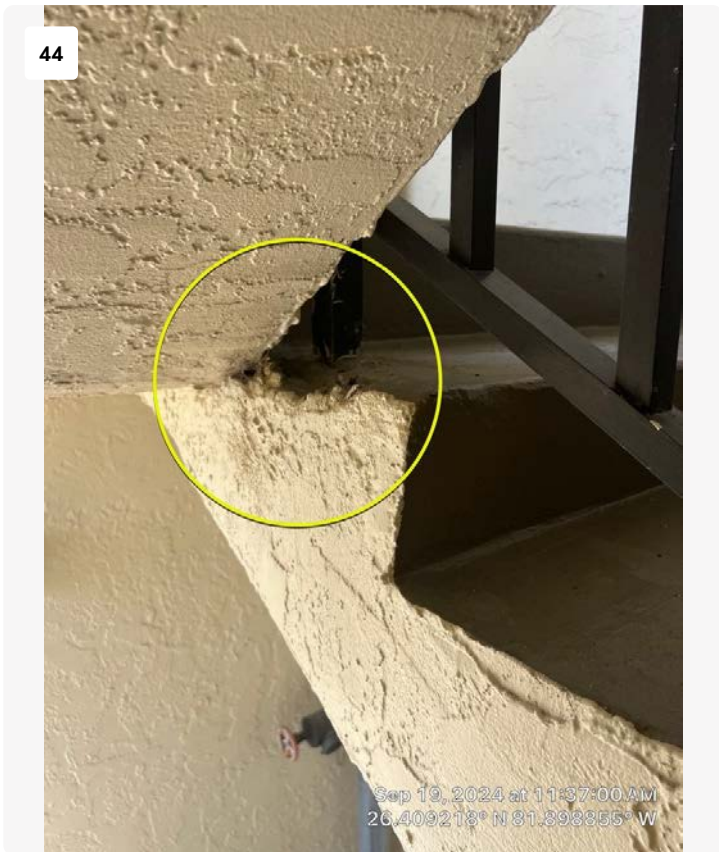
Location of damaged concrete observed on riser headed down to 9th floor. This appears to be related to original construction of the building, likely due to imperfect concrete consolidation. No action is required at this time.

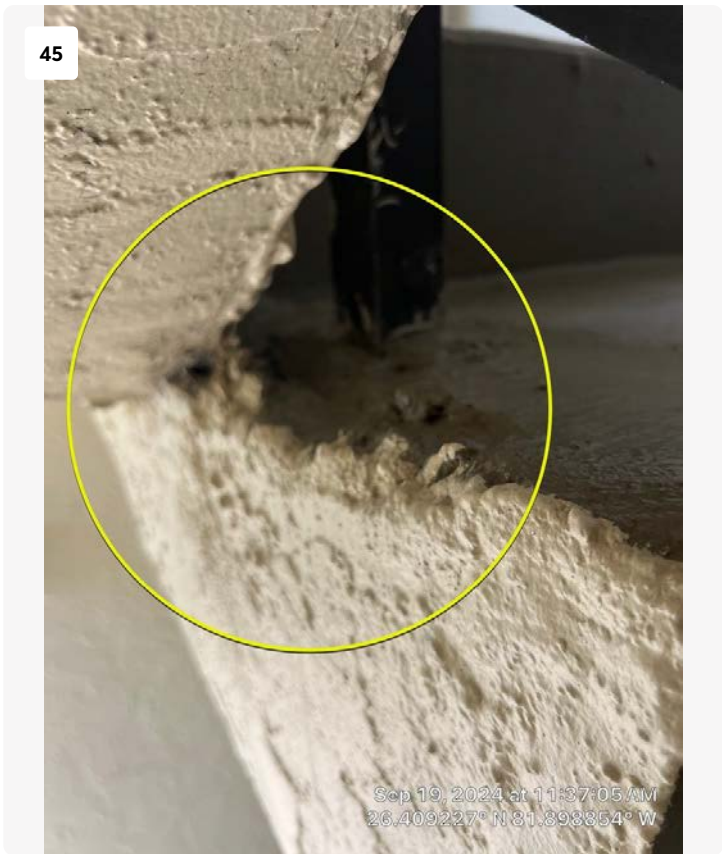
Location of damaged concrete observed on riser headed down to 9th floor. This appears to be related to original construction of the building, likely due to imperfect concrete consolidation. No action is required at this time.

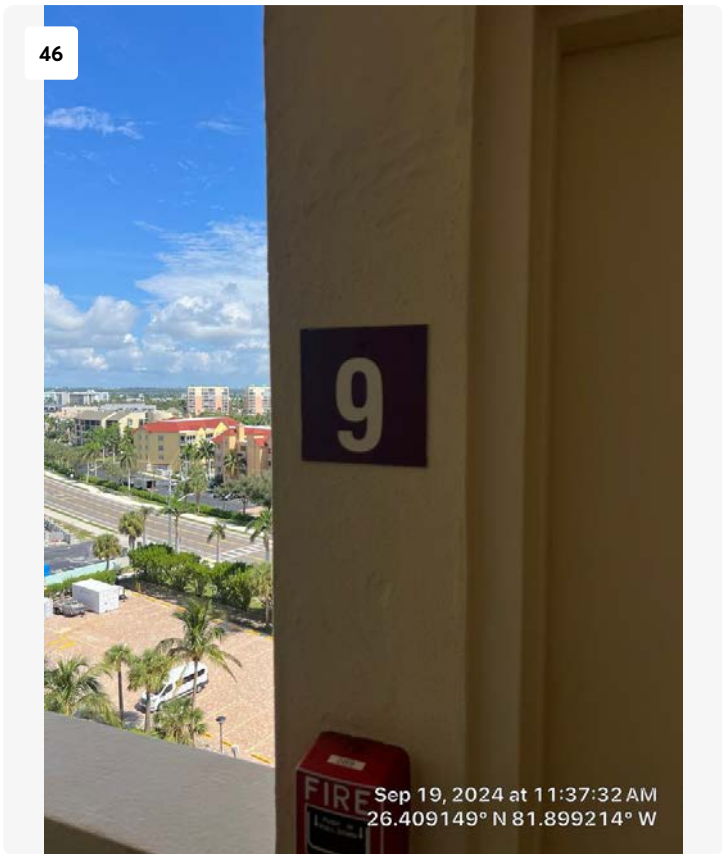
Project: Riviera Club
Date: 9/19/2024, 11:37am
Creator: Field Tech #1

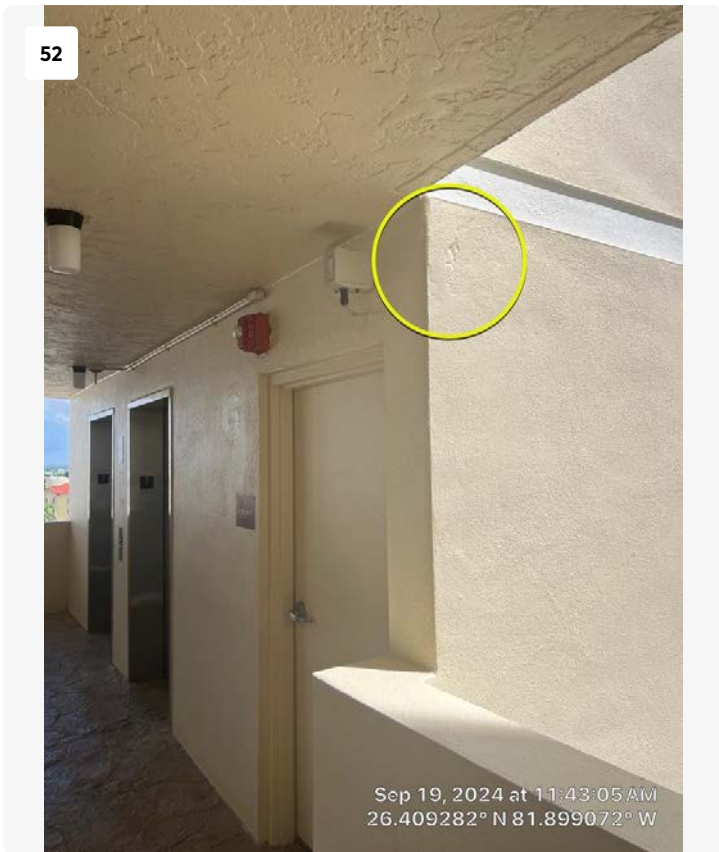
Just to the south of the 7th floor elevators. Previous repair noted. No action required.
