MATERIAL FINDINGS AND RECOMMENDATIONS:
INSPECTOR SUMMARY OF MILESTONE PHASE 1 INSPECTION

Property Name: Riviera Club Condominium

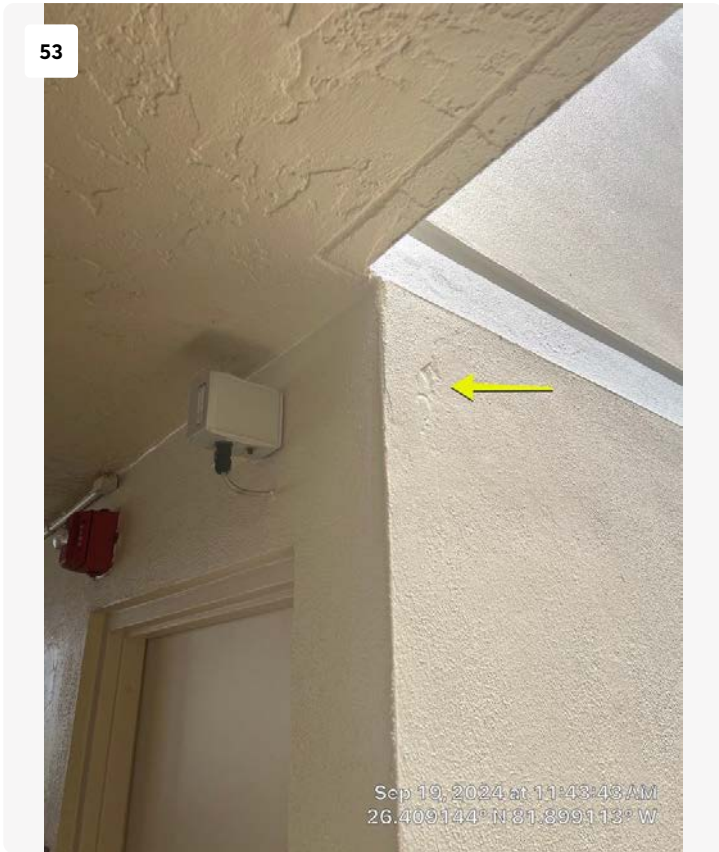
Just to the south of the 7th floor elevators. Previous repair noted.

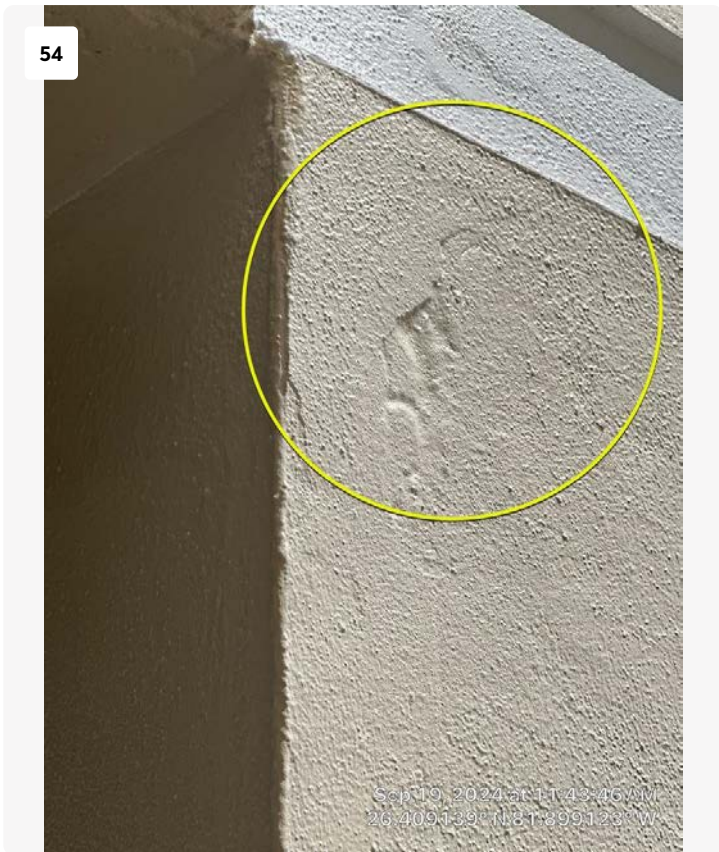
Just to the south of the 7th floor elevators. Previous repair noted. No action required.

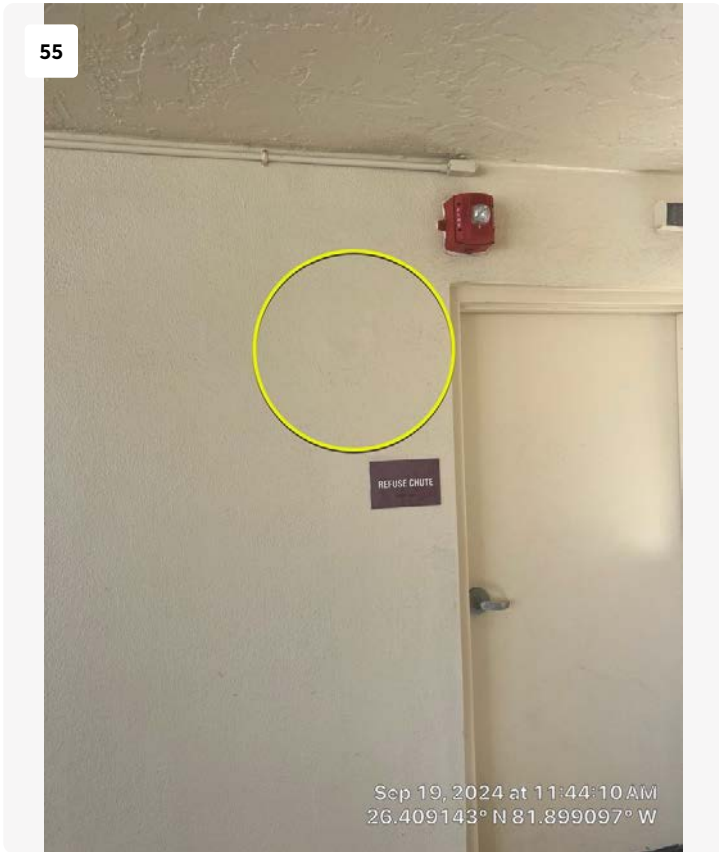
7th floor refuse chute. Previous repair noted. No action required.

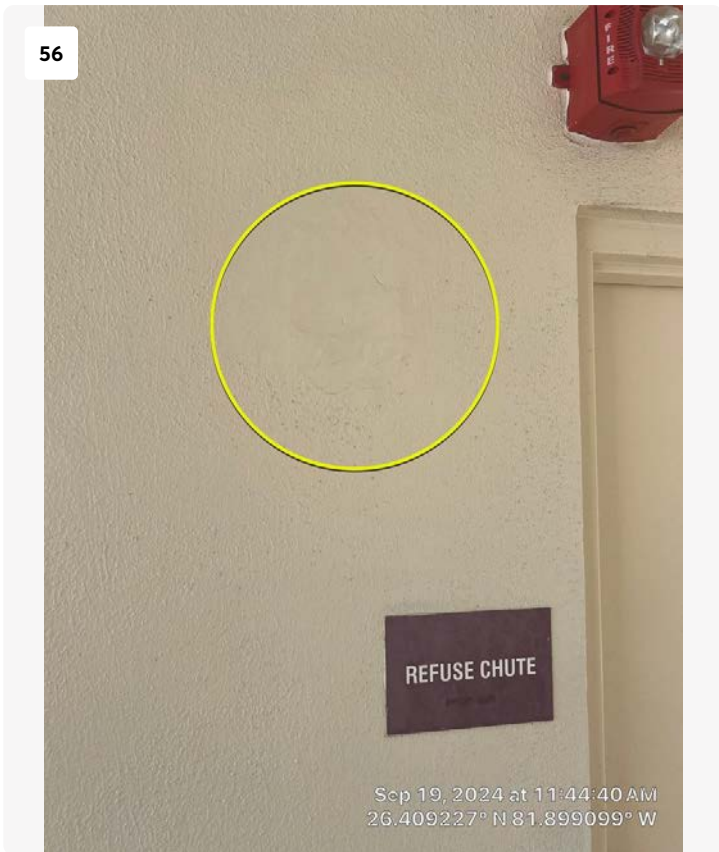
7th floor refuse chute. Previous repair noted.

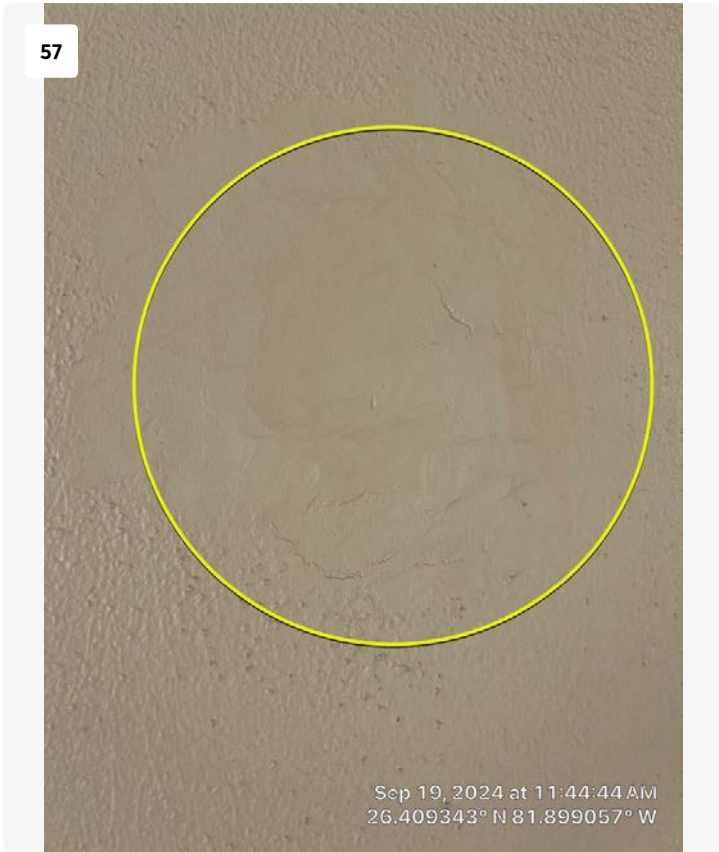
7th floor refuse chute. Previous repair noted.

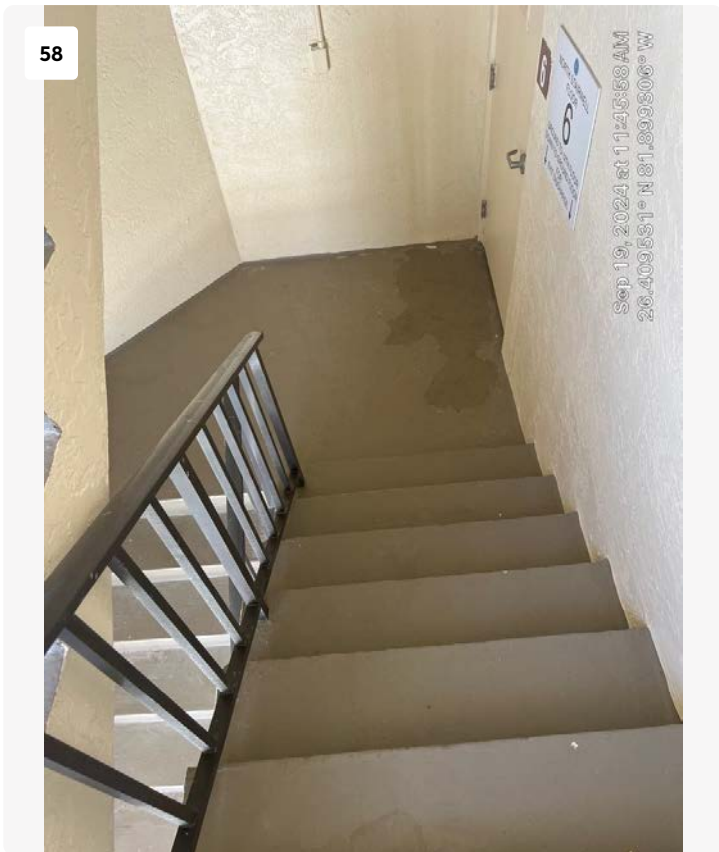
View down to 6 floor of north stairwell. Typical conditions observed throughout the stairwells.

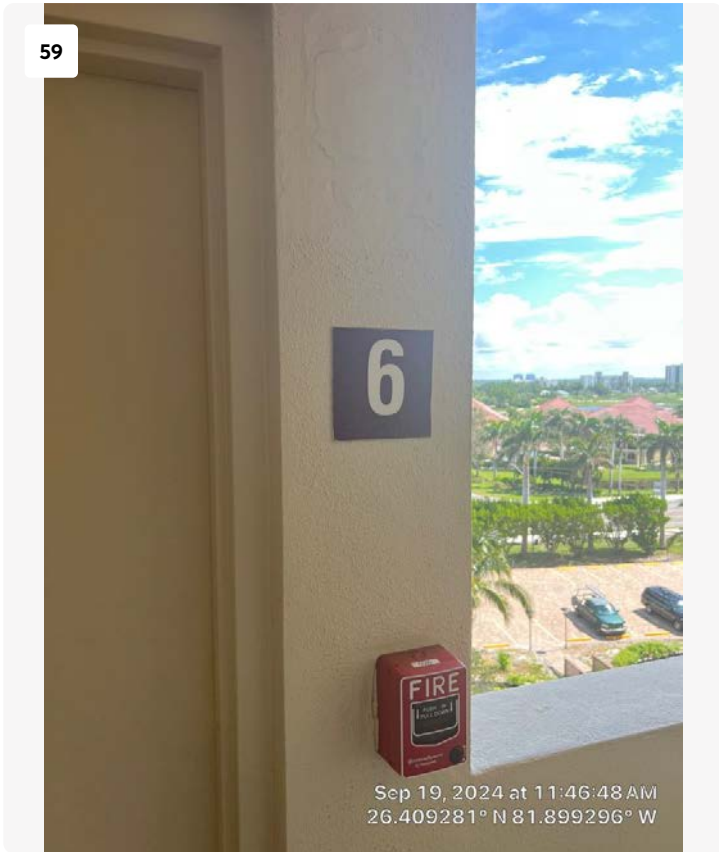
Project: Riviera Club
Date: 9/19/2024, 11:46am
Creator: Field Tech #1

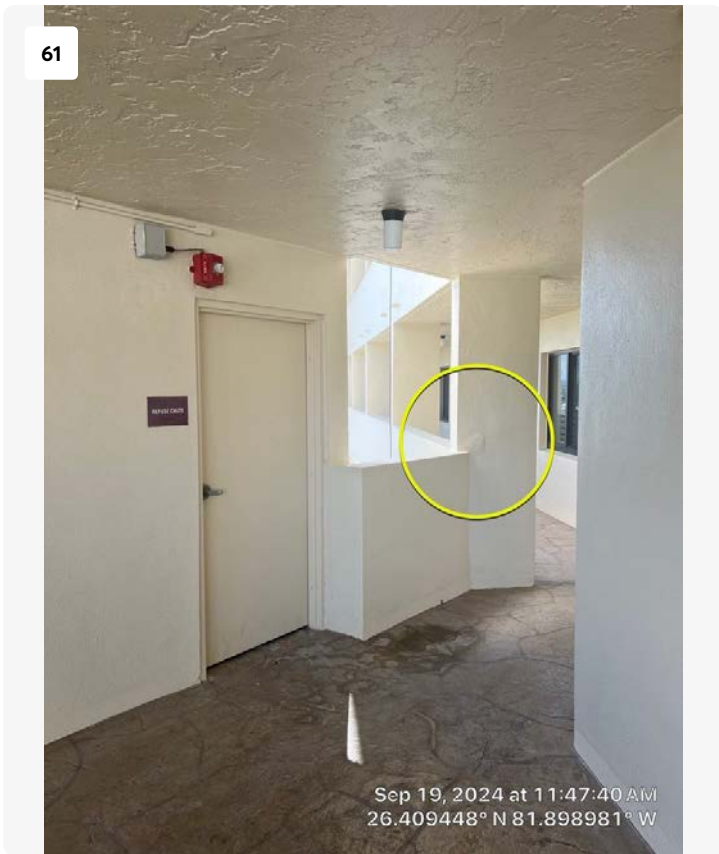
Adjacent to 6th floor elevators. Stucco delamination noted on column--stucco repair is required, and a structural concrete repair may also be needed. Unable to determine until stucco is removed.

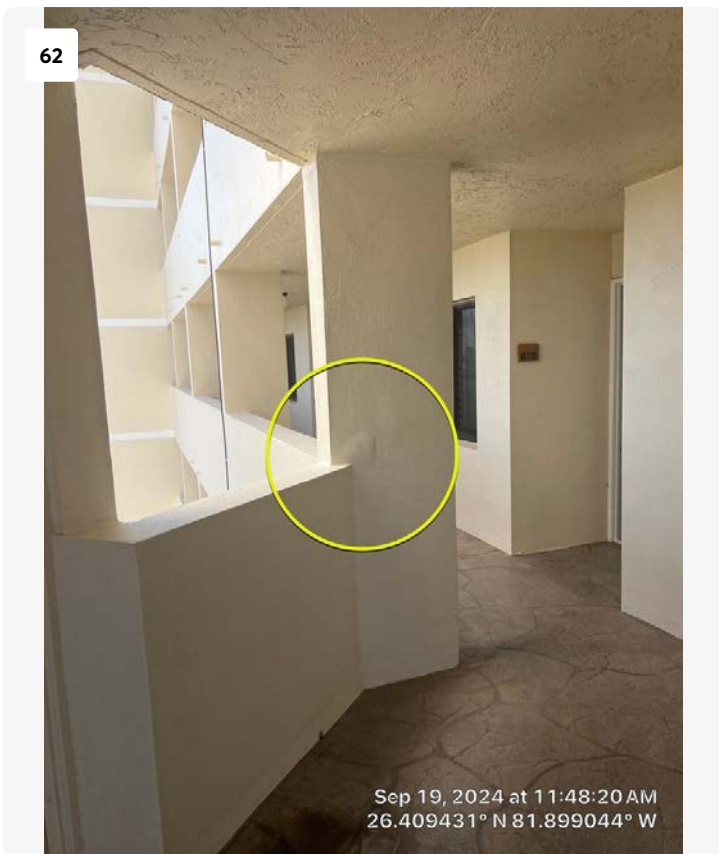
Adjacent to 6th floor elevators. Stucco delamination noted on column--stucco repair is required, and a structural concrete repair may also be needed. Unable to determine until stucco is removed.

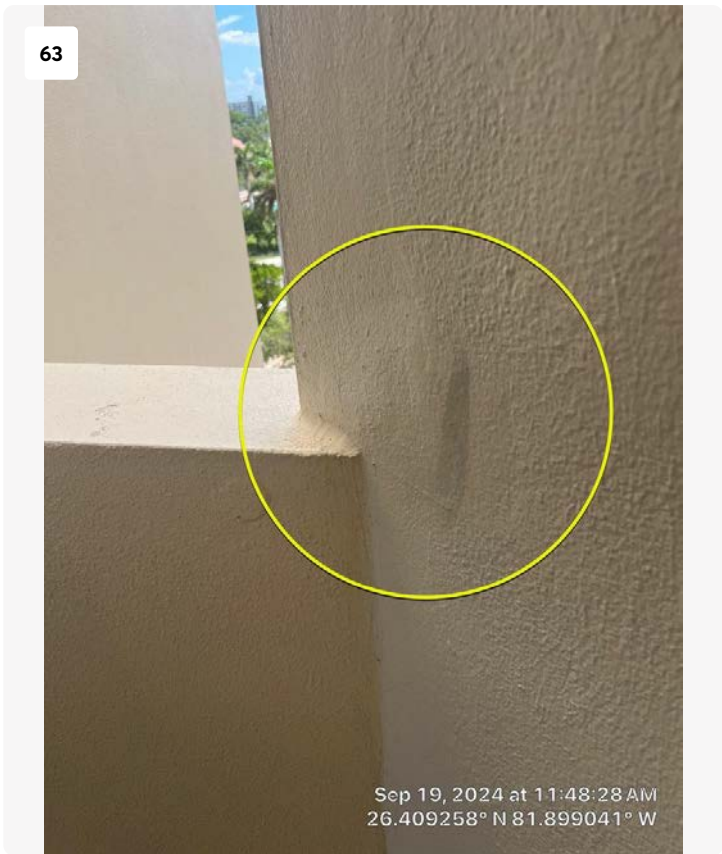
Adjacent to 6th floor elevators. Stucco delamination noted on column--stucco repair is required, and a structural concrete repair may also be needed. Unable to determine until stucco is removed.

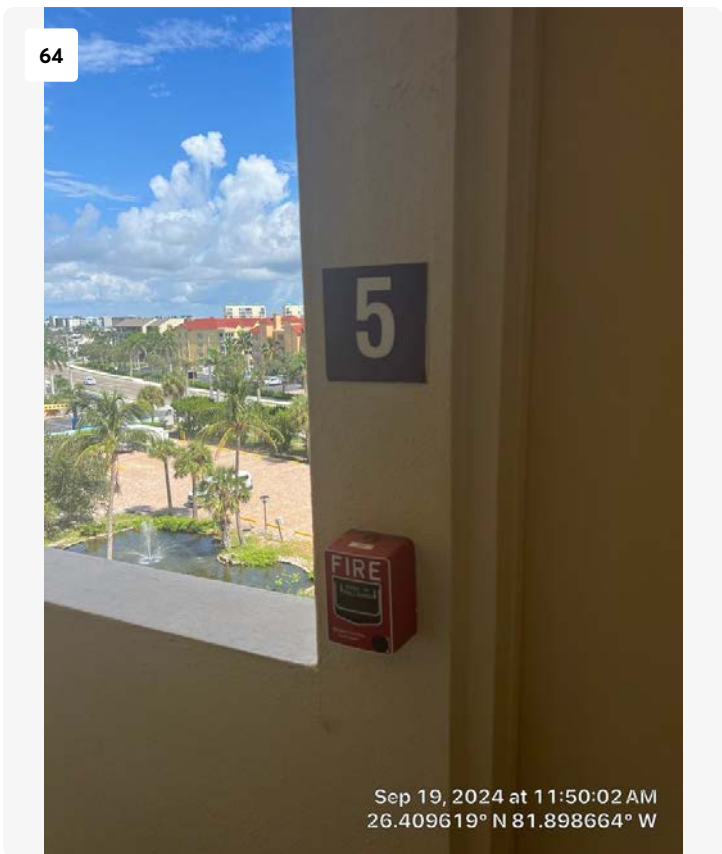
Project: Riviera Club
Date: 9/19/2024, 11:50am
Creator: Field Tech #1

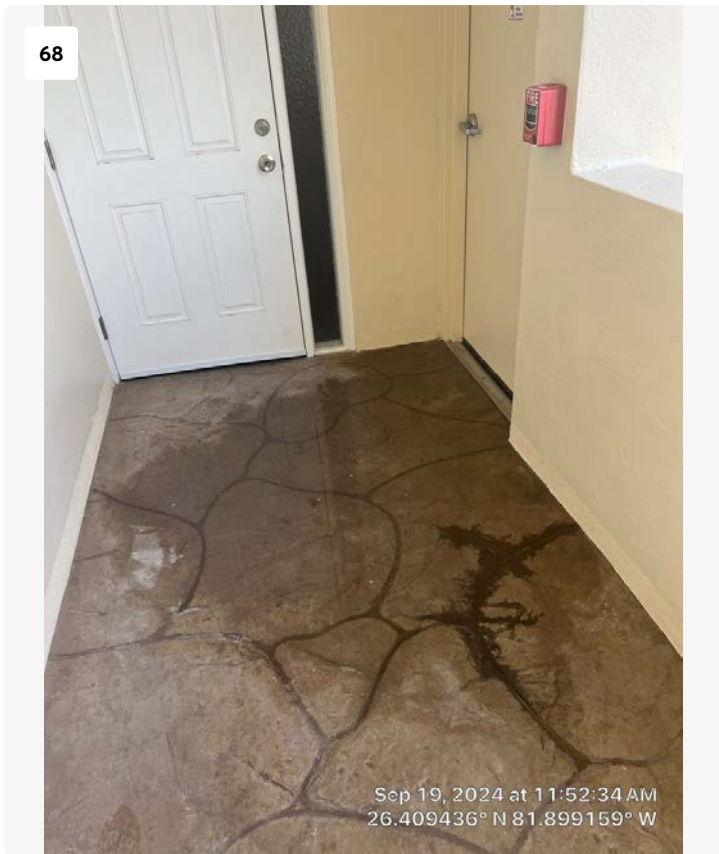
Outside north stairwell at 4th floor. Excessive water ponding noted. Resloping of walkways may be needed, or potentially a floor drain installed in this area.

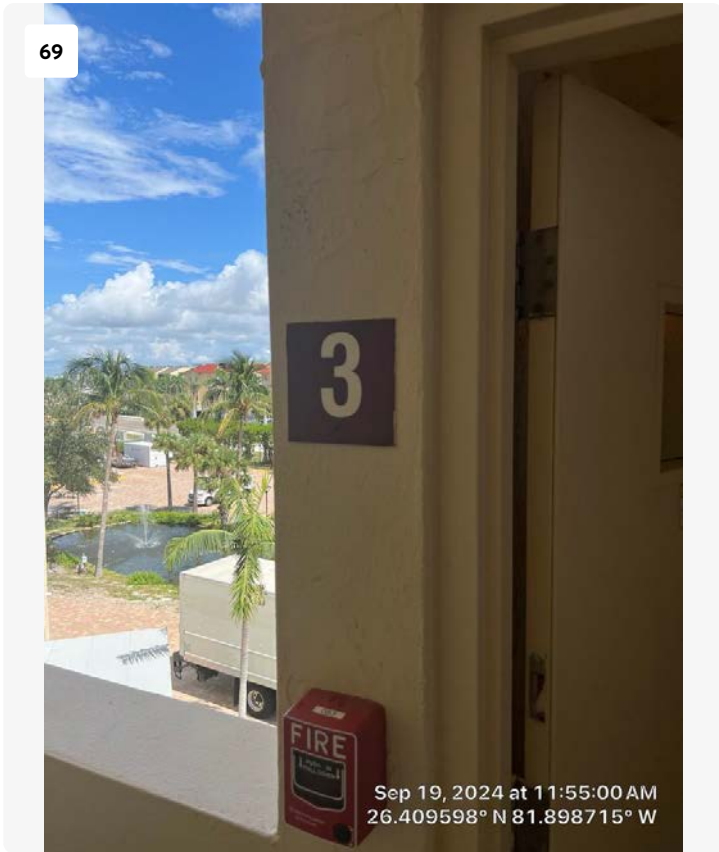
Project: Riviera Club
Date: 9/19/2024, 11:55am
Creator: Field Tech #1

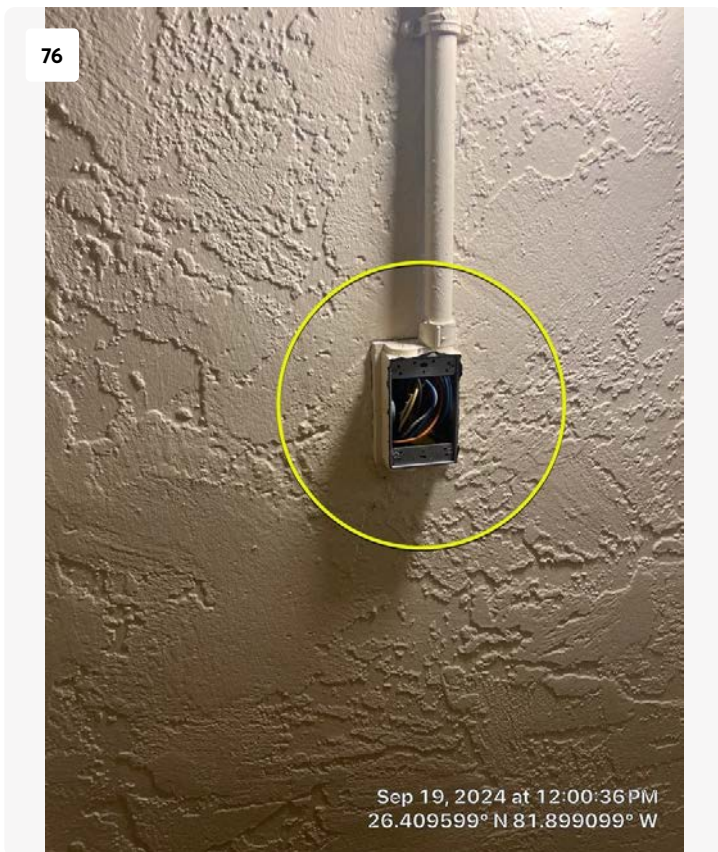
Location of open electrical junction box, 1st floor north stairwell. This box requires repair and a cover plate installed.

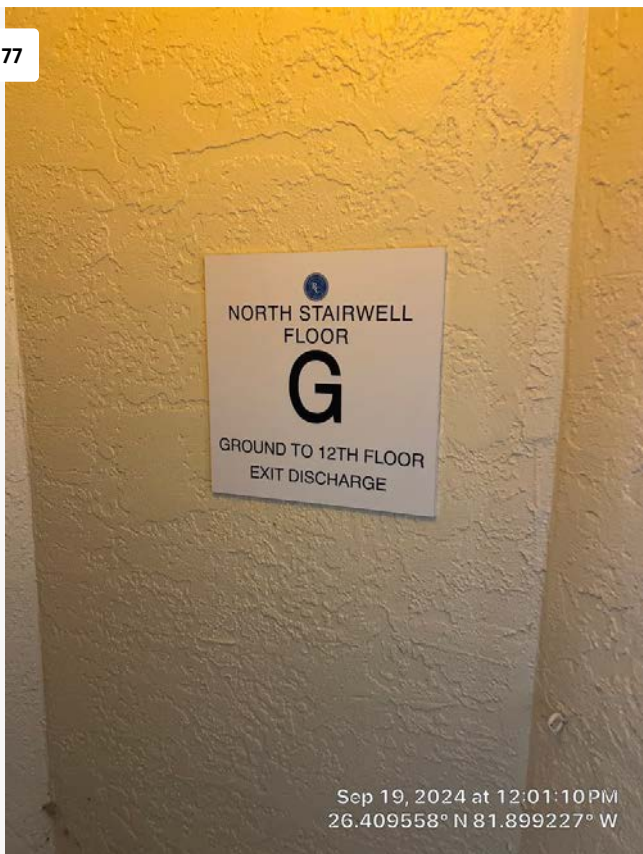
Location of loose handrail. All fasteners appear to be in good condition, but hand rail showed a fair amount of movement when tested. The hand rail needs to be anchored to prevent movement and potential trip hazard.

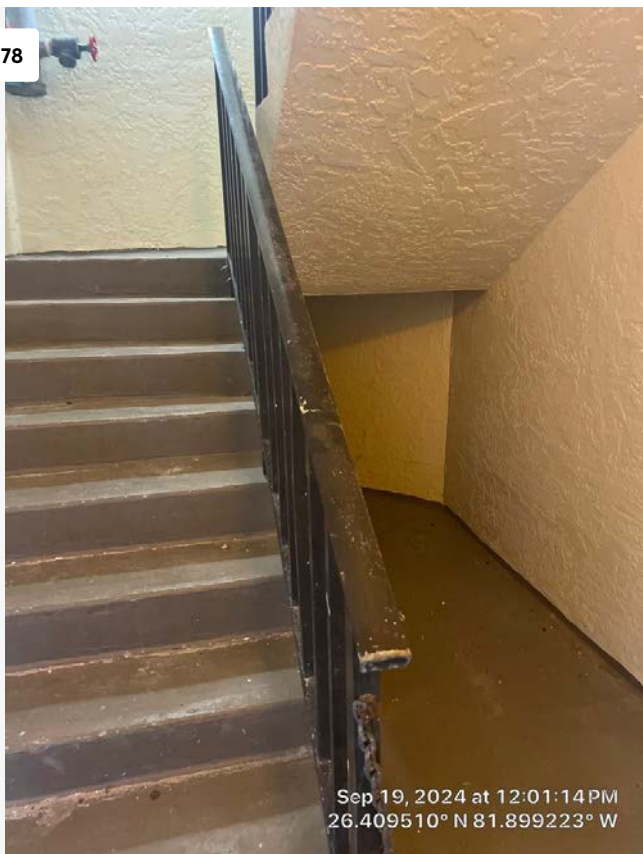
All fasteners look good but handrail is loose. The handrail should be anchored to prevent movement and potential trip hazard.

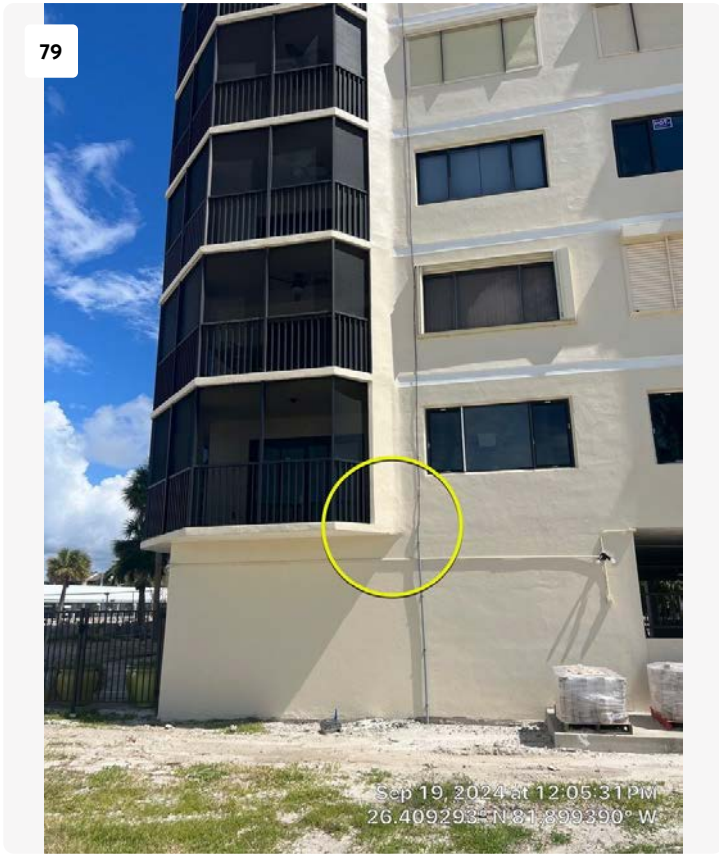
Northwest elevation, first floor balcony. Possible spall observed in balcony slab edge. It may also simply be a prior repair with texture mismatch. No action required at this time.

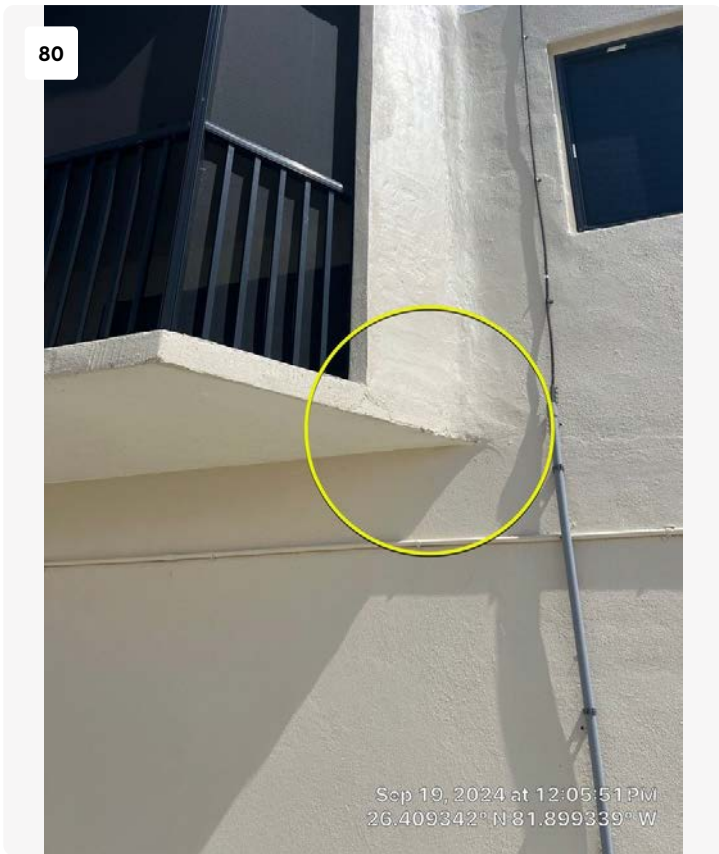
Northwest elevation, first floor balcony. Possible spall observed in balcony slab edge. It may also simply be a prior repair with texture mismatch. No action required at this time.

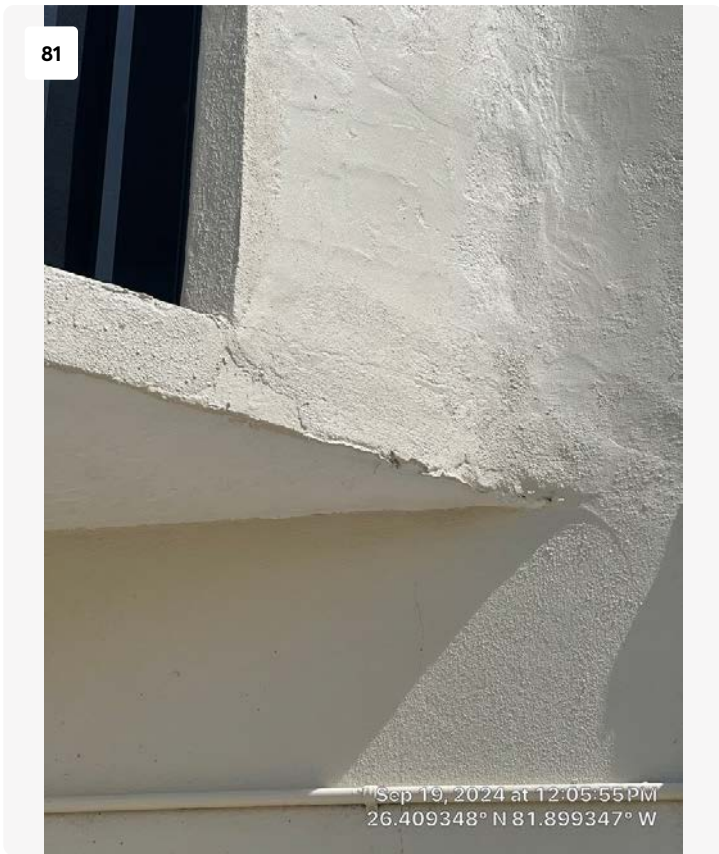
Northwest elevation, first floor balcony. Possible spall observed in balcony slab edge.

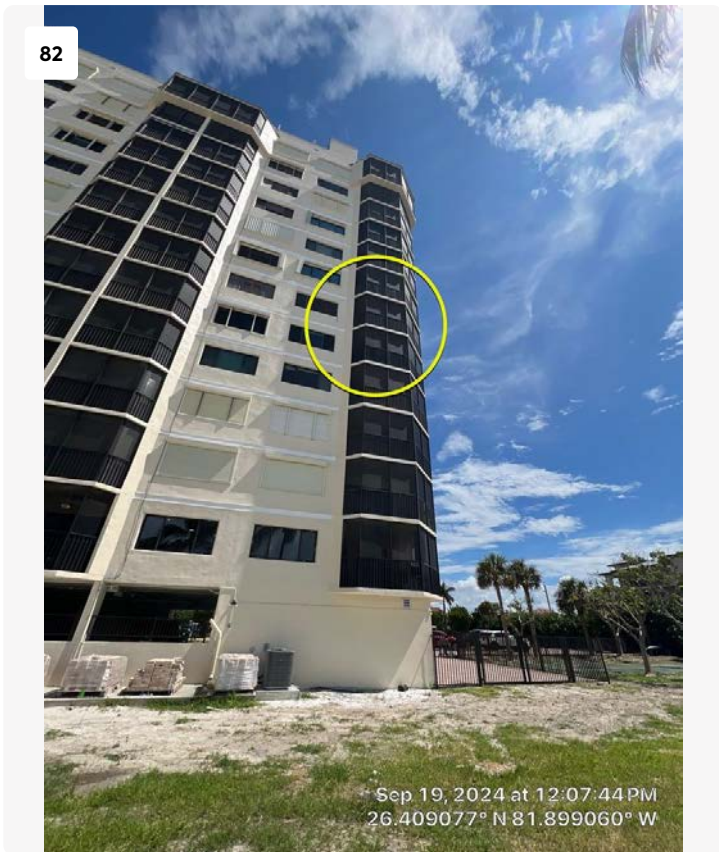
Southwest elevation 6th floor slab edge.

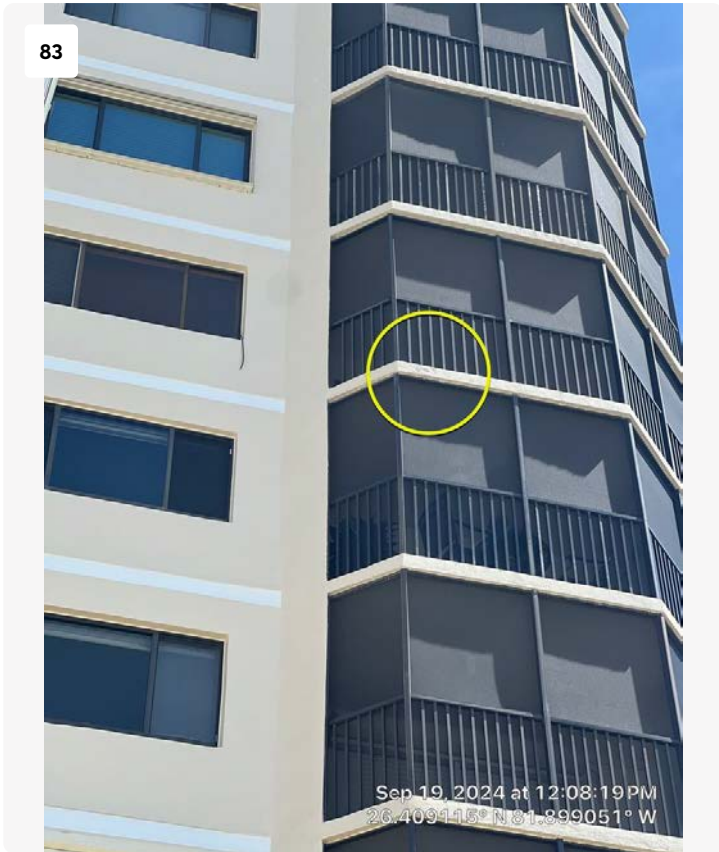
Possible spall observed on 6th floor balcony slab edge.

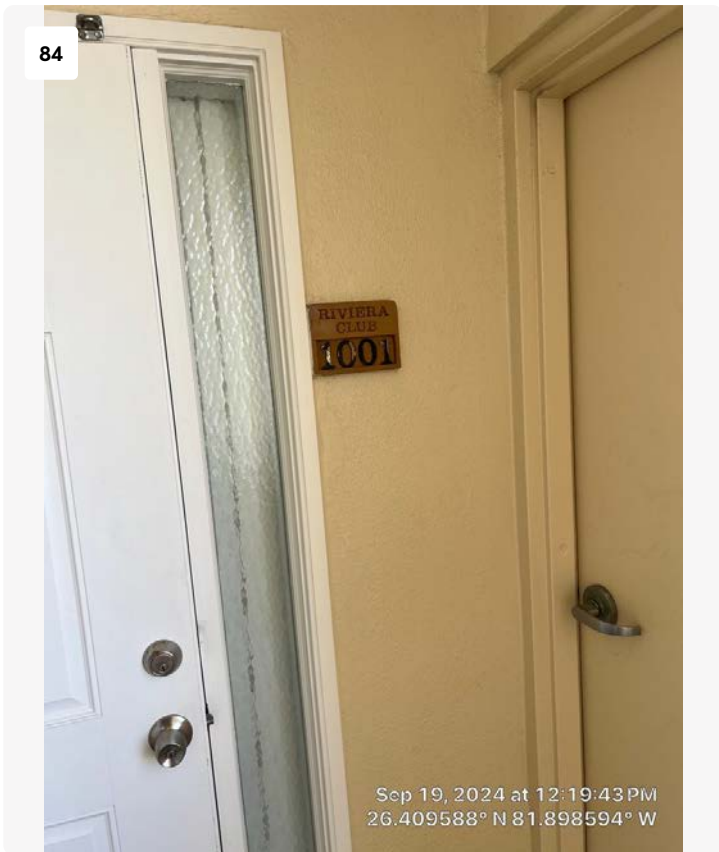
Project: Riviera Club
Date: 9/19/2024, 12:08pm
Creator: Field Tech #1

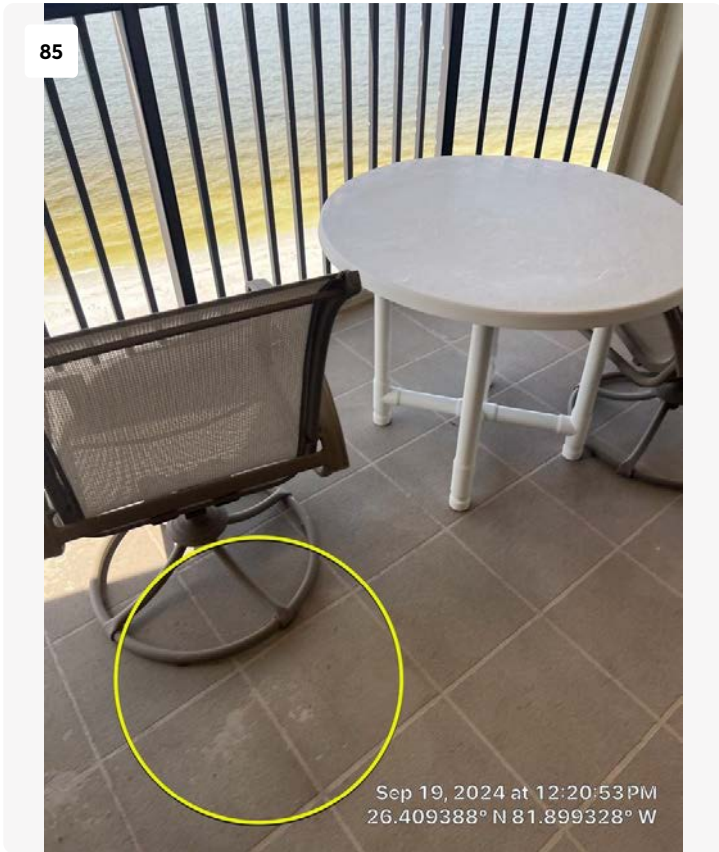
Mild deterioration of balcony coatings observed on balcony of Unit 1001.

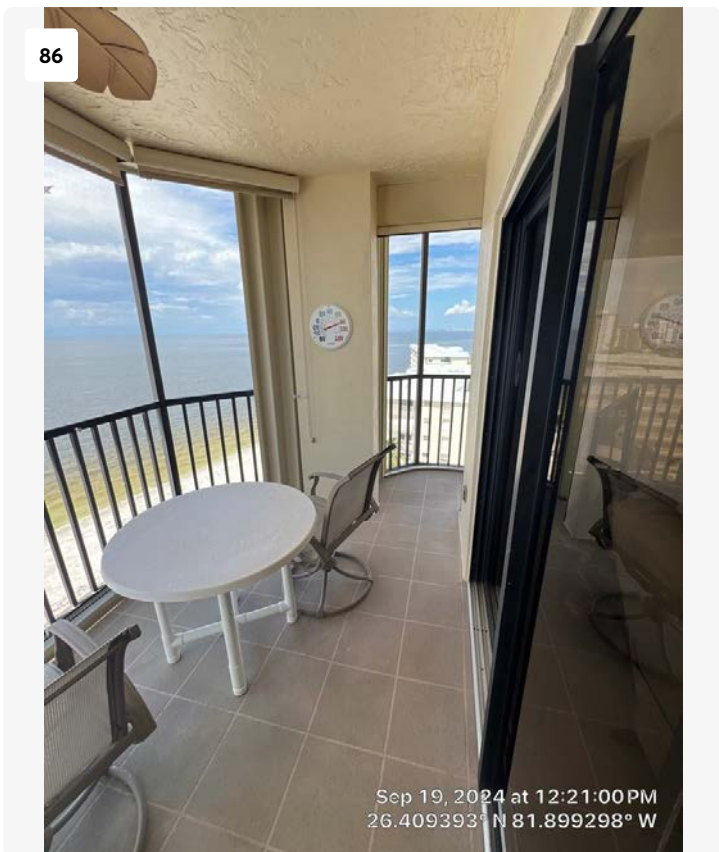
Balcony of Unit 1001.

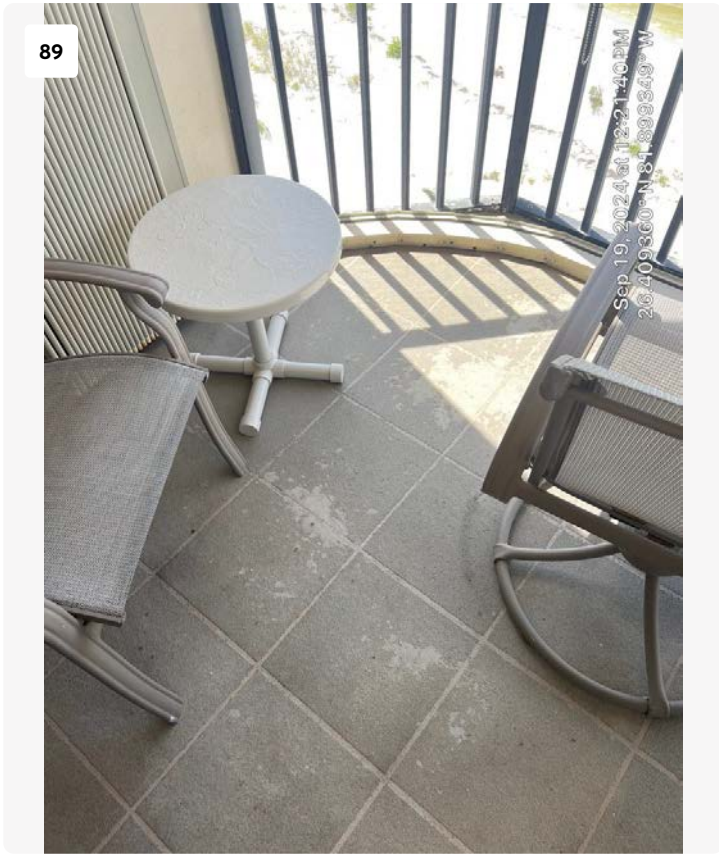
Project: Riviera Club
Date: 9/19/2024, 12:21pm
Creator: Field Tech #1

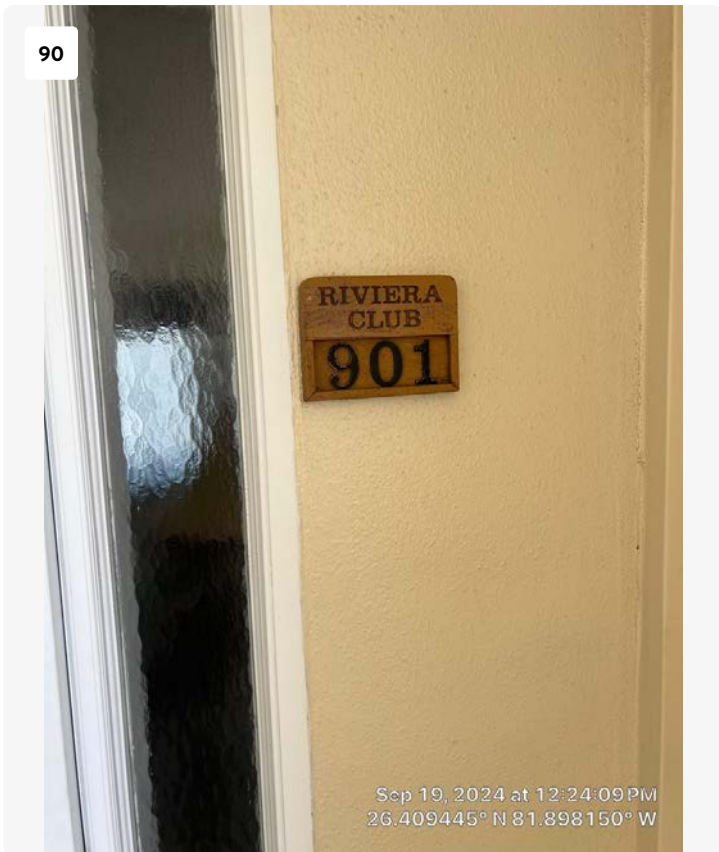
Project: Riviera Club
Date: 9/19/2024, 12:21pm
Creator: Field Tech #1

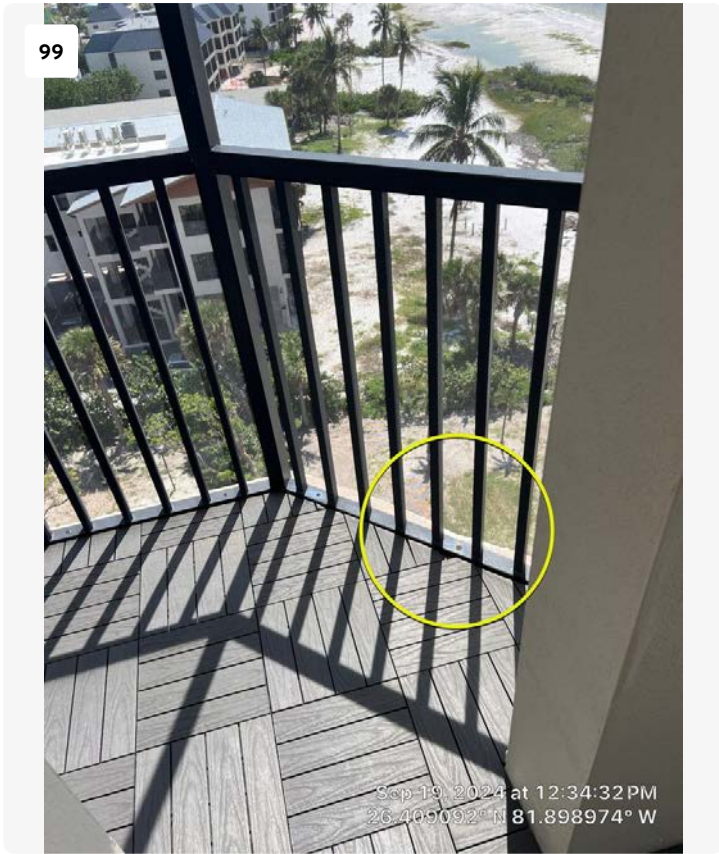
Northwest elevation, first floor balcony. Concrete spall observed at balcony slab edge. This area should be repaired to prevent additional structural deterioration.

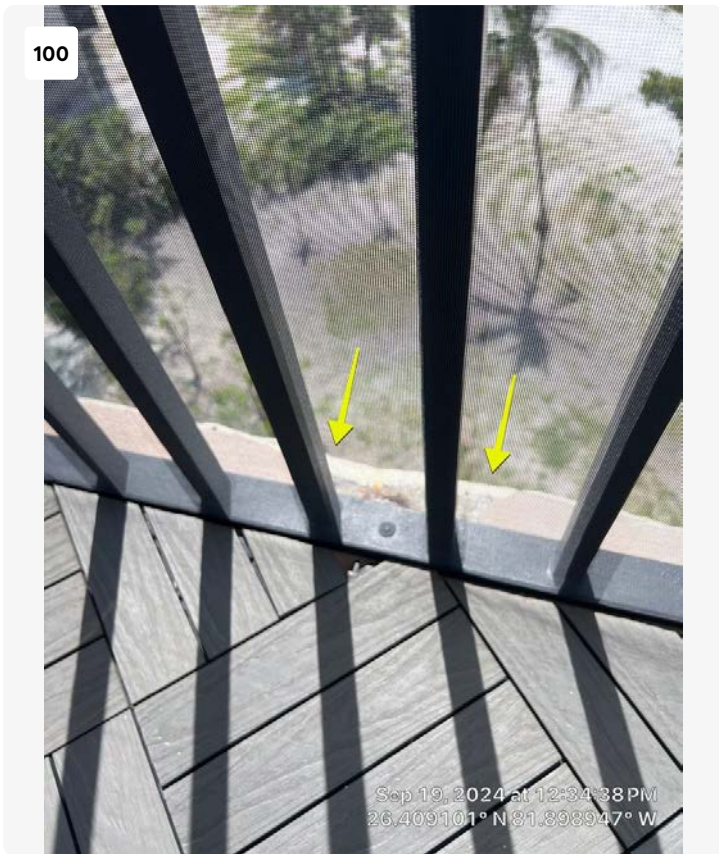
Northwest elevation, first floor balcony. Concrete spall observed at balcony slab edge. This area should be repaired to prevent additional structural deterioration.

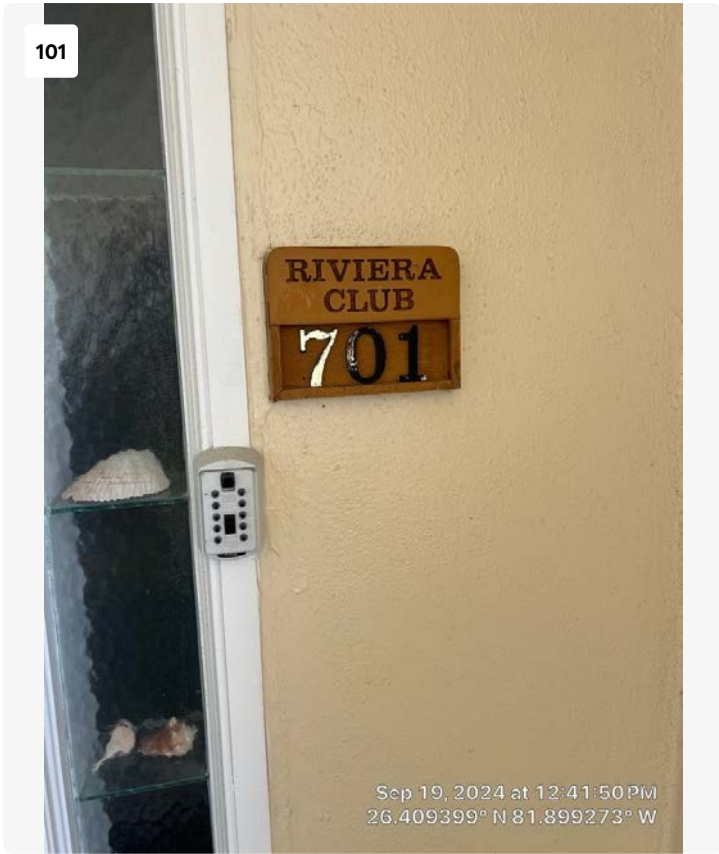
Project: Riviera Club
Date: 9/19/2024, 12:34pm
Creator: Field Tech #1

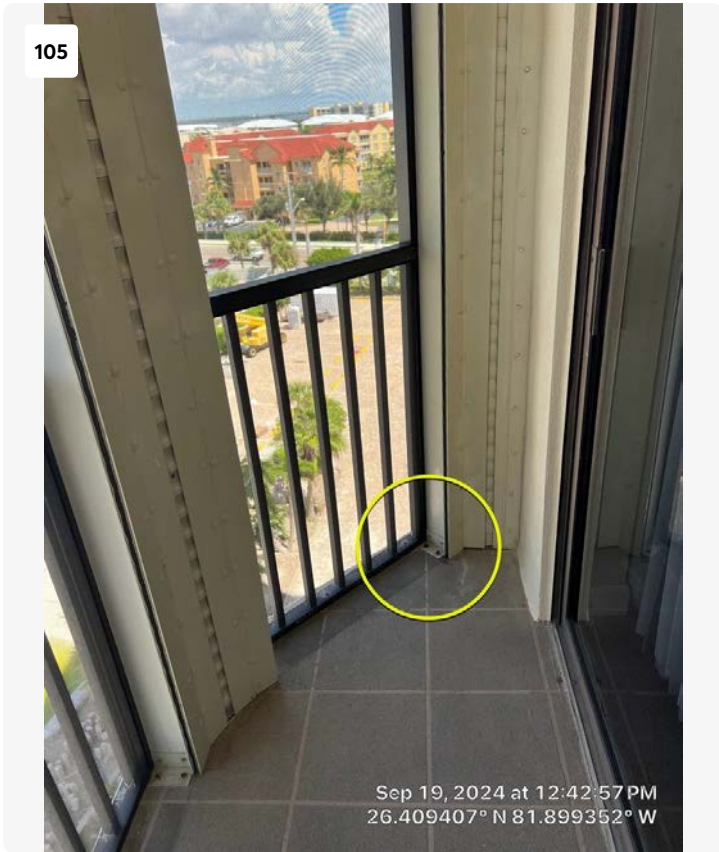
Minor corrosion noted on fasteners on small side balcony of Unit 701.

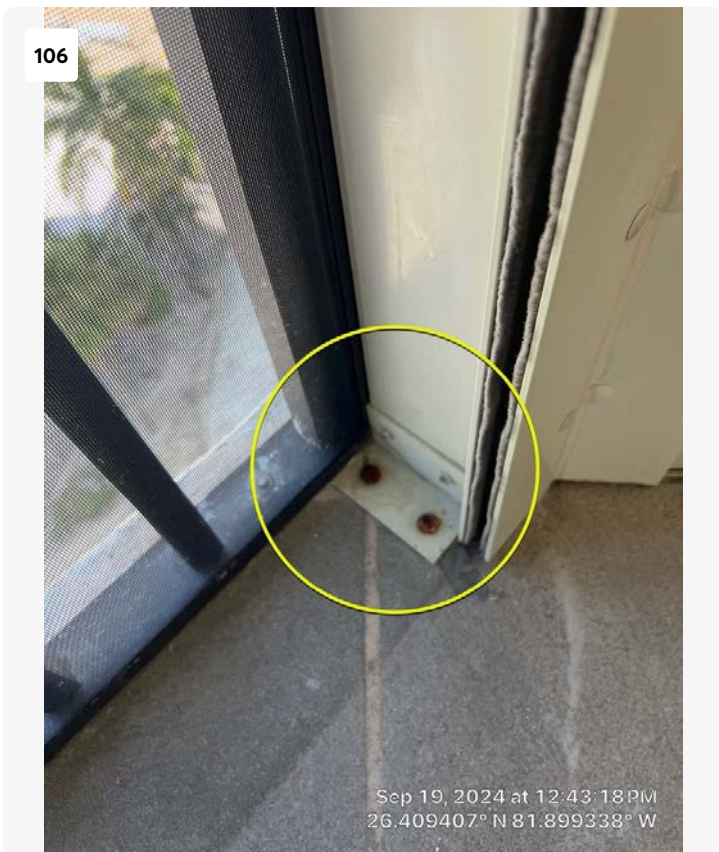
Minor corrosion noted on fasteners on small side balcony of Unit 701. Fasteners like this should be periodically inspected and can be replaced on an as-needed basis.

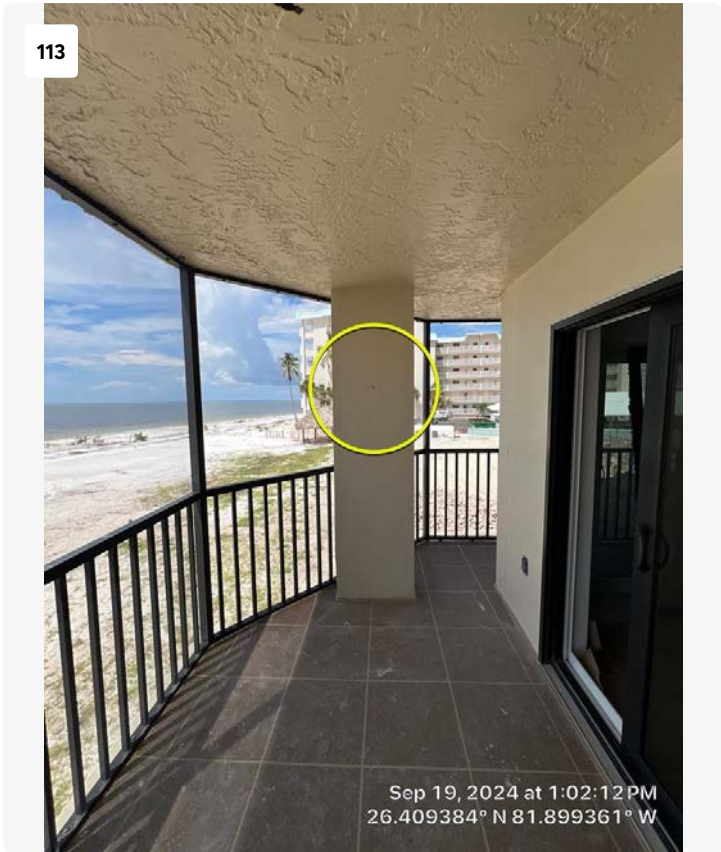
Location of corroded fastener on balcony of Unit 101.

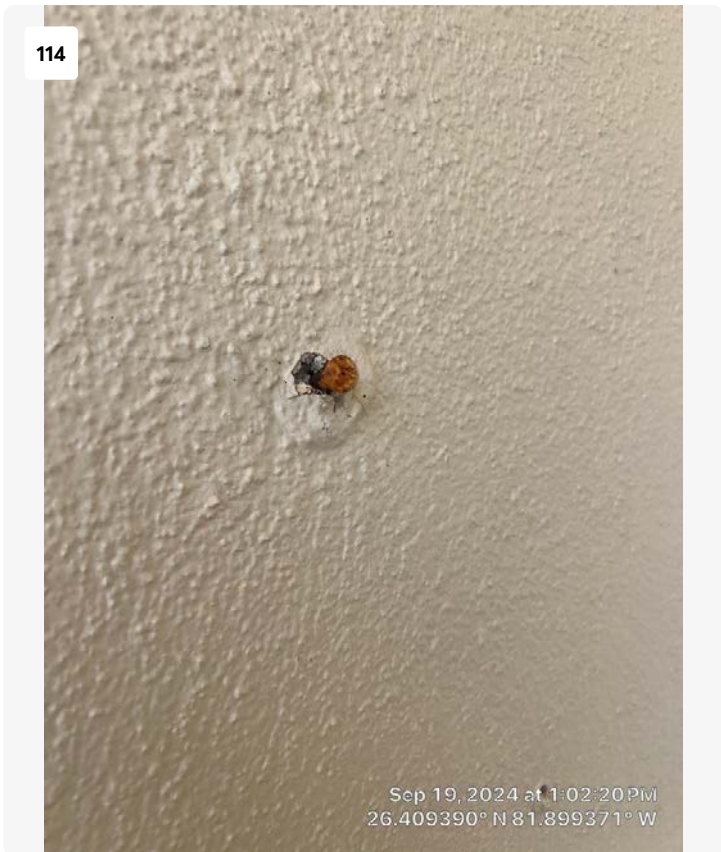
Corroded fastener on balcony of Unit 101. This was likely installed by a unit owner to hold decorations or signage. The fastener should be removed and the concrete patched to prevent moisture intrusion into the concrete.

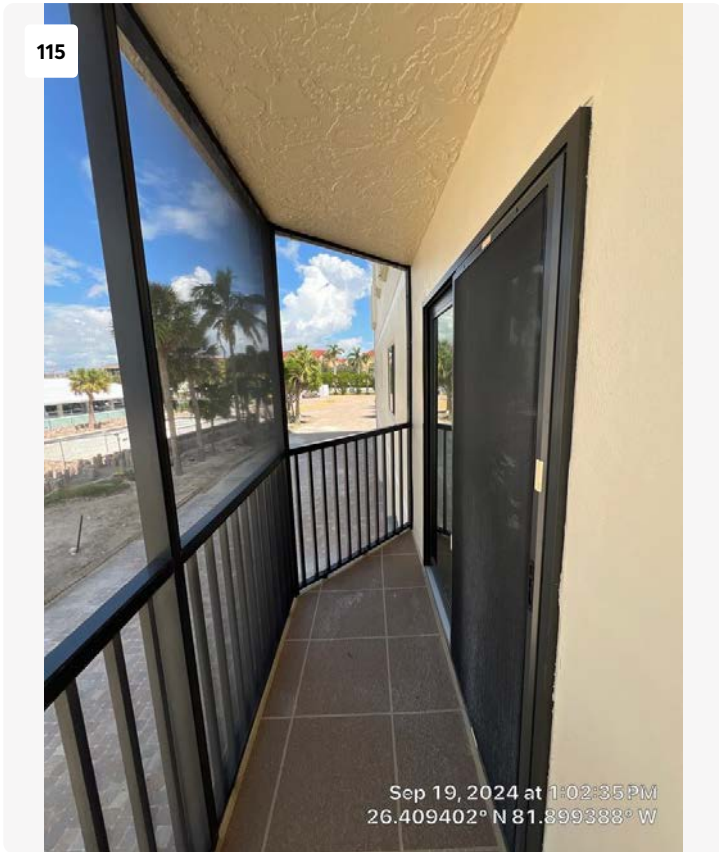
Small side balcony of Unit 101.

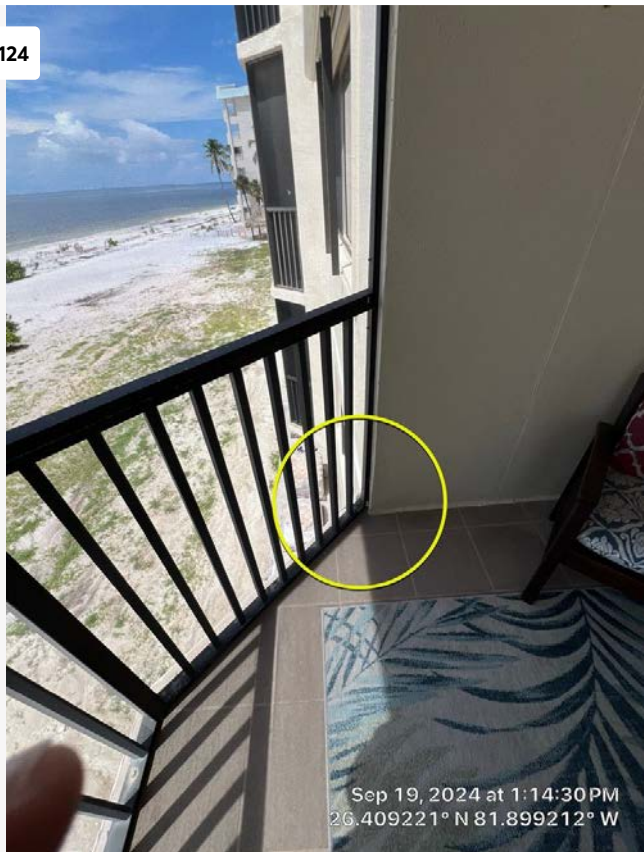
Small crack in slab edge on balcony of Unit 204. This is very likely a concrete spall which needs to be repaired to prevent moisture intrusion into the slab.

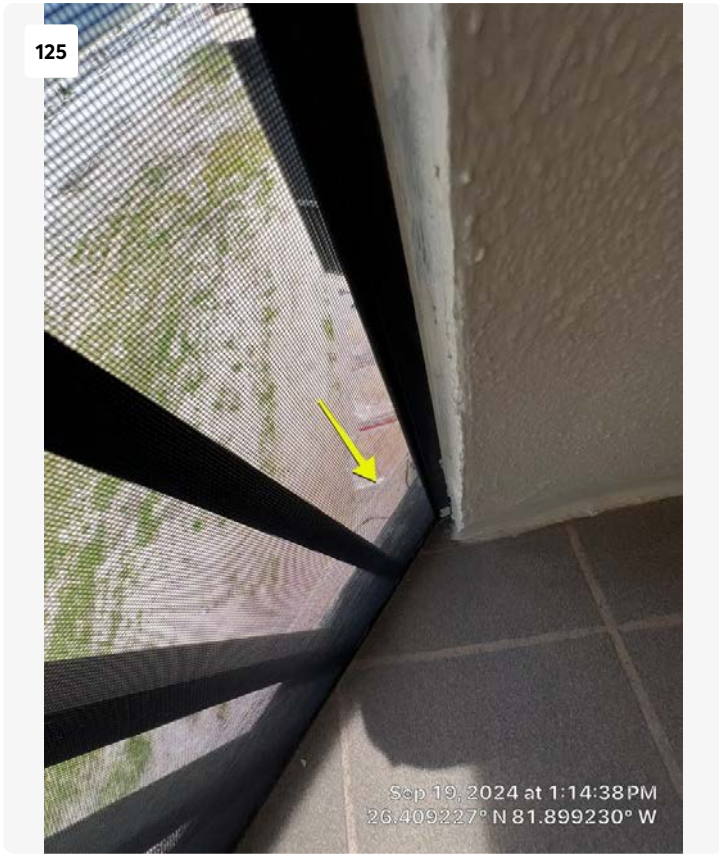
Small crack in slab edge on balcony of Unit 204. This is very likely a concrete spall which needs to be repaired to prevent moisture intrusion into the slab.
