MATERIAL FINDINGS AND RECOMMENDATIONS:
INSPECTOR SUMMARY OF MILESTONE PHASE 1 INSPECTION

Property Name: Riviera Club Condominium

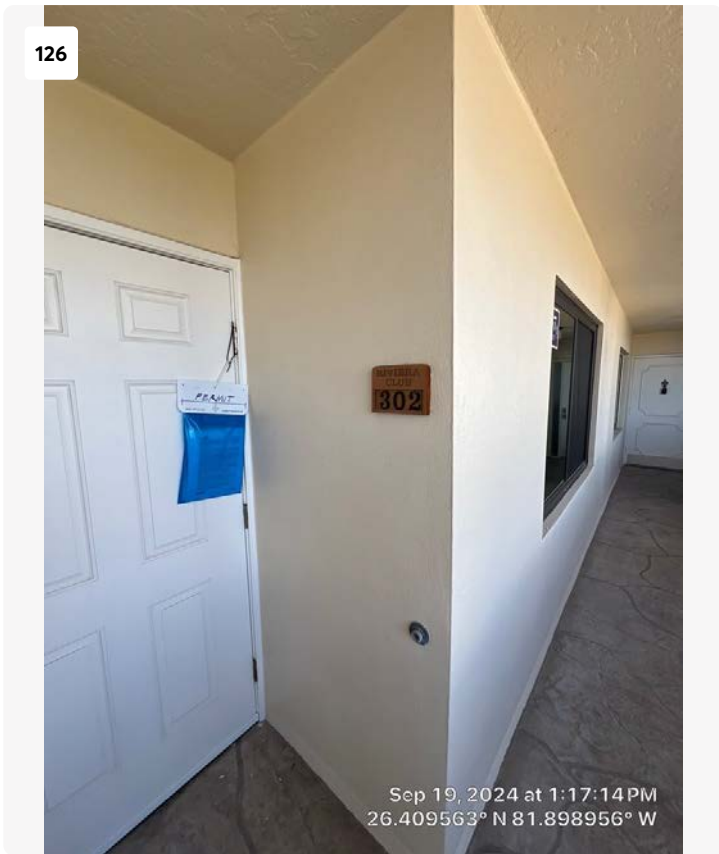
Project: Riviera Club
Date: 9/19/2024, 1:14pm
Creator: Field Tech #1

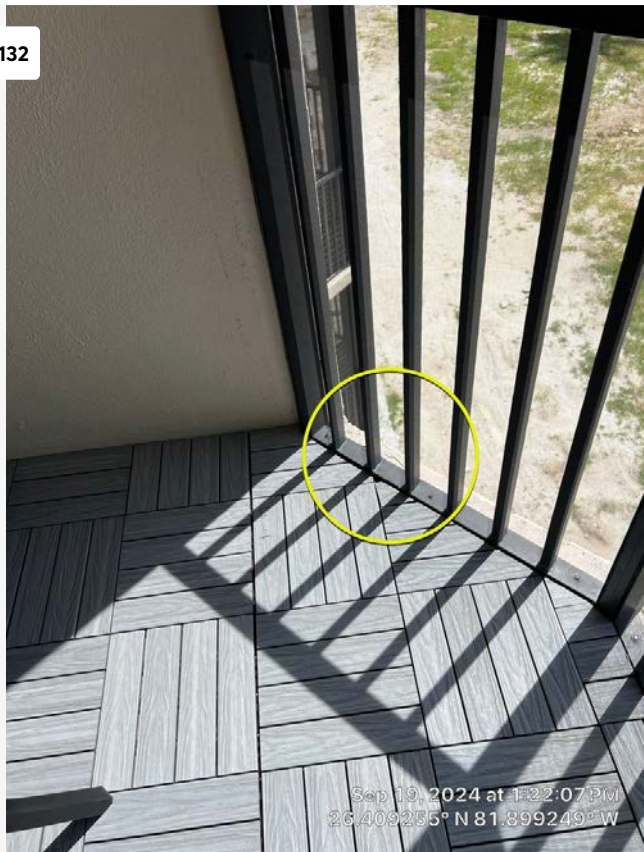
Concrete spall in slab edge of balcony 303. Requires repair.

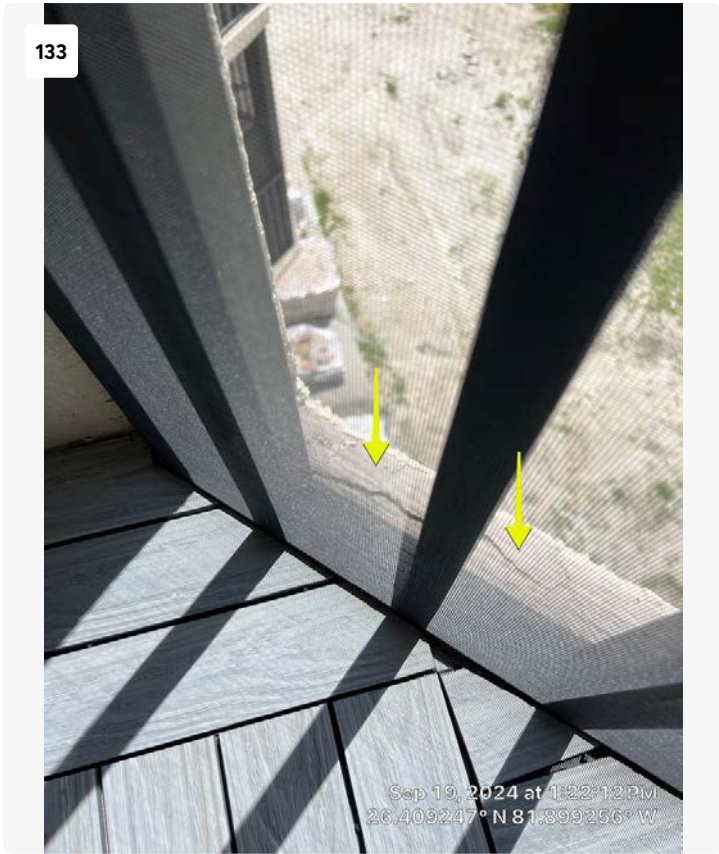
Concrete Spall requiring repair at slab edge of balcony 303.

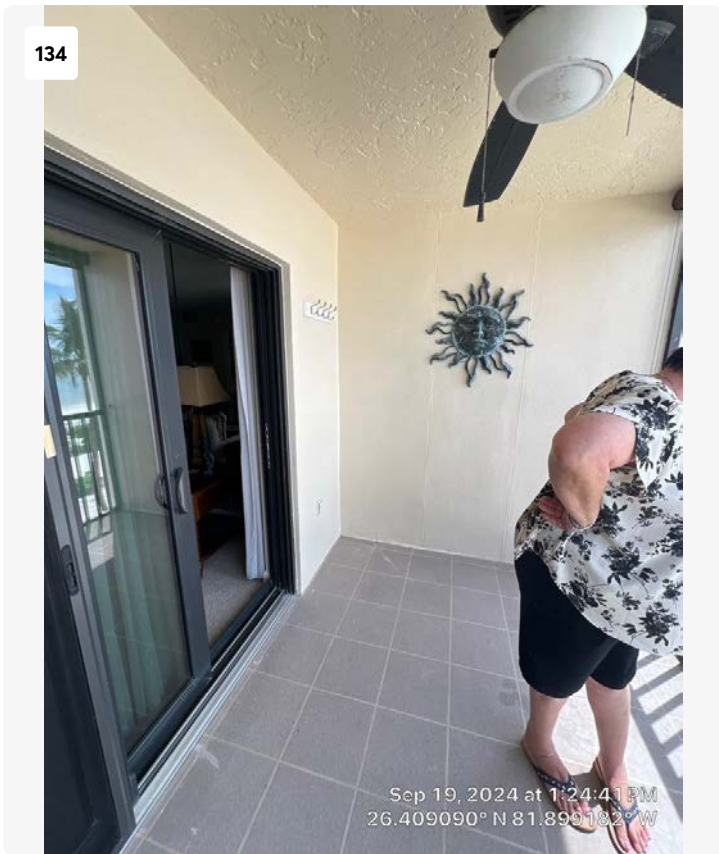
Balcony of Unit 305.

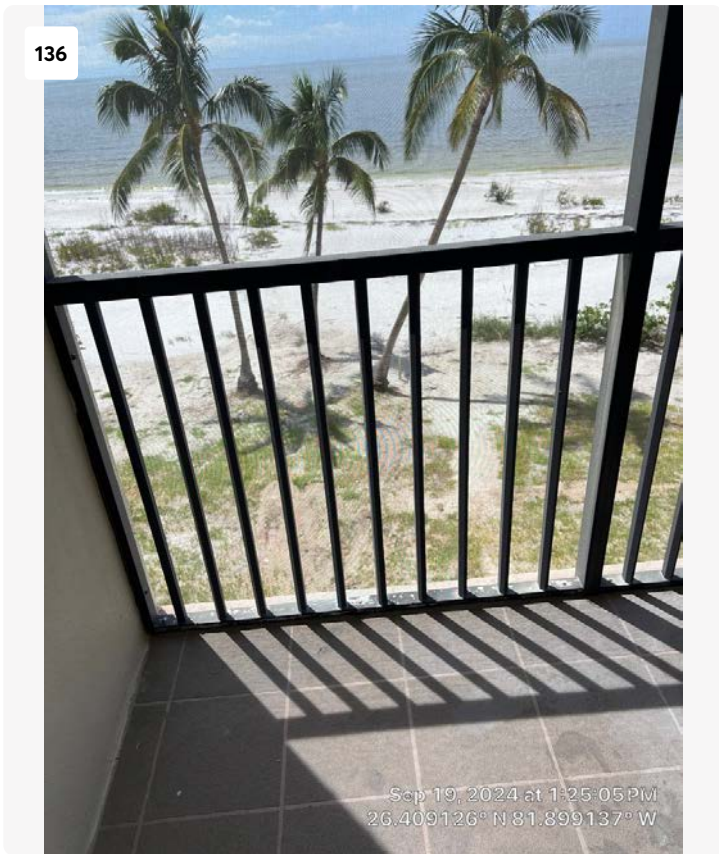
Very minor corrosion observed on guardrail fasteners of balcony Unit 305.

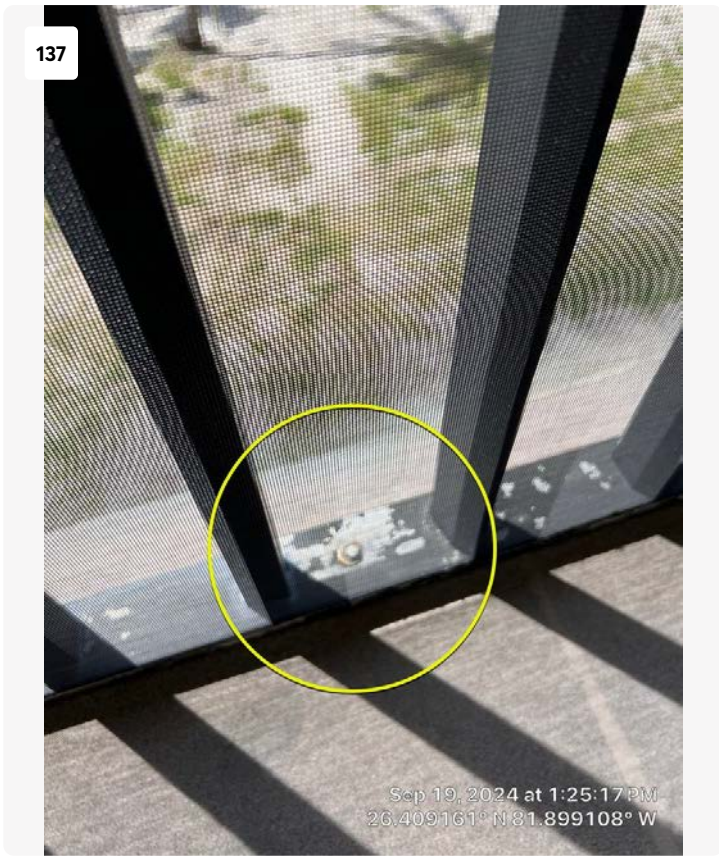
Very minor corrosion observed on guardrail fasteners of balcony Unit 305.

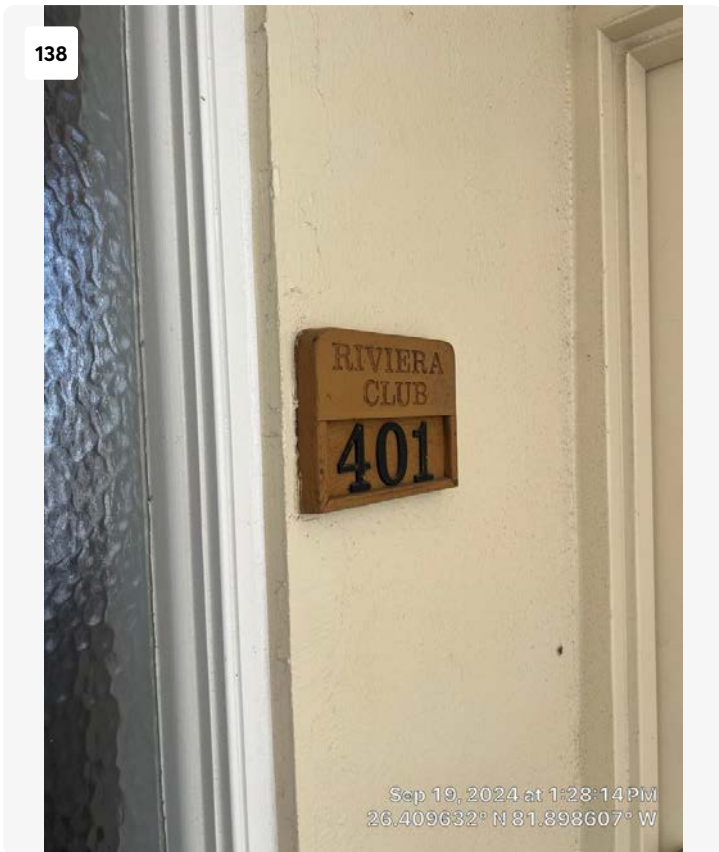
Project: Riviera Club
Date: 9/19/2024, 1:25pm
Creator: Field Tech #1

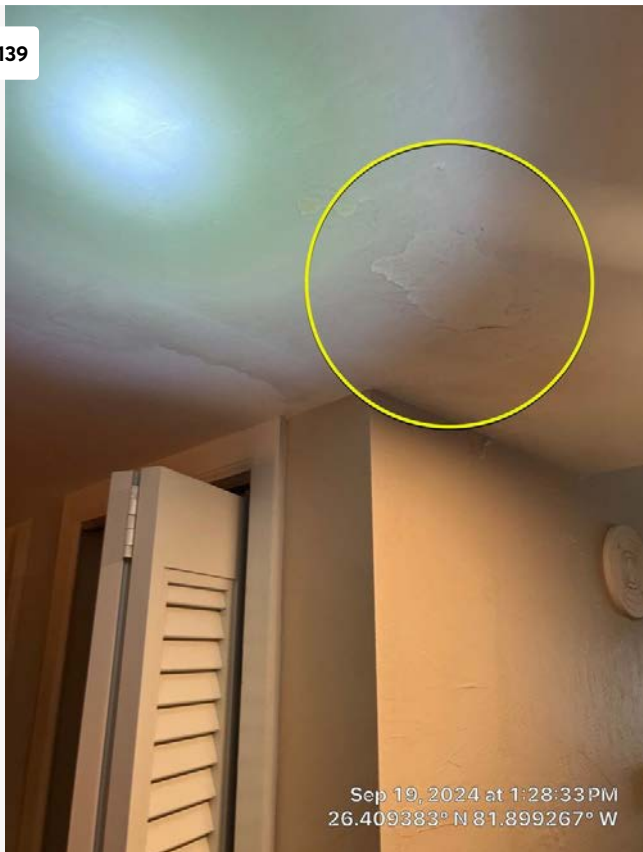
Water damage observed on ceiling just outside guest bathroom in Unit 401. Unable to determine if this is still an active leak.

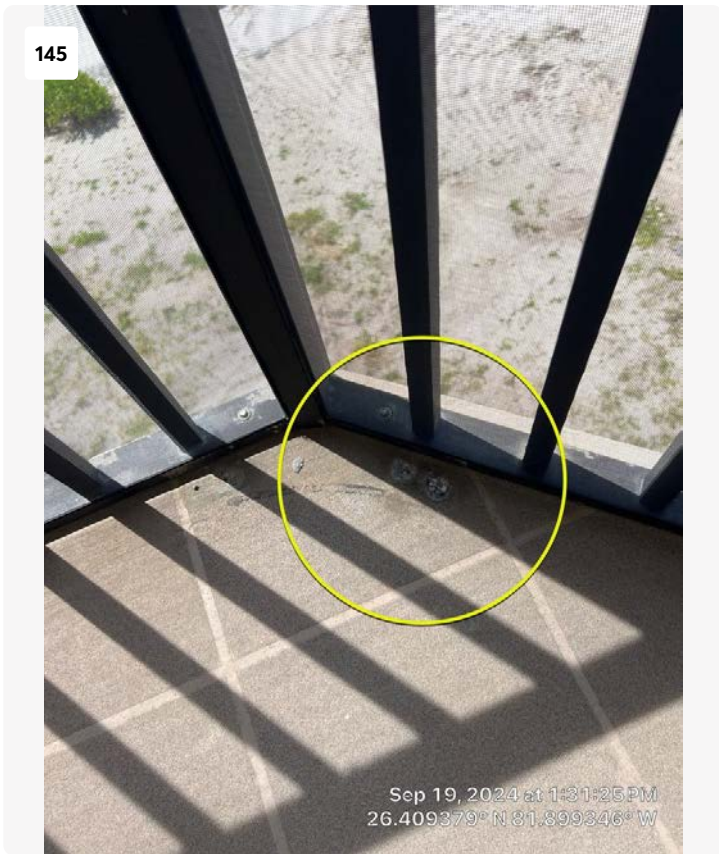
Unrepaired railing attachment points on floor of balcony Unit 401. These locations should be coated to help prevent moisture intrusion into the concrete slab.

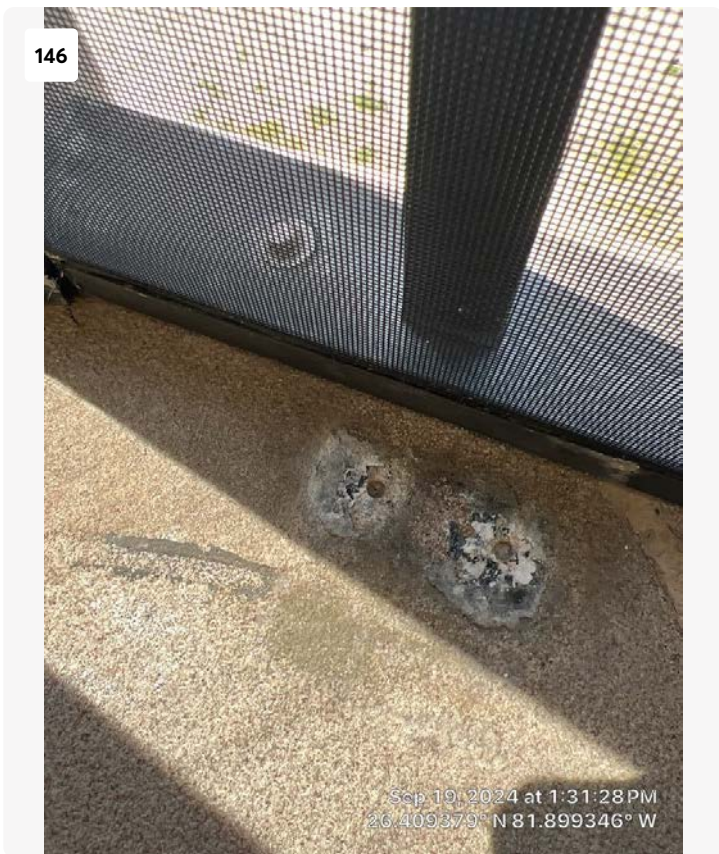
Unrepaired railing attachment points on floor of balcony Unit 401. These locations should be coated to help prevent moisture intrusion into the concrete slab.

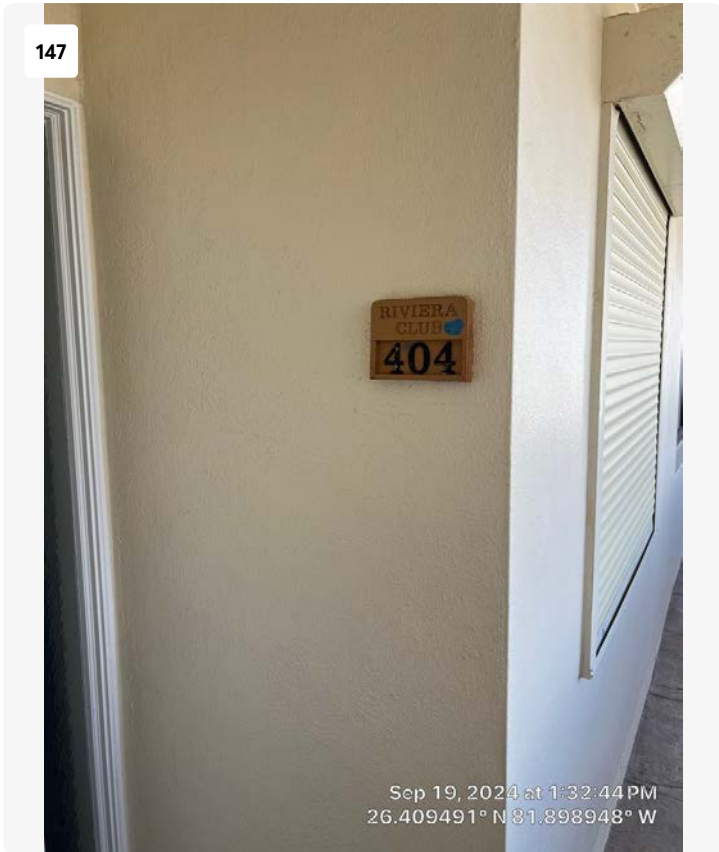
Project: Riviera Club
Date: 9/19/2024, 1:31pm
Creator: Field Tech #1

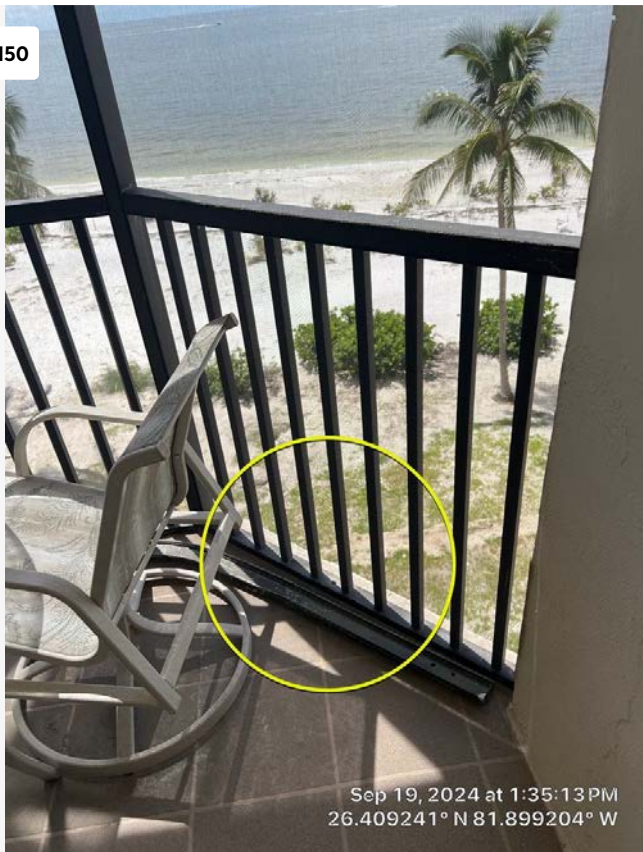
Sep 19, 2024 at 1:35:13 PM
26.409241° N 81.899204° W

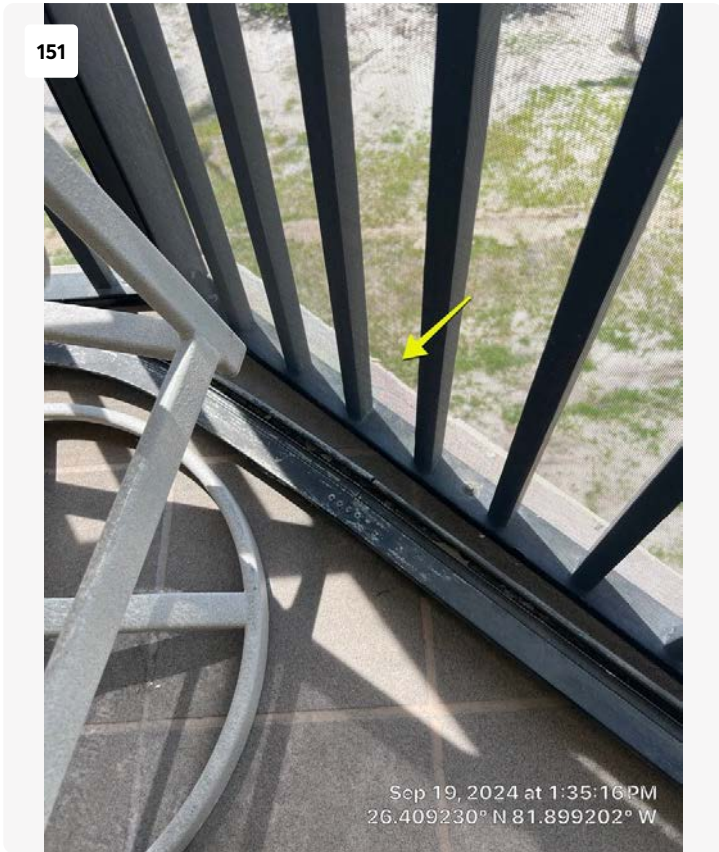
Minor slab edge damage observed on balcony of Unit 404. This is potentially a concrete slab edge spall.

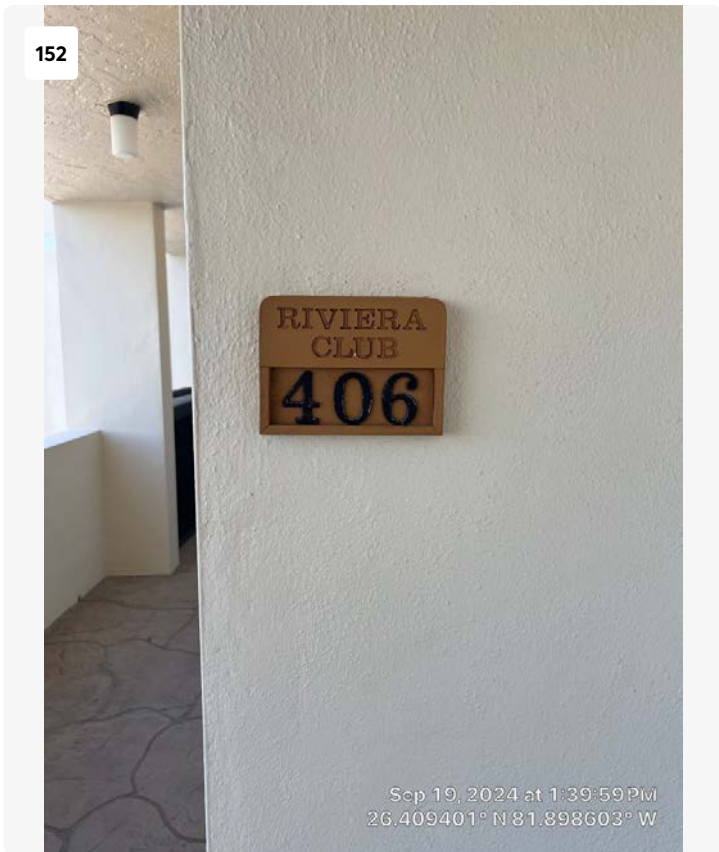
Project: Riviera Club
Date: 9/19/2024, 1:35pm
Creator: Field Tech #1

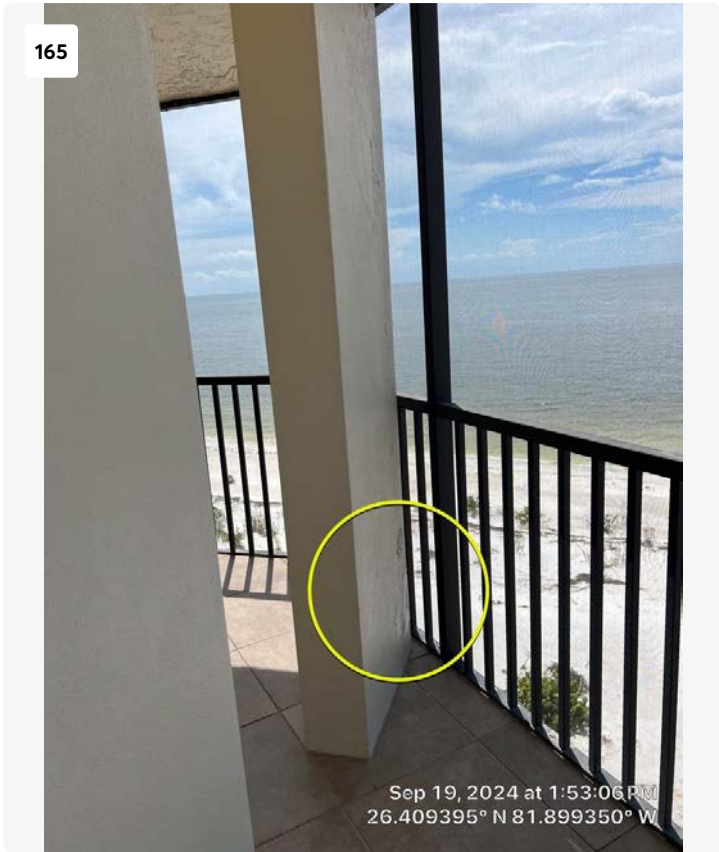
Possible previous repair noted on balcony column Unit 601.

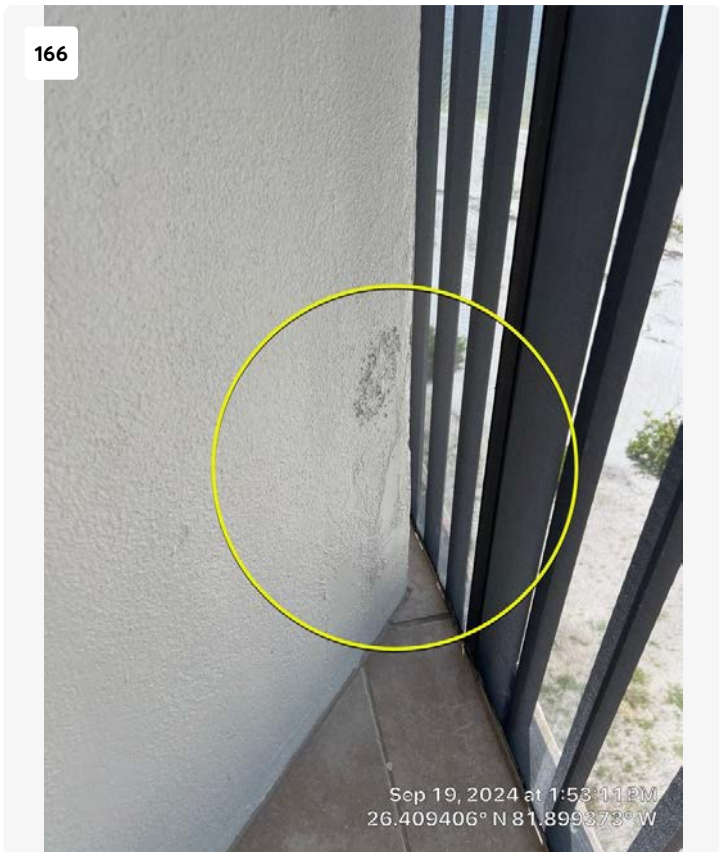
Possible previous repair noted on balcony column Unit 601. No action required at this time.

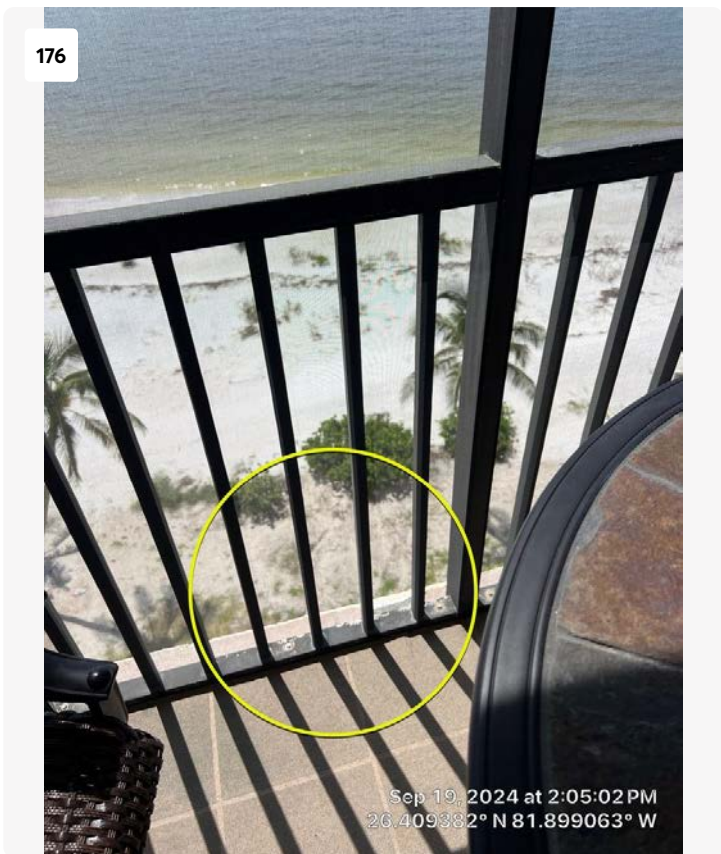
Minor damage to slab edge noted on balcony of Unit 804.

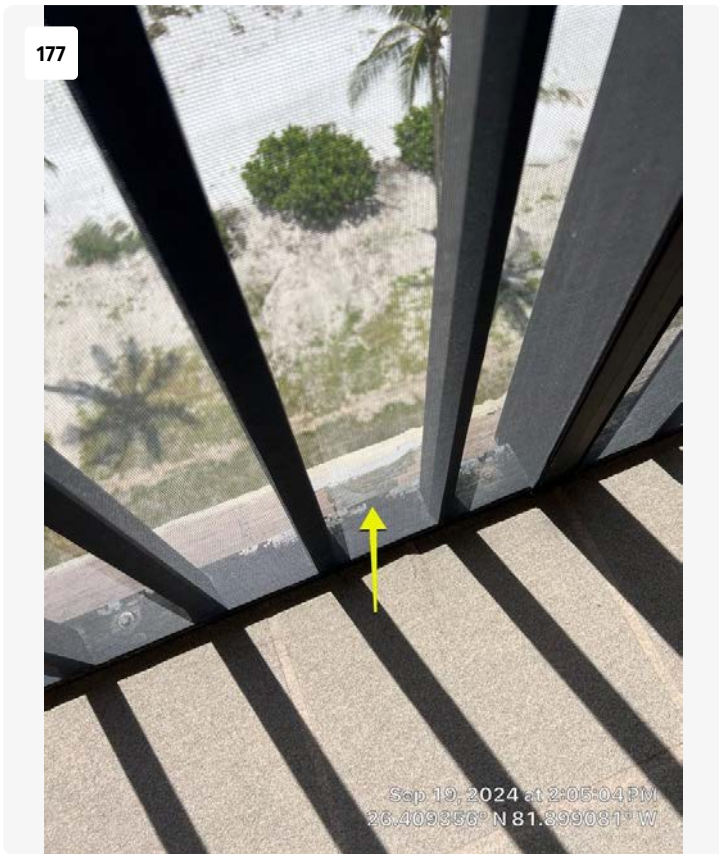
Minor damage to slab edge noted on balcony of Unit 804. This area should be coated to help prevent moisture intrusion.

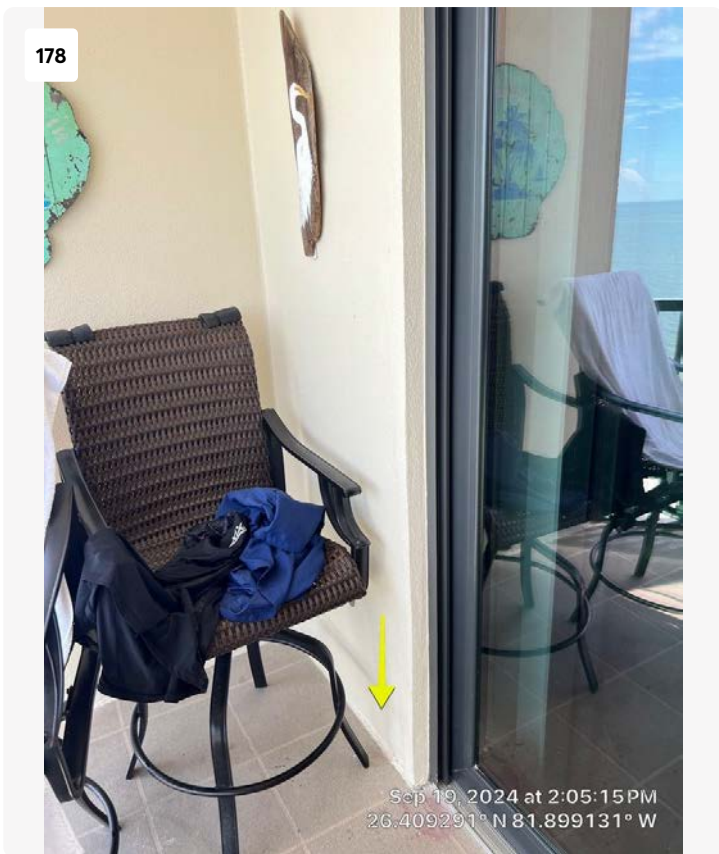
Small crack noted just outside slider on balcony of Unit 804.

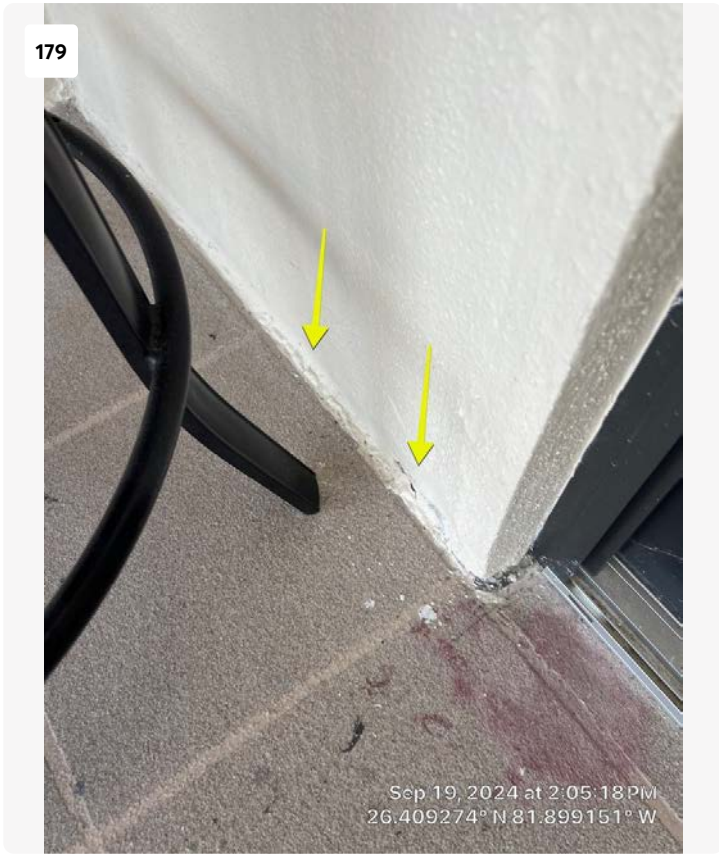
Small crack noted just outside slider on balcony of Unit 804. This area should be repaired to help prevent moisture intrusion into slab.

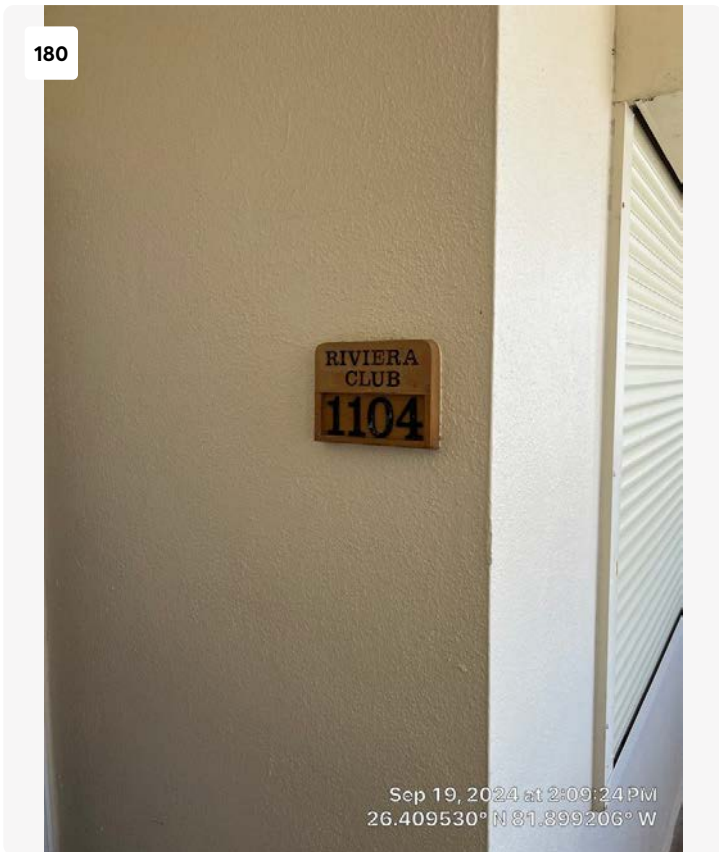
Project: Riviera Club
Date: 9/19/2024, 2:05pm
Creator: Field Tech #1

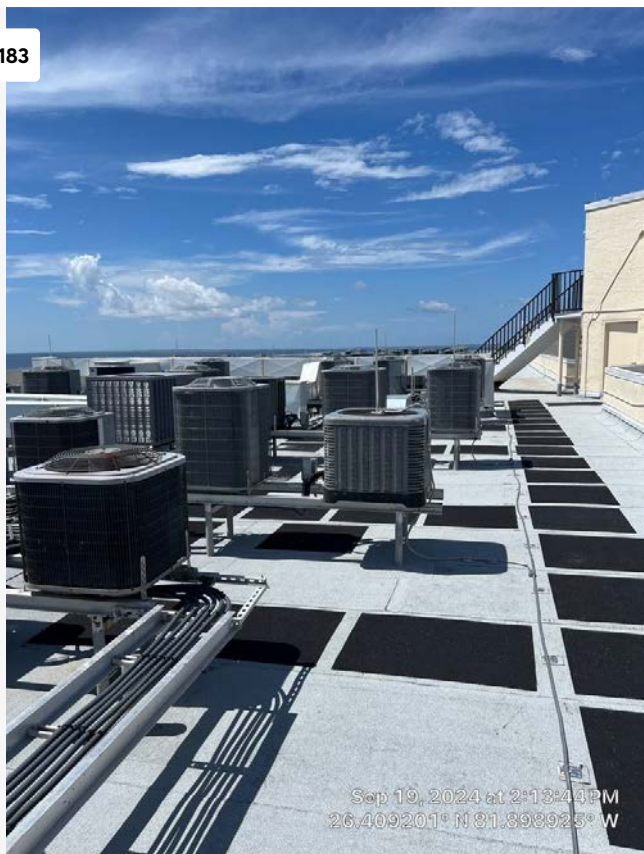
Looking north on roof at Riviera Club. Overall condition of roof appears to be very good.

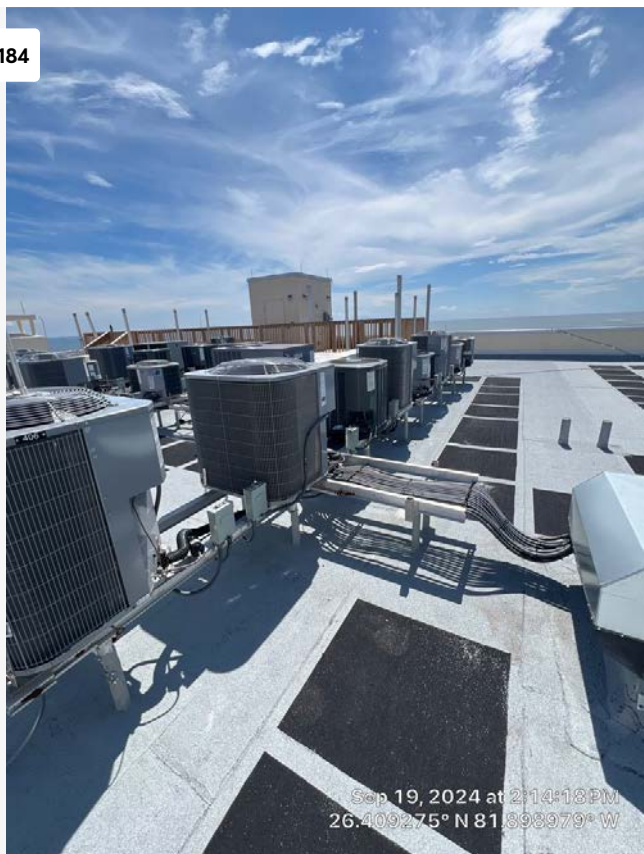
View looking east at AC clusters. All hurricane straps appear to be in like new condition.

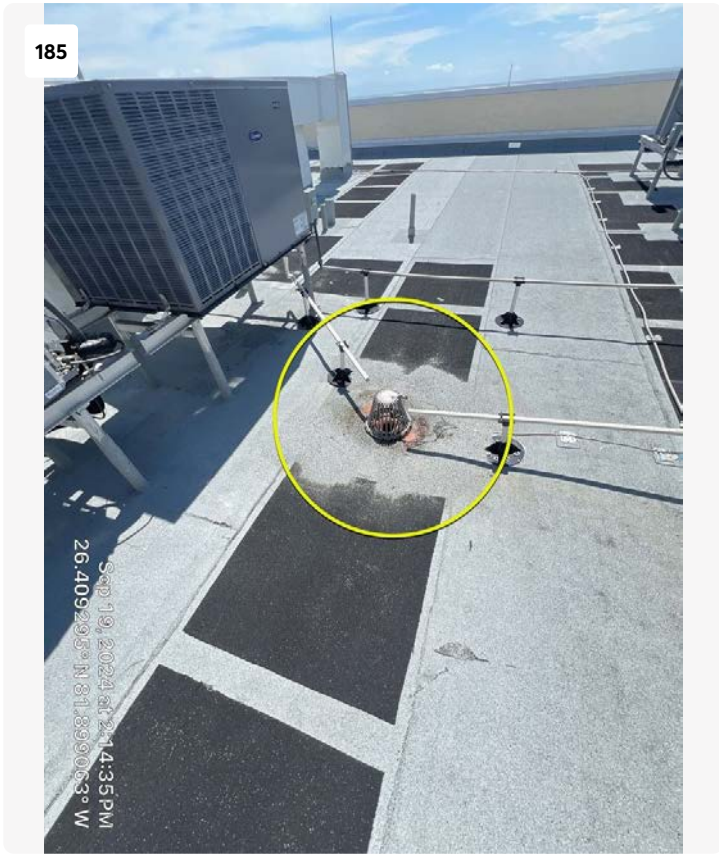
Roof drains are well maintained and free of debris.

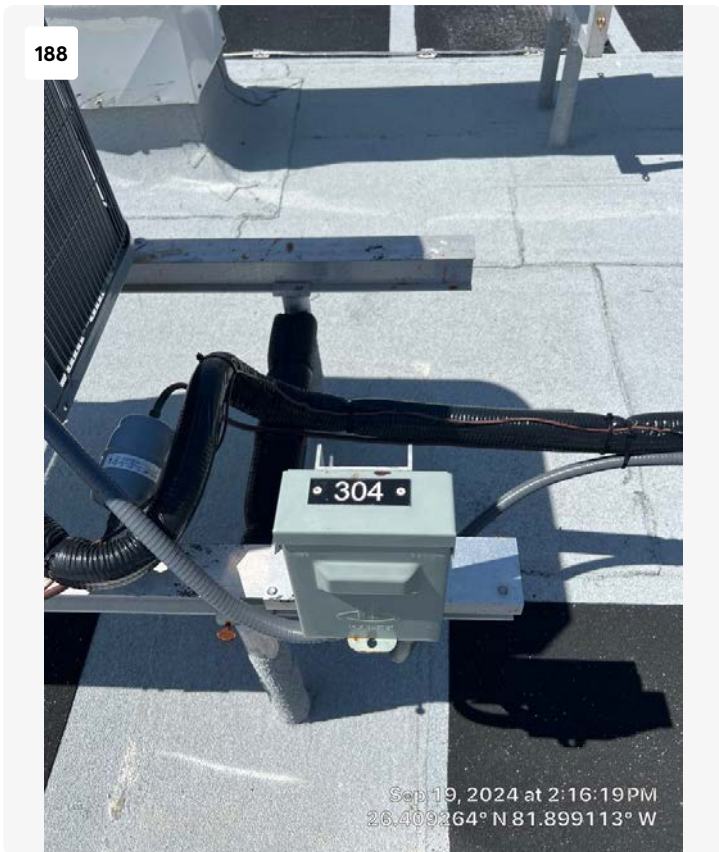
Typical of excellent conditions noted on roof of building.

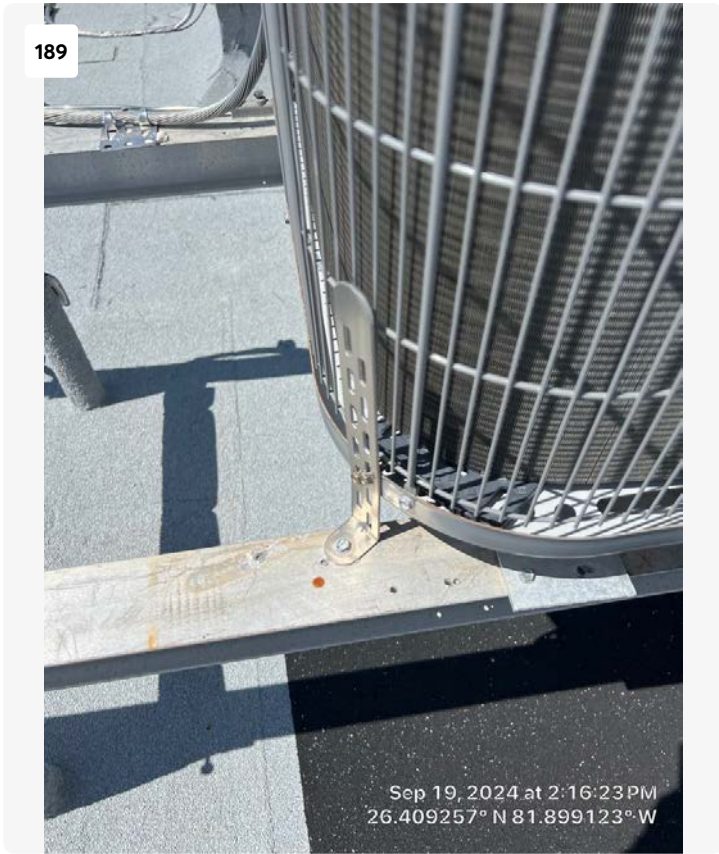
All hurricane fasteners are present and in like new condition.

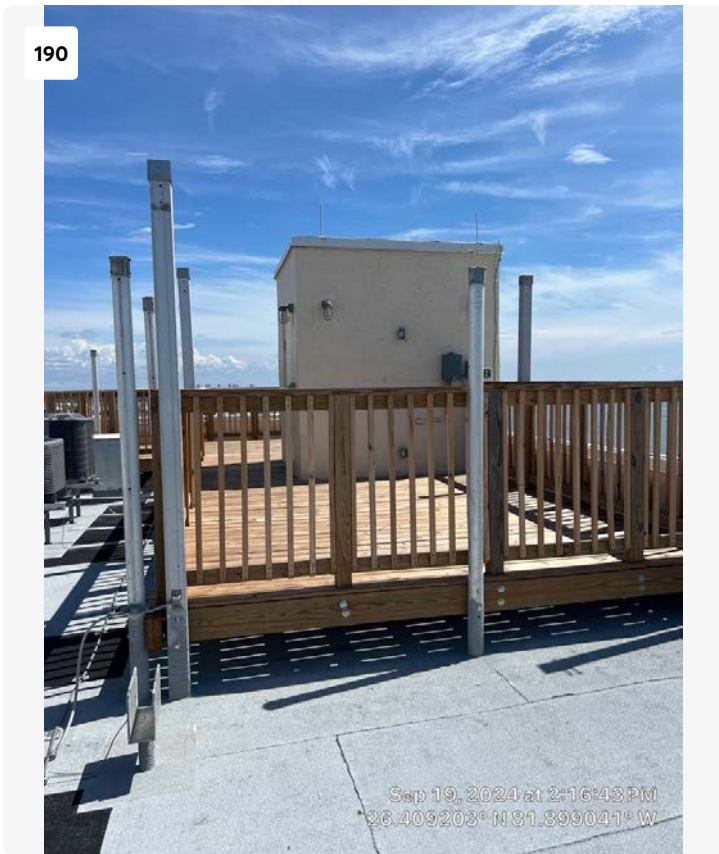
Observation deck on southeastern corner of roof.

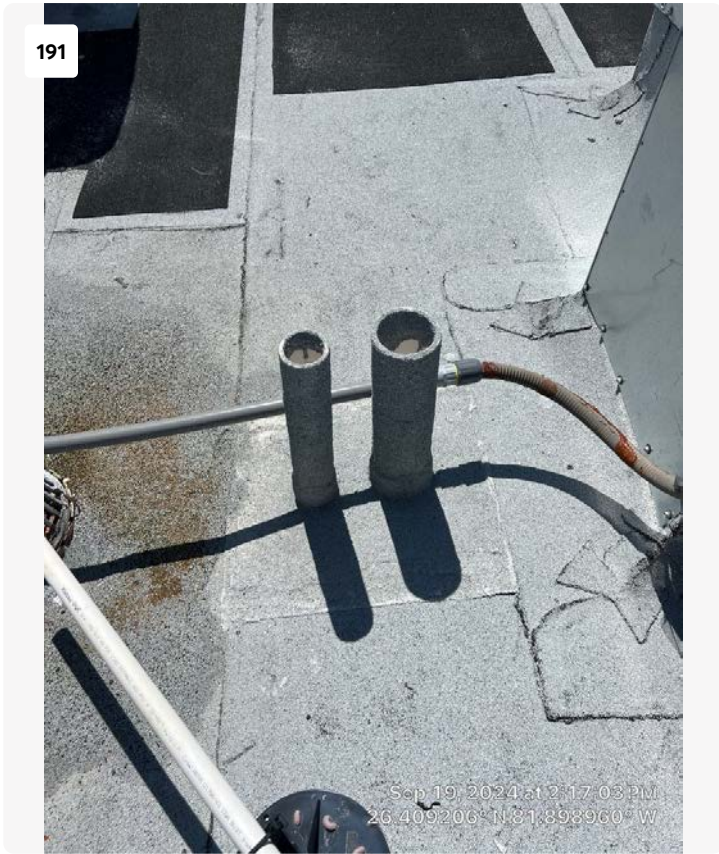
Project: Riviera Club
Date: 9/19/2024, 2:16pm
Creator: Field Tech #1
