Riviera Club Association, Inc.

April 23, 2024 • Fort Myers Beach, FL

**STRUCTURAL INTEGRITY
RESERVE STUDY**

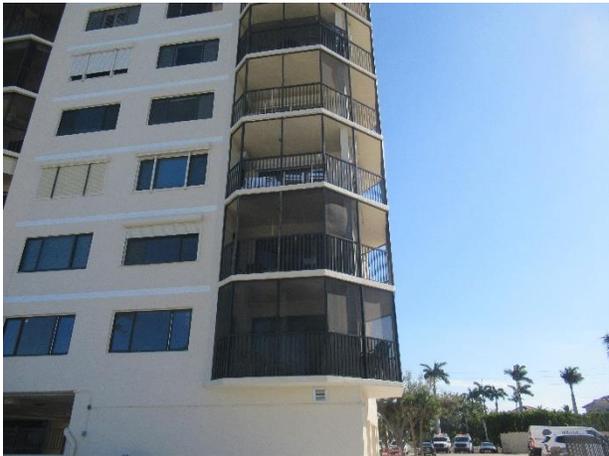
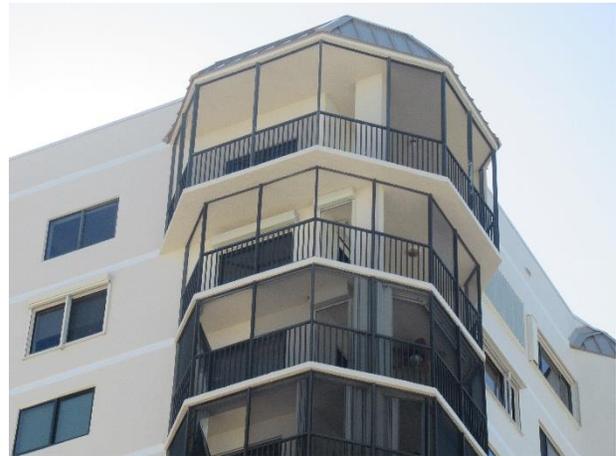
History: Repaired and coated in 2024

Condition: Good to fair overall with no significant deterioration evident.

Balcony overview

Useful Life: Capital repairs including a close-up visual inspection, patching of delaminated concrete, routing and filling of cracked concrete, and waterproof coating replacements every 10- to 15-years.

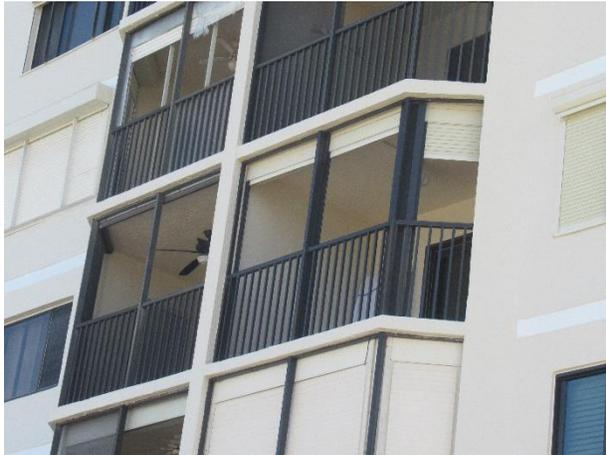
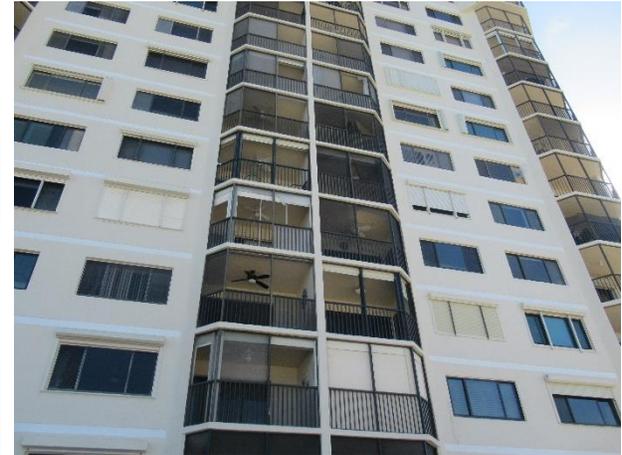
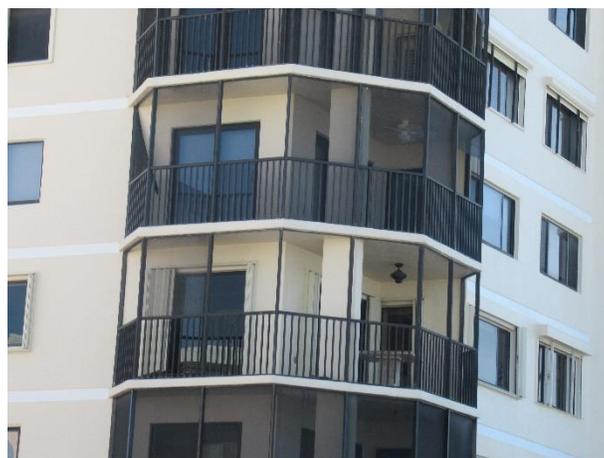
History: Last replaced in 2000. The Association plans to replace the screens and frames in 2024.

Condition: Poor overall with frequent screen damage

Screen damage

Useful Life: 20- to 30-years

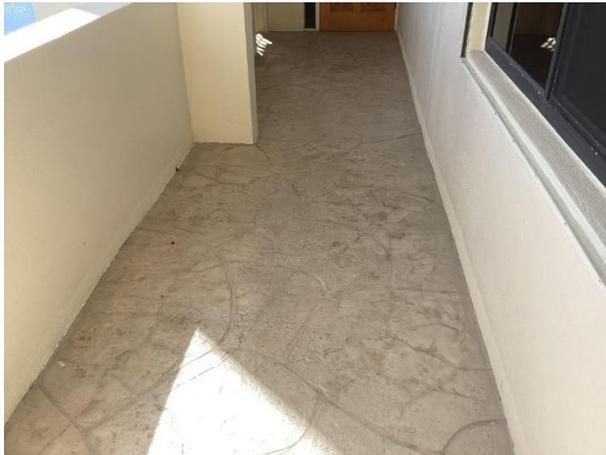
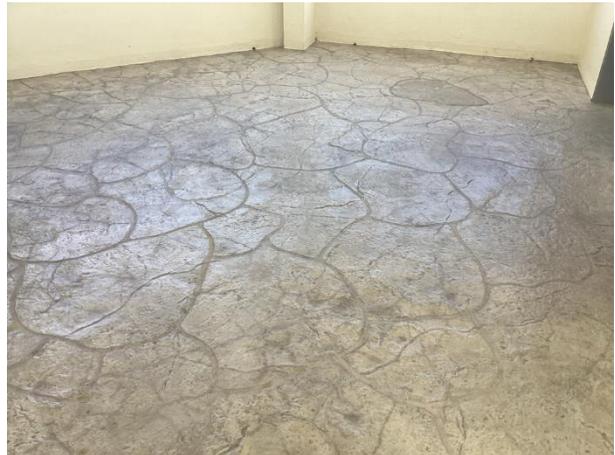
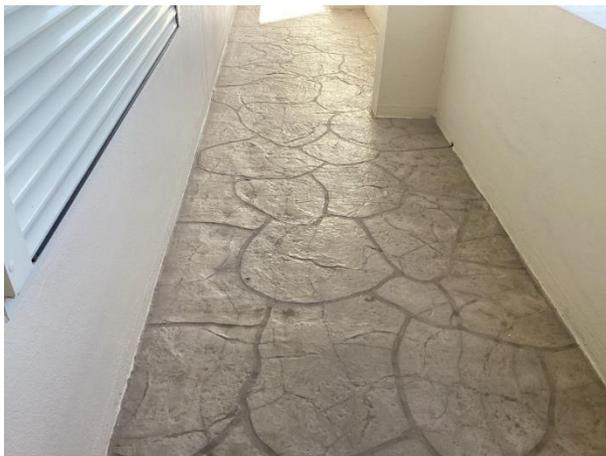
History: Waterproof coatings were applied in 2014 and the breezeways were sealed in 2022.

Breezeway overview

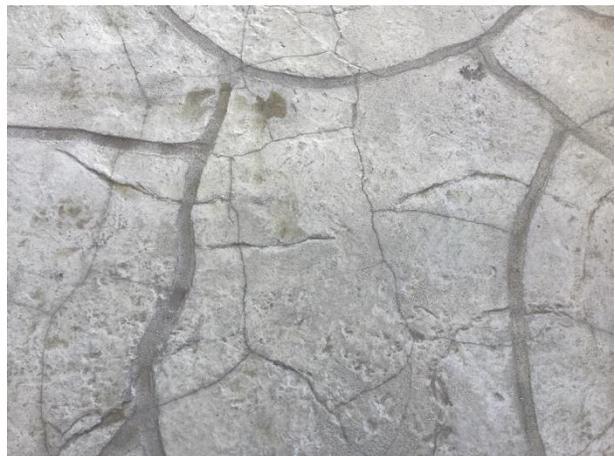
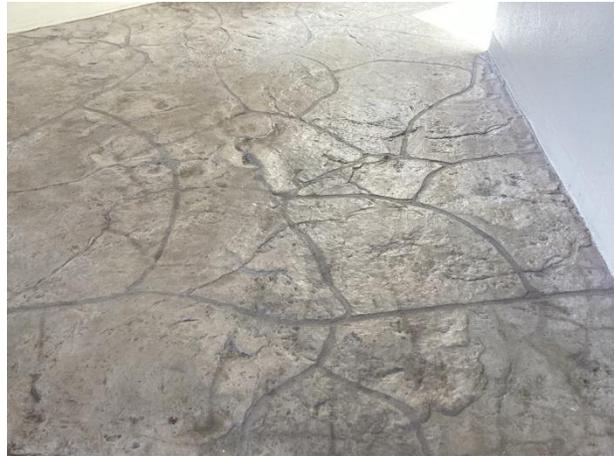
Condition: Good to fair overall with isolated cracks evident

Breezeway cracks

Useful Life: Capital repairs including a close-up visual inspection, patching of delaminated concrete, routing and filling of cracked concrete, and waterproof coating replacements every 15- to 20-years.

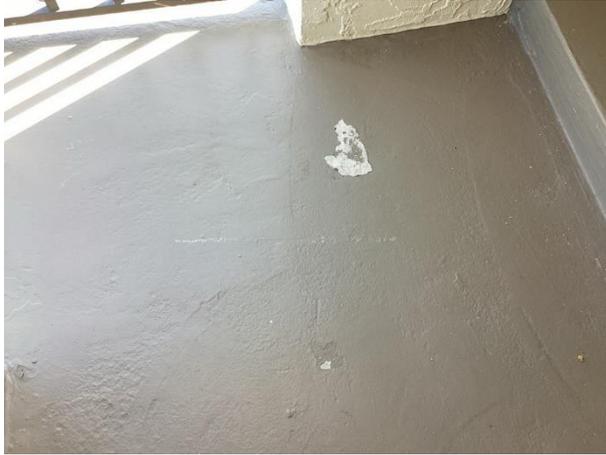
Coating deterioration

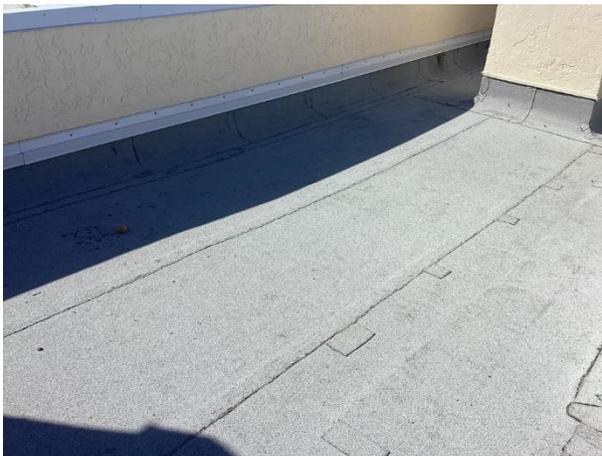
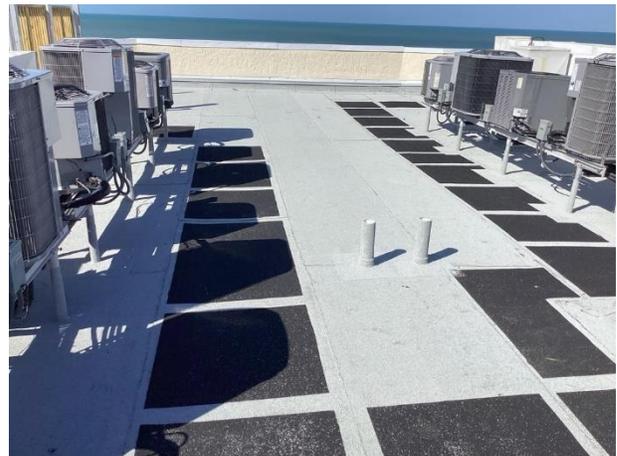
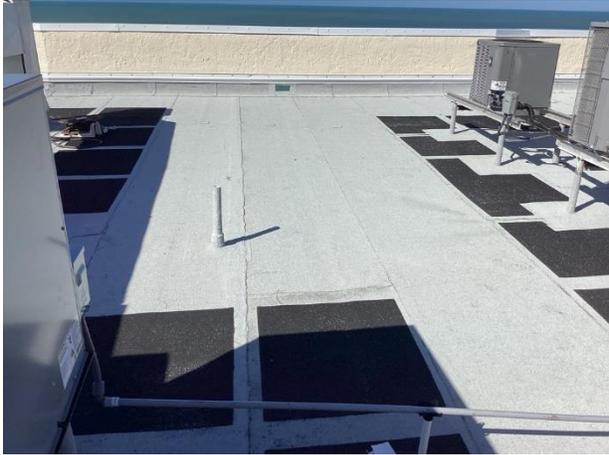
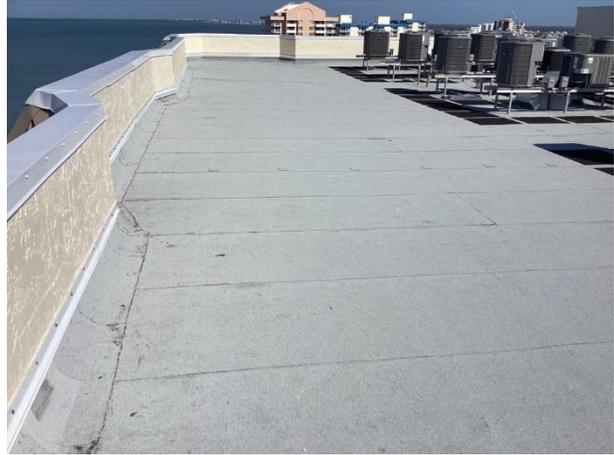
History: Replaced in 2024

Condition: Good overall

Modified bitumen roof overview

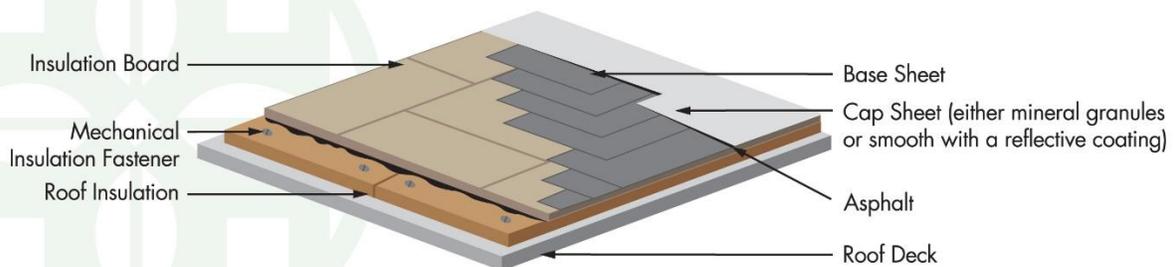
MODIFIED BITUMEN ROOF DETAIL

Component Detail Notes: Modified bitumen roofing systems are composed of factory manufactured sheets of polymer-modified bitumen with polyester and/or fiberglass reinforcements. The bitumen adds a waterproof characteristic to the system and the reinforcements add strength and puncture resistance. These factory-assembled roofing systems offer the advantages of a built-up roofing system through a less labor-intensive installation. The following detail depicts a typical modified bitumen roof although it may not reflect the actual configuration at Riviera Club:

Contractors can install a new modified bitumen roof in one of two ways: *tear-off* or an *overlay*. An overlay is the application of a new roof membrane over an existing roof. This method, although initially more economical, often covers up problems with the deck, flashing and saturated insulation. The tear-off method of replacement includes removal of the existing roofing, flashings and insulation, and installation of a new roofing system.

The contractor should follow the manufacturer's directions and specifications upon installation of the roof. The contractor should remove the original insulation if saturated or compacted and apply a new layer of insulation per the manufacturer's instructions. The insulation should fit loosely with gaps no greater than ¼ inch. Gaps will cause failure of the membrane later. Mechanical fastening of the insulation is the best manner of installation. The contractor applies the base sheet of roofing over the insulation board. This sheet is normally 30-pound material. The contractor should start the installation of a roof membrane from the lowest points of the roof. Mechanical fastening and embedding the base sheet in a flood coat of hot asphalt is the best manner of installation. The membrane and plies are either torch applied (thermoset) or hot asphalt applied. We recommend the contractor use the torch method to install a modified bitumen membrane roof system.

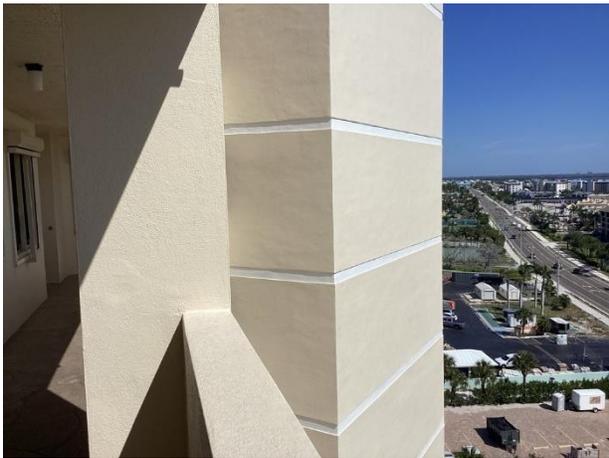
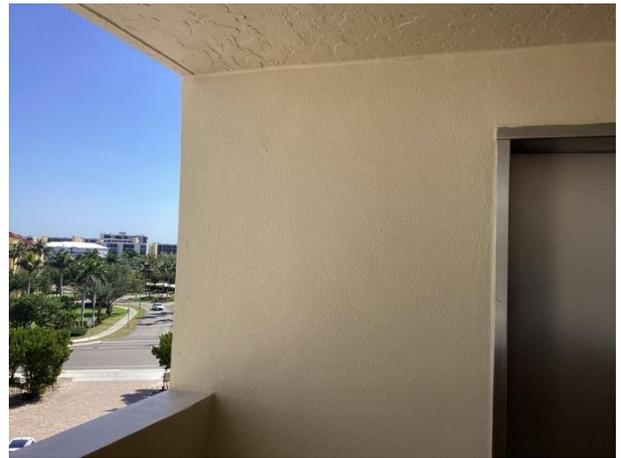
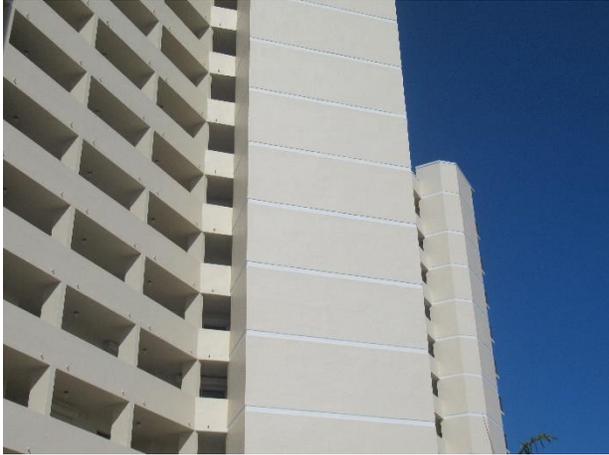
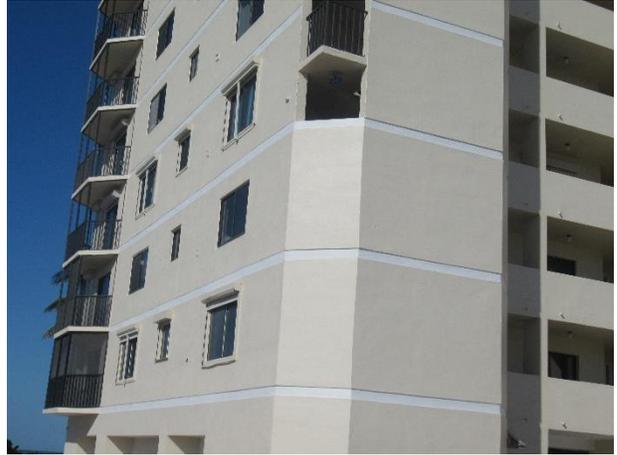
History: Painted and repaired in 2024

Condition: Good overall with no significant deterioration evident.

Stucco wall finishes

Useful Life: We recommend inspections, repairs and paint finish applications every five-to seven-years.

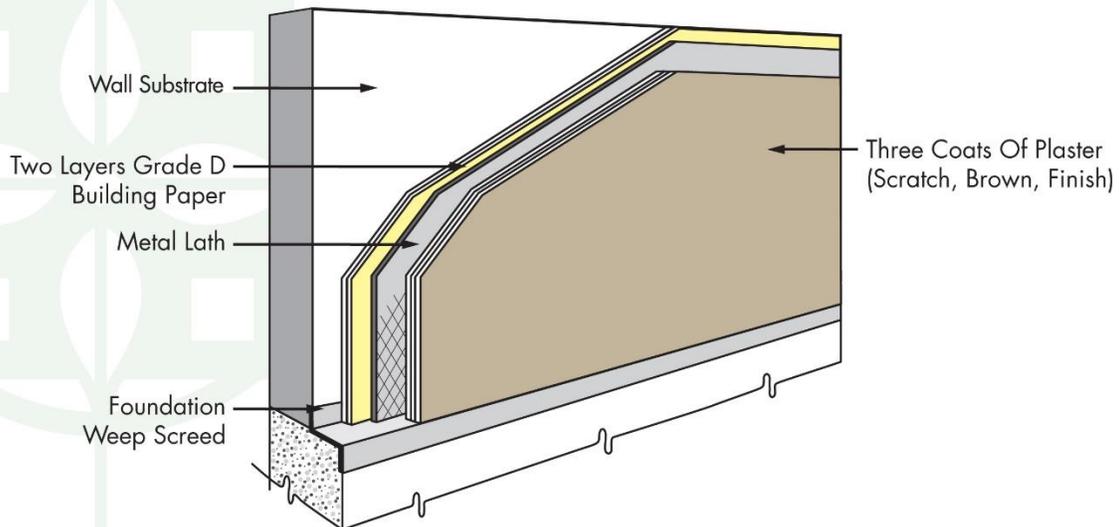
STUCCO DETAIL

Component Detail Notes: The following graphic details the typical components of a stucco wall system on frame construction although it may not reflect the actual configuration at Riviera Club:

Correct and complete preparation of the surface before application of the paint finish maximizes the useful life of the paint finish and surface. The contractor should remove all loose, peeled or blistered paint before application of the new paint finish. The

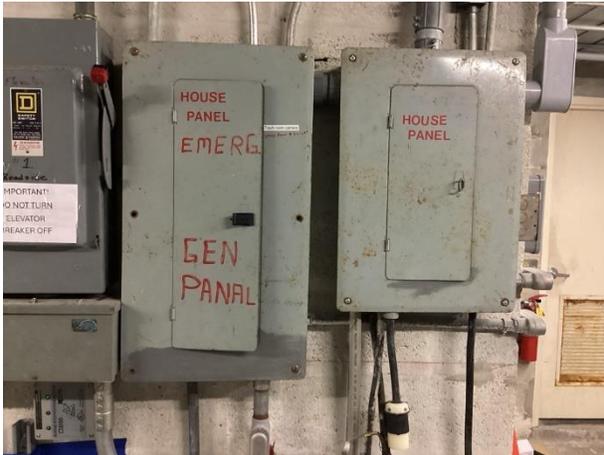
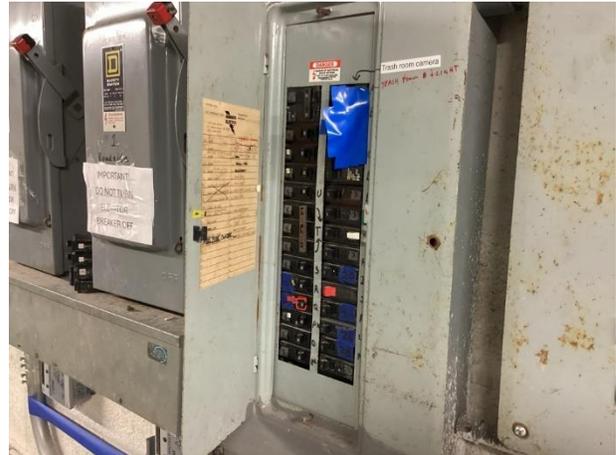
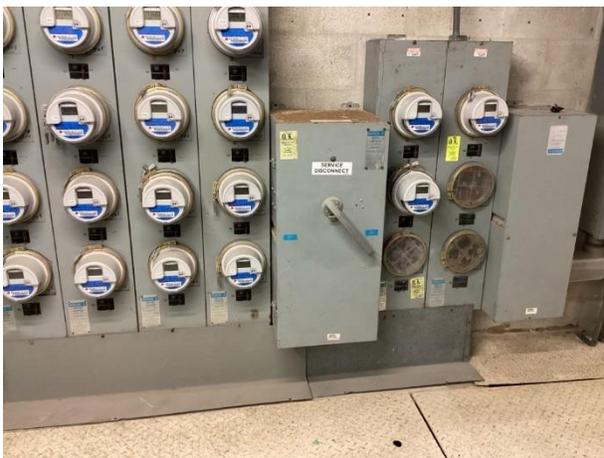
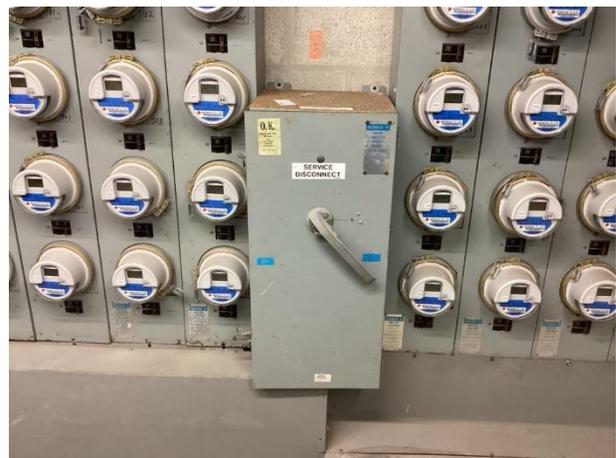
History: Primarily original to construction

Condition: Reported good to fair overall and the Association reports no issues at this time.

Electrical system components

Electrical system main panel

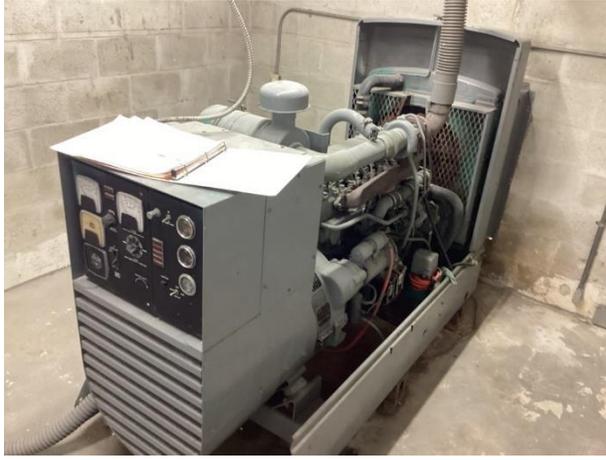
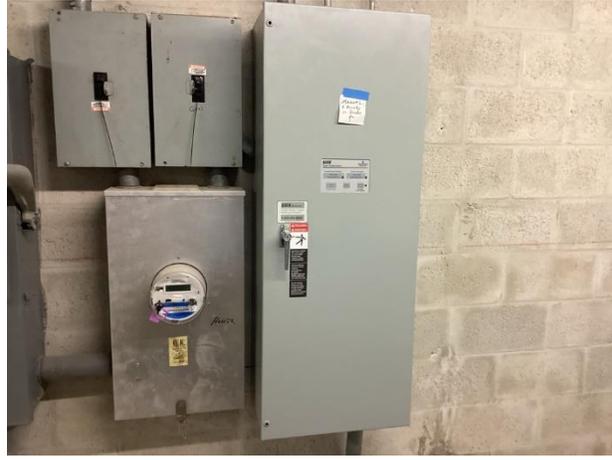
History: Mostly original. The Association informs us they have replaced the fuel tanks.

Condition: Reported satisfactory without operational deficiencies

Emergency generator

Transfer switch

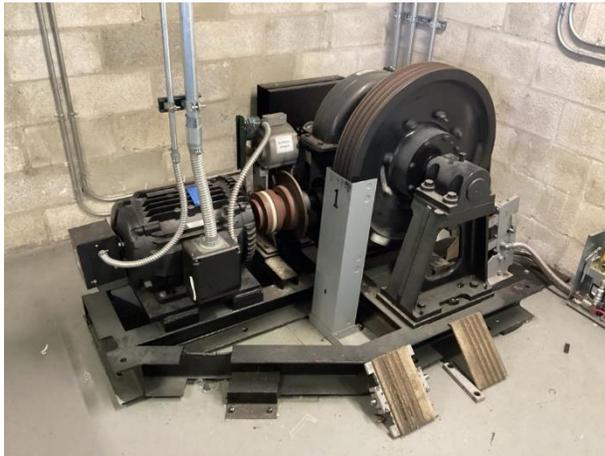
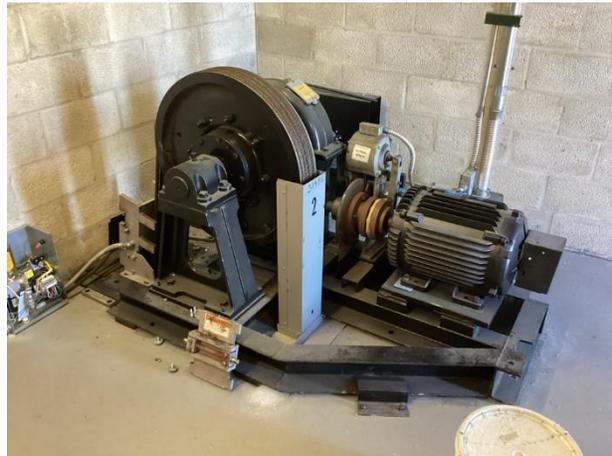
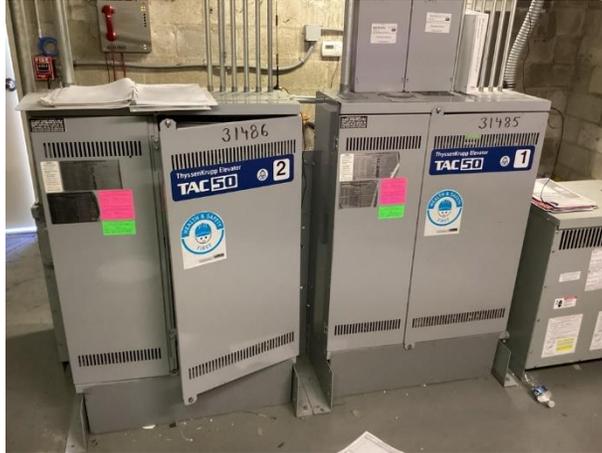
- Controls and call buttons: Major repairs conducted in 2024 for approximately \$250,000.
- Hoists and motors: Original

Condition: The controls and call buttons are reported in satisfactory condition and the hoists and motors are reported in satisfactory condition. Service interruptions are reportedly infrequent.

Traction elevator equipment

Traction elevator controls

Useful Life: Up to 25 years for the controls and call buttons and up to 40 years for the hoists and motors. However, the scarcity of parts, and the potential frequency and duration of service interruption makes controls replacement more desirable as the components age.

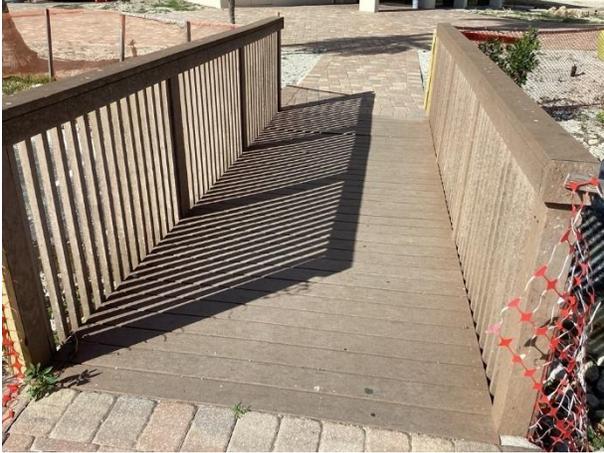
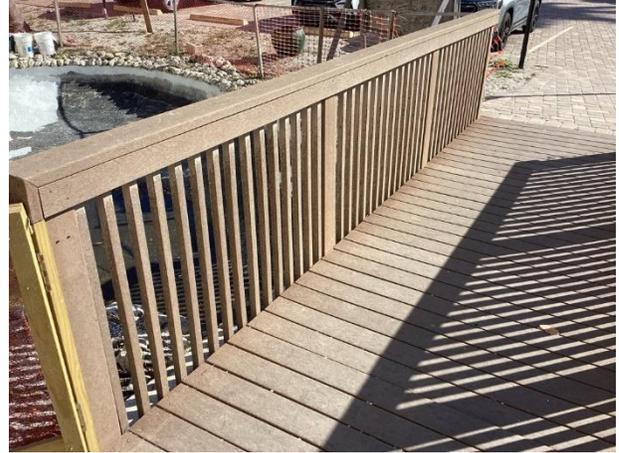
History: Replaced in 2008

Condition: Good to fair overall

Bridge overview

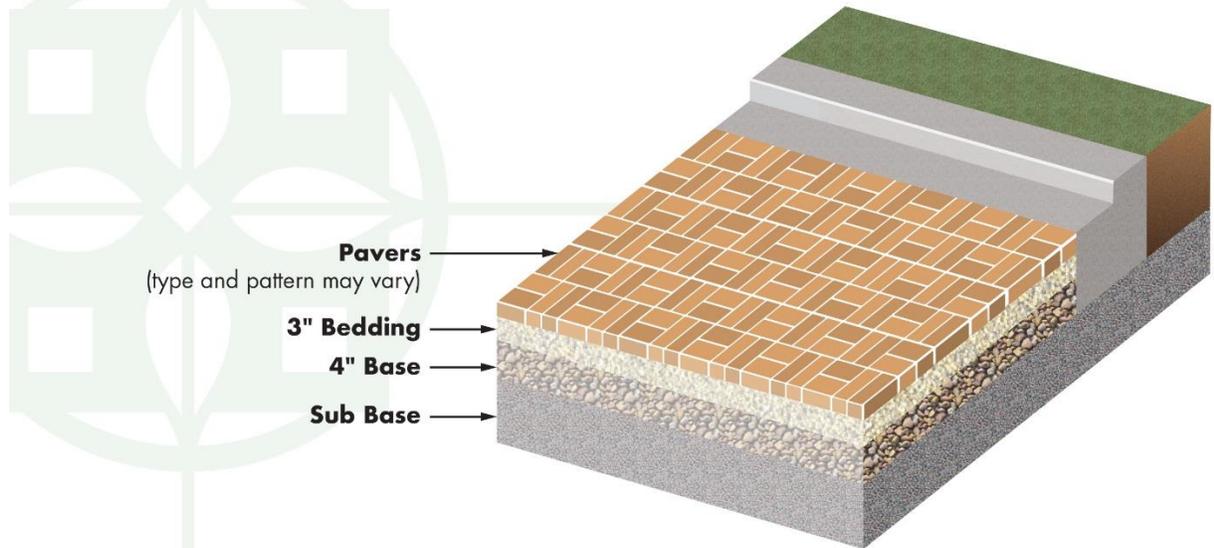
MASONRY PAVER DIAGRAM

Component Detail Notes: The following diagram depicts the typical components of a masonry paver system although it may not reflect the actual configuration at Riviera Club:

Preventative Maintenance Notes: We note the following select recommended preventative maintenance activities to maximize the remaining useful life:

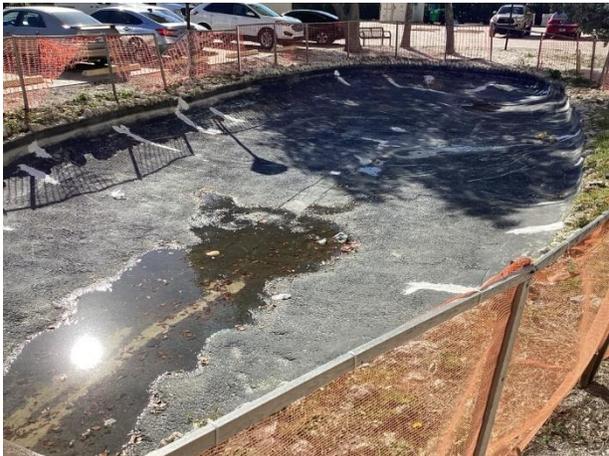
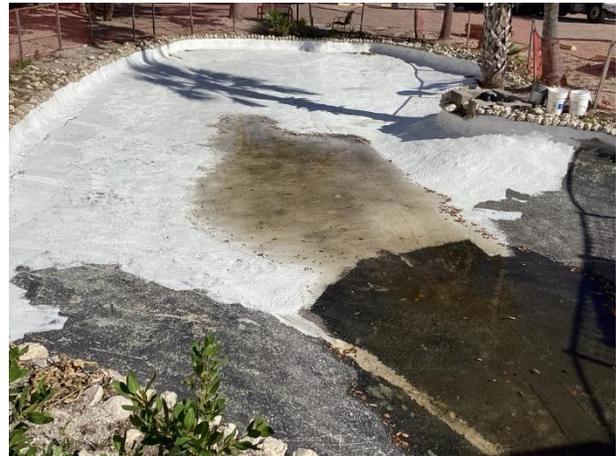
History: The structure is being repaired and coated in 2024.

Condition: Good to fair overall

Pond structure overview

Useful Life: 8- to 12-years for repairs and waterproof coatings and up to 60 years for the structure replacement
